FINAL REPORT AIRCRAFT SERIOUS INCIDENT

M-00511/AIG-05

TF-FIH

Boeing 757-200 PCF

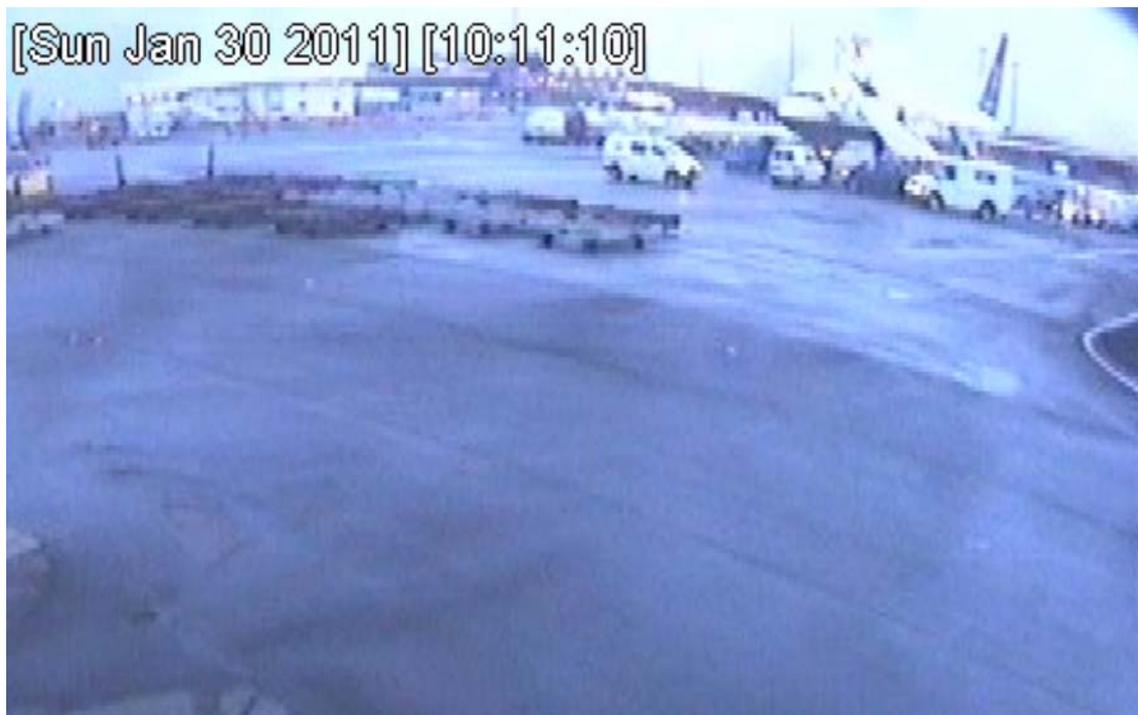
Figure 2 – Stand 20 as seen on airport surveillance video

The airport surveillance video shows the main cargo door on TF-FIH starting to sway back and forth in the fully open position at 10:11:10. Figure 2 gives a snap shot of this, as the main cargo door sways past its top position.

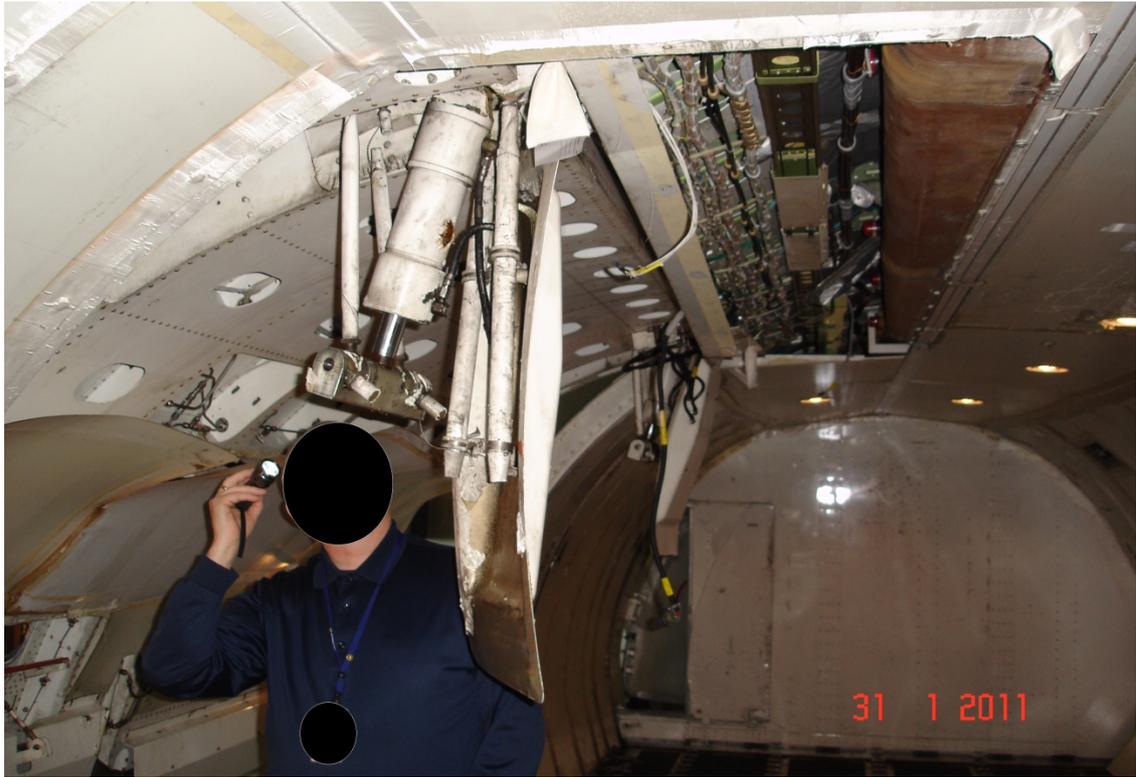
The door hinges at the top of the main cargo door had gouge markings along their total length and pulled fasteners were found in many locations. All four rods in the upper forward and aft position of the main cargo door were sheared off. Supporting assemblies for the rods were torn out. The forward and aft hydraulic actuators were pulled out of position and partially sheared off. The upper sill inner skin was buckled. The upper sill beam assembly was buckled and cracked in several places. The next two pages contain pictures showing the damage (marked as Figure 3).

Door hinge damage

- Review the structural design of the main cargo door with respect to the 45 knots maximum wind operation loading and make the necessary design changes in order to meet the requirements of FAA FAR and EASA CS, subchapters 25.301(a) and 25.303.

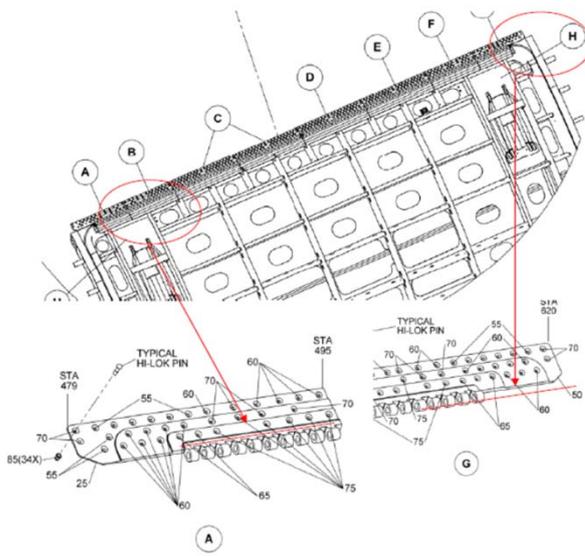
AFT support assembly hinge torn

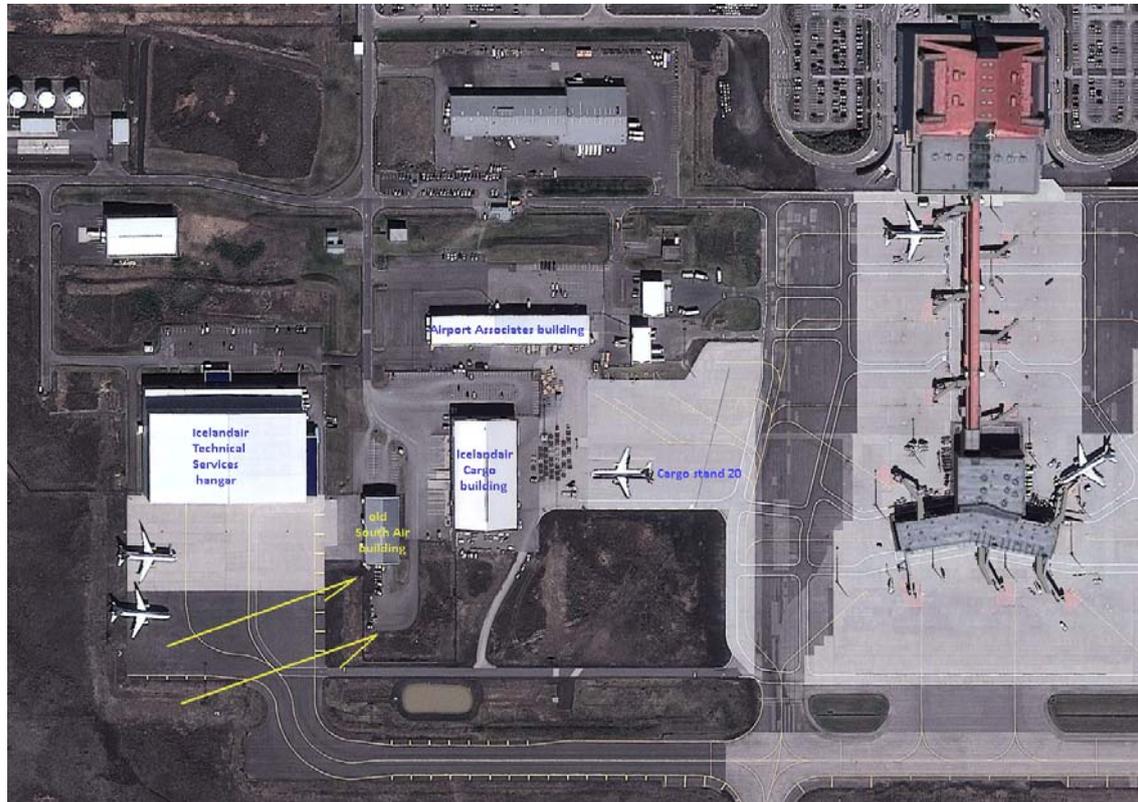
Figure 5 : Cargo stand 20 and surrounding area (yellow arrows indicate wind direction)

Cargo stand 20 at Keflavik International Airport is located close to several large buildings and hangars, as seen in Figure 5. At the cargo stand the local wind conditions are likely to vary slightly from those measured at the RWY11 and RWY20 monitoring stations, due to local wind channeling effects between buildings.

The flight operator set this limit to allow a 10 knot buffer to the manufacturer's limit in high winds. The flight operator also installed in cooperation with Isavia¹³ a wind monitoring station at the cargo ramp, to measure the actual wind where the cargo aircraft are parked. The procedures for the operator's maintenance control and/or central load control are as follows:

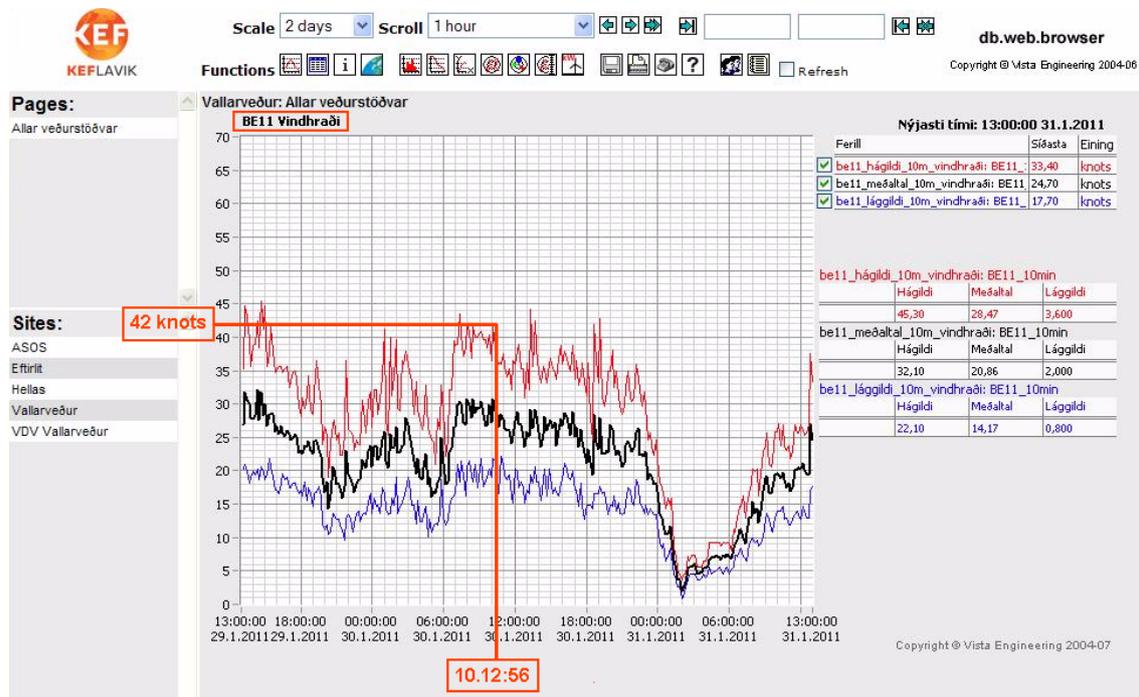
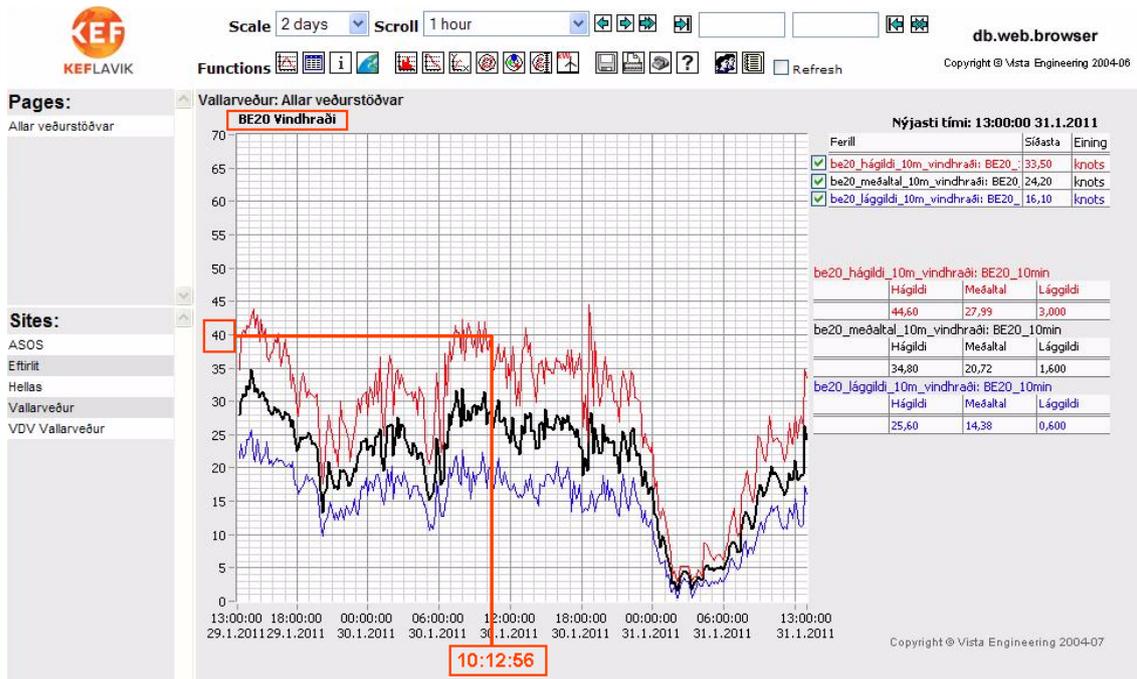
The actual wind data was collected from the two closest wind monitoring stations at the airport, i.e. at RWY11 and at RWY20. Figure 6 to Figure 9 in the Appendix show the wind direction and the wind strength when the incident occurred. Special attention should be given to the highest (gust) values at the time of the incident, which were as follows:

- RWY11 monitoring: Gust 42 knots from a direction of 282°
- RWY20 monitoring: Gust 40 knots from a direction of 280°

Therefore, at the time of this serious incident the maximum gust at the closest airport wind monitoring stations was 42 knots from a direction of 282°. This is 3 knots below the (actual or anticipated) maximum operating wind limit, set by the Precision Conversions B757-200PCF Operations Manual, for the main cargo door.
