## Report on aircraft serious incident

Case no: **M-00513/AIG-04**

Location: **Keflavik Airport (BIKF)**

Description: **Uncommanded left roll during final approach**

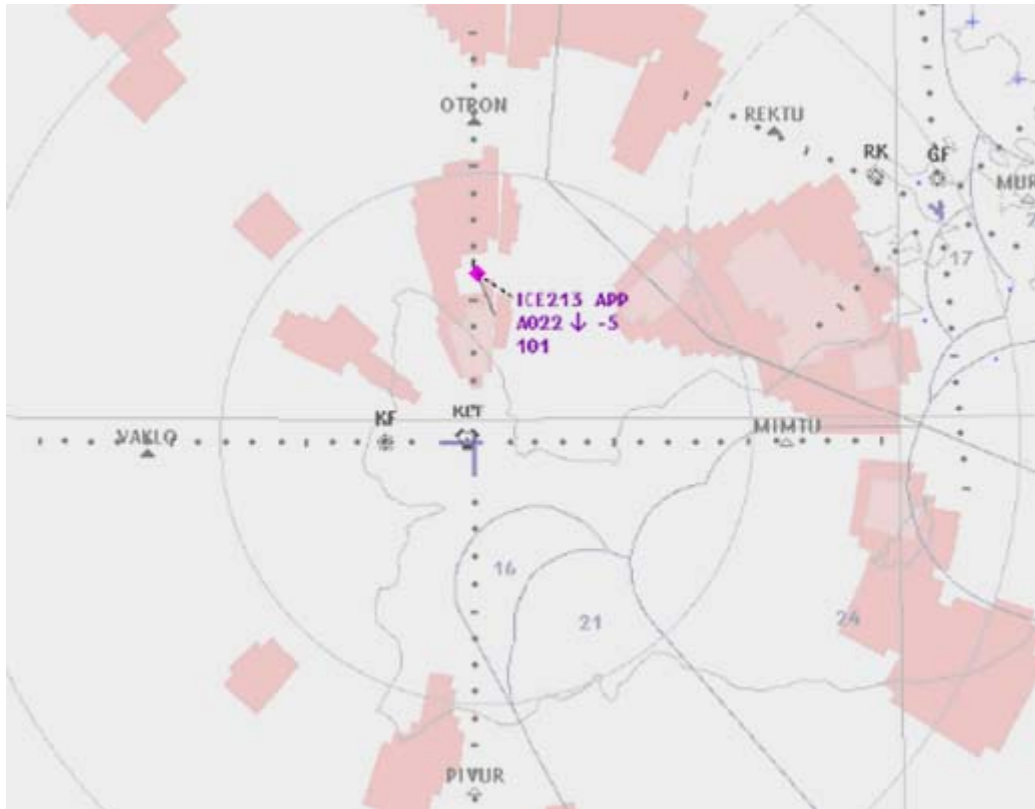
The flaps were extended and the landing gear selected down. At 22:26:47, during night, when the flaps had reached the 30° position, the flying pilot [first officer] noticed vibration and the airplane started an uncommanded roll to the left. The airplane was at an altitude of 2400 feet and a distance of 7 NM from the runway when this occurred. The flying pilot scanned the instruments, expecting to see asymmetry indications on the EICAS, but there were none. The flying pilot then noticed that according to the “trend vector” the airplane was beginning to turn to the left. See Figure 1 for details.

Figure 1: The airplane (ICE213) starts to turn to the left (ATC radar)

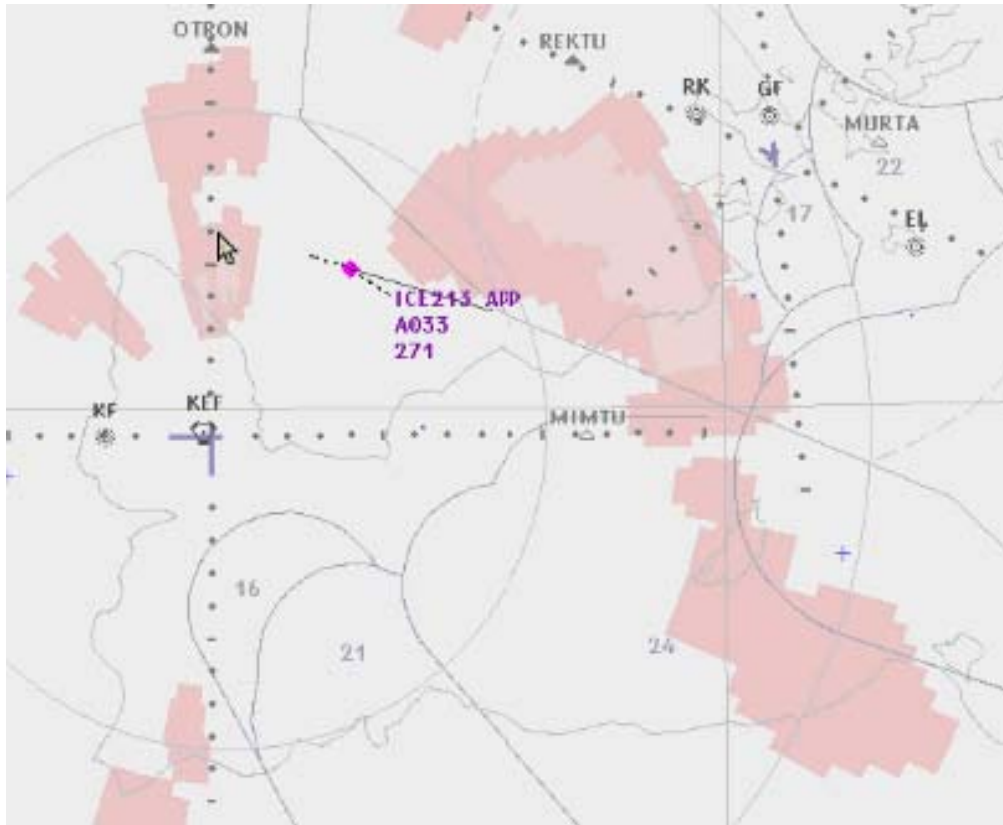
One minute and 21 seconds after the upset, at 22:28:09, following a descent rate of about 3500 feet/min for few seconds and the pilot flying declaring that they were descending too quickly, the commander declared an emergency to ATC. At the same time flap retraction was stopped with the flaps in 1° flap position, leaving the airplane in a flap overspeed condition. At this time the airplane was located as shown in Figure 2.

Figure 2: Location of TF-FIJ when the commander declared an emergency at 22:28:09

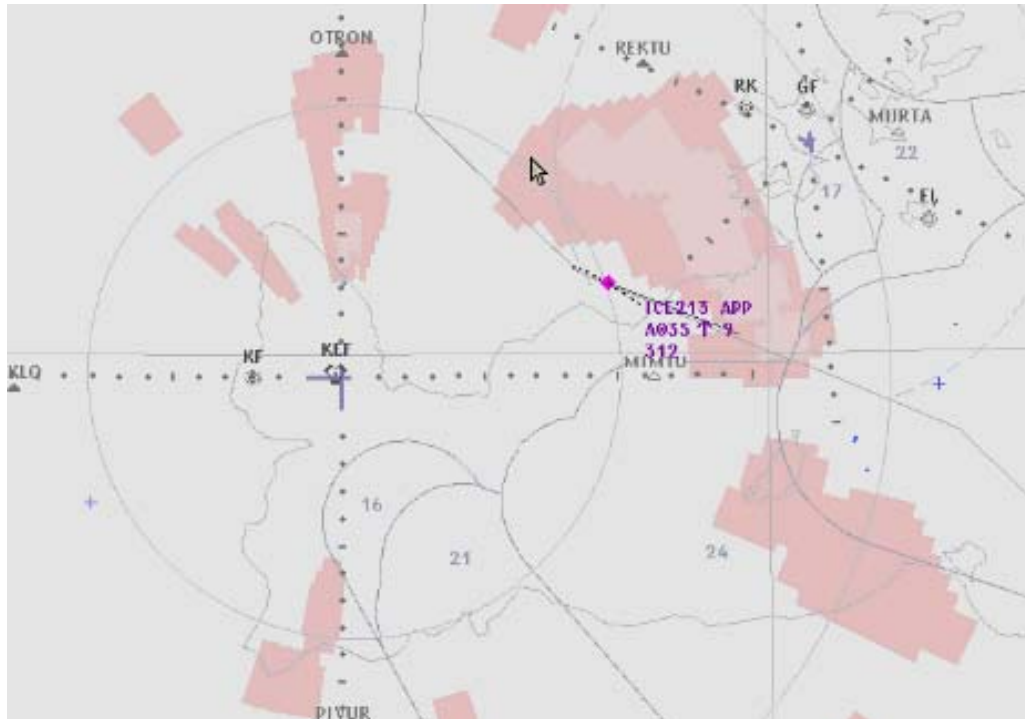
The commander took over as the pilot flying two minutes and 22 seconds after the upset, and seven second later the first officer replied to the ATC officer [in Icelandic]: “*We’re going to start by regaining control of the airplane. We have lost the right hydraulic system and it behaves strangely. We are trying to regain control and would like to continue the present course if possible.*” At this time the airplane was located as shown in Figure 3.

Figure 3: The flight crew replied to Keflavik tower ATC officer that they were trying to regain control

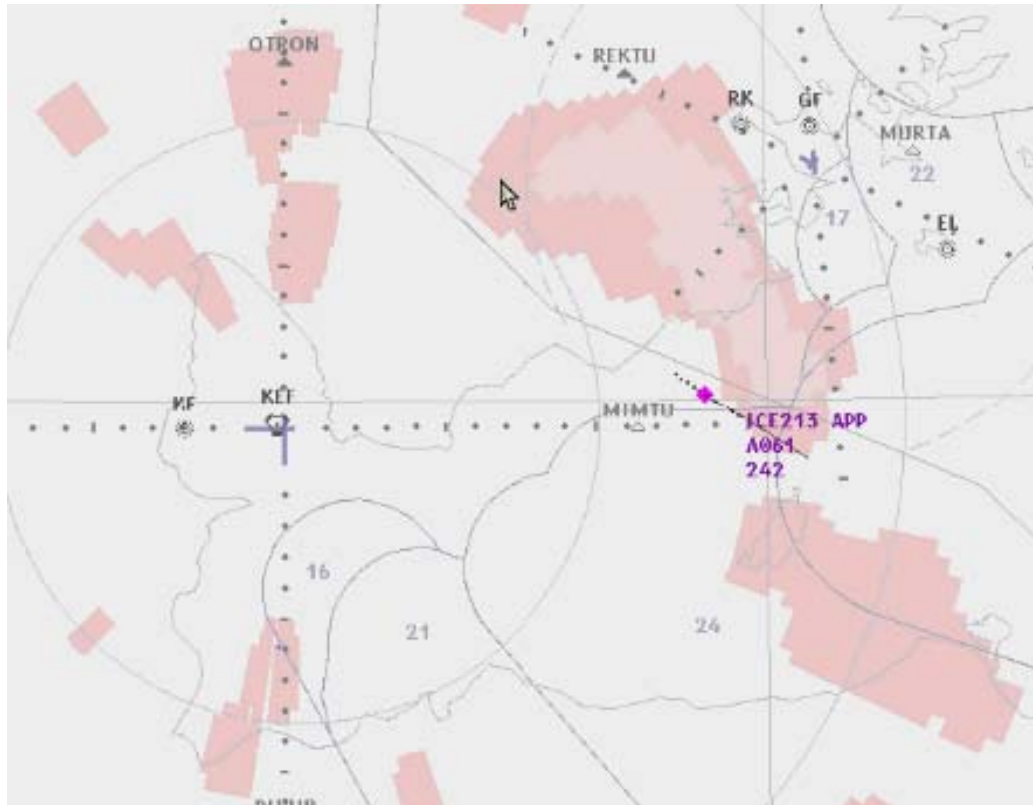
Three minutes and 22 seconds after the initial upset, the flight crew contacted ATC and advised that they had regained control of the airplane. At this time the airplane was located south of “Straumsvík” as shown in Figure 4.

Figure 4: The flight crew contacted ATC and notified that they had regained control at 22:30:09

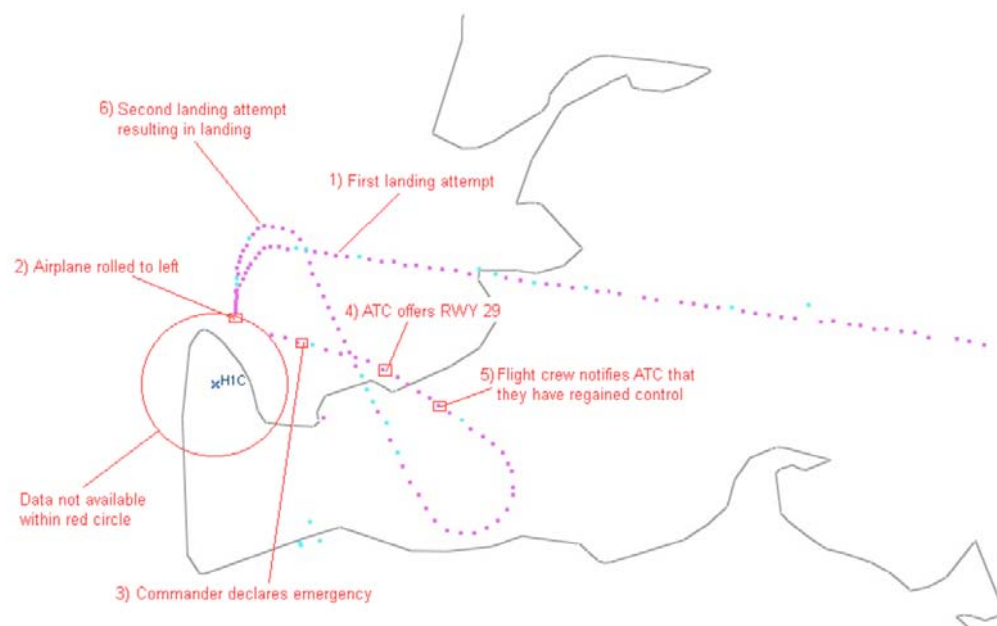
In Figure 5 below, the flight radar track is shown with combined details on what occurred during the incident.

Figure 5: Detailed explanation on radar plot

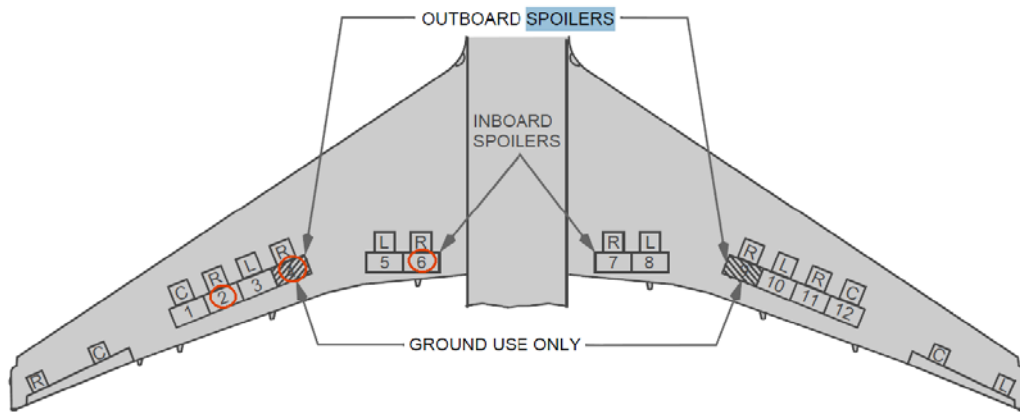
- Removing hydraulic pressure from the spoiler's system
- Physically, trying to move the spoilers by a "strong" hand
- Spoiler #2 did not move
- Spoiler #4 was stiff, but did move
- Spoiler #6 was loose and moved easily
- See Figure 6 for details on spoilers location

**Figure 6: Spoilers on B757-200 airplanes**

It was confirmed that spoiler #4 and #6 were not fully locking down as required during hydraulic system backpressure loss. It was decided to remove all three spoiler actuators on the left wing that were connected to the right hydraulic system (# 2, #4 and #6) and to send them for further testing at the component manufacturer's site, Moog. Figure 7 shows one of the actuators shipped to Moog.

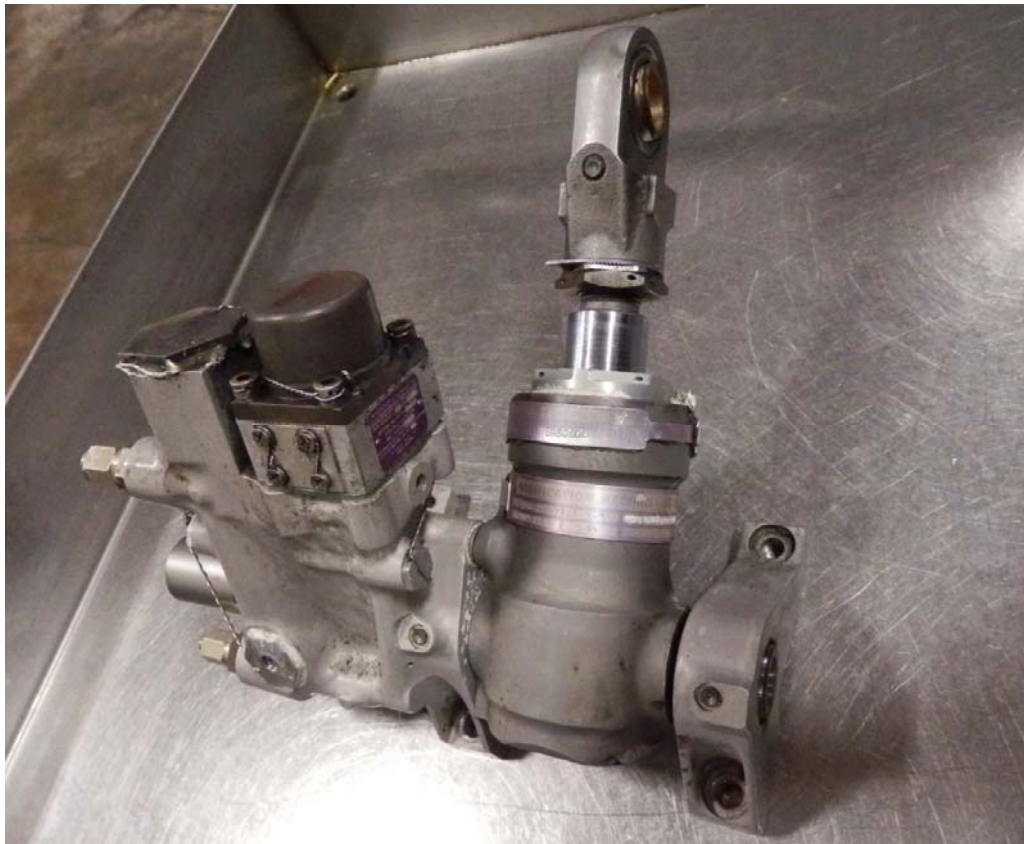
**Figure 7: One of the actuators shipped to Moog**

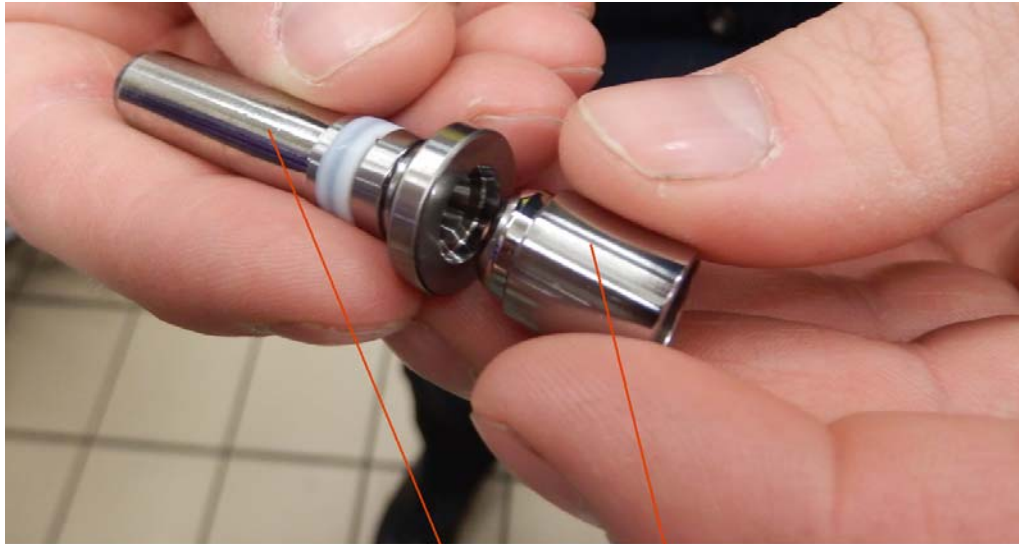
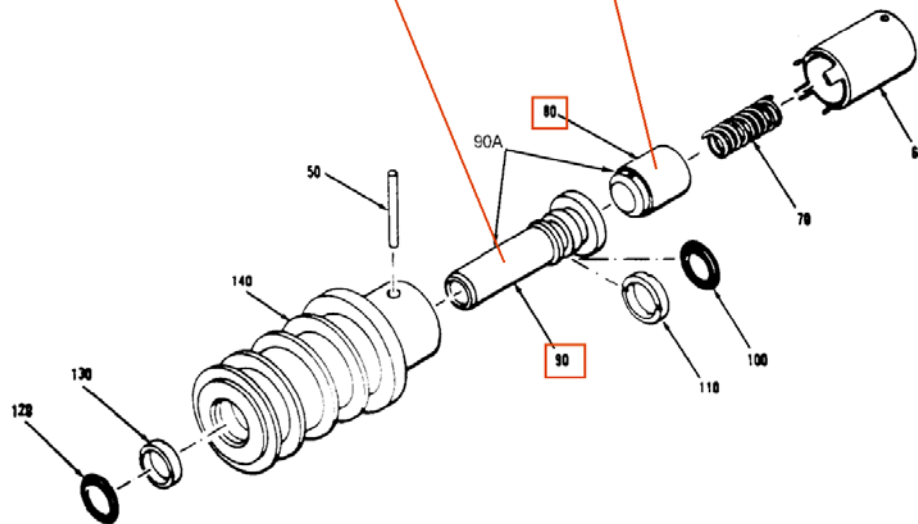
The teardown inspection on the actuator for spoiler #4 revealed microscopic scratches on the blocking and thermal relief valve seat (item 90 in Figure 8) and the poppet (item 80 in Figure 8). These microscopic cracks were believed to be the source of the failed tests on the #4 spoiler actuator, as they allowed tiny leak of hydraulic fluid.

**Figure 8: Actuator of spoiler #4 - Blocking and thermal relief valve – Scratches on seat and poppet**

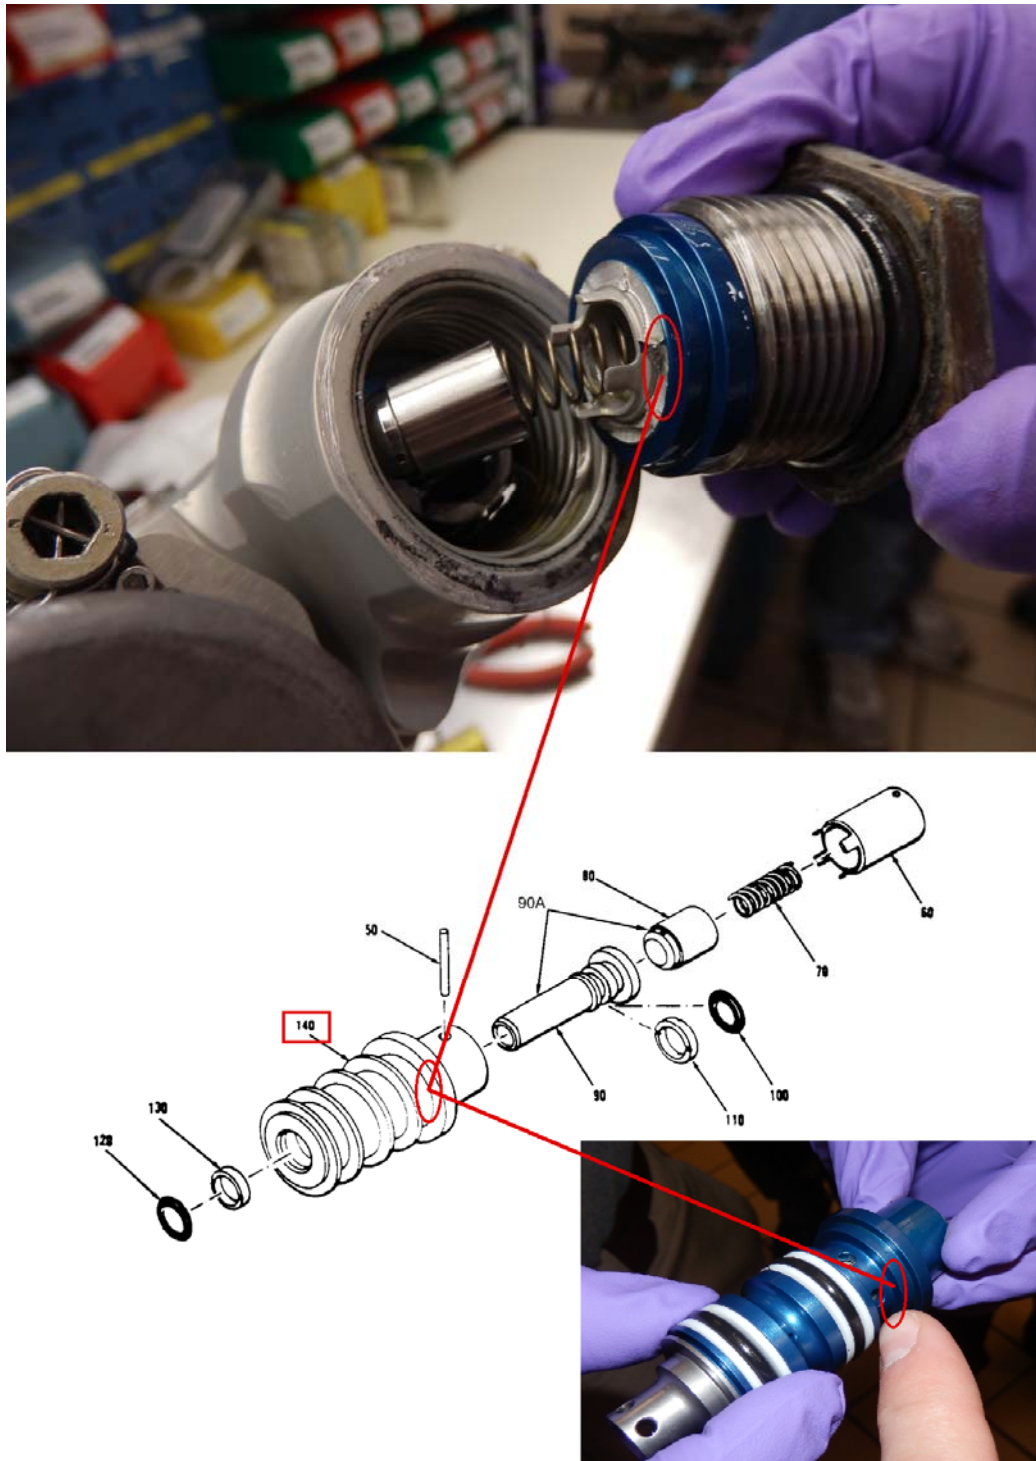
In the case of the actuator for spoiler #6, once the disassembly started it quickly became apparent that the Blocking and Thermal Relief Valve Housing (item 140 in Figure 9) was fractured. The component manufacturer (Moog) advised having seen this failure mode on several occasions, during overhauls, although never as a part of reported in-flight incident. These cases had not been reported to Boeing (the airplane manufacturer).

**Figure 9: Actuator of spoiler #6 - Blocking and thermal relief valve - Housing fractured**

According to Boeing the function of the Blocking and Thermal Relief Valve Housing is to hold down the spoiler in the event of a hydraulic failure. Normally, hydraulic pressure would hold the broken halves together, but with the loss of hydraulic pressure, the halves separate, allowing large scale leakage and spoiler float.

The fractured Blocking and Thermal Relief Valve Housing, in spoiler #6 actuator, was a latent<sup>14</sup> failure. It did not raise any flags with maintenance, because with the right hydraulic system working the hydraulic pressure in the actuator kept the spoilers from floating.

Once the right hydraulic system became non-functioning, due to the cracked hydraulic tube, the hydraulic back pressure in the actuator was no longer present. This, combined with the fractured Blocking and Thermal Relief Valve Housing, allowed spoiler #6 to float when the flaps were fully extended.

- Redesigned the Blocking and Thermal Relief Valve Housing with thicker material section and more radius in the area of the fracture surface. The redesigned Blocking and Thermal Relief Valve Housing is made from stainless steel instead of aluminum. This results in better fatigue performance of the Blocking and Thermal Relief Valve Housing

- In co-operation with the airplane's manufacturer, set up a program to support fleet wide replacement of the blocking and thermal relief valve housing with the fatigue improved unit made from stainless steel

- Issue the planned service bulletin 757-SB57A0154 to support fleet wide replacement of the Blocking and Thermal Relief Valve Housing in co-operation with the actuator's manufacturer
- Research other Boeing large transport category aircraft for similar spoiler actuator design and take corrective action as needed

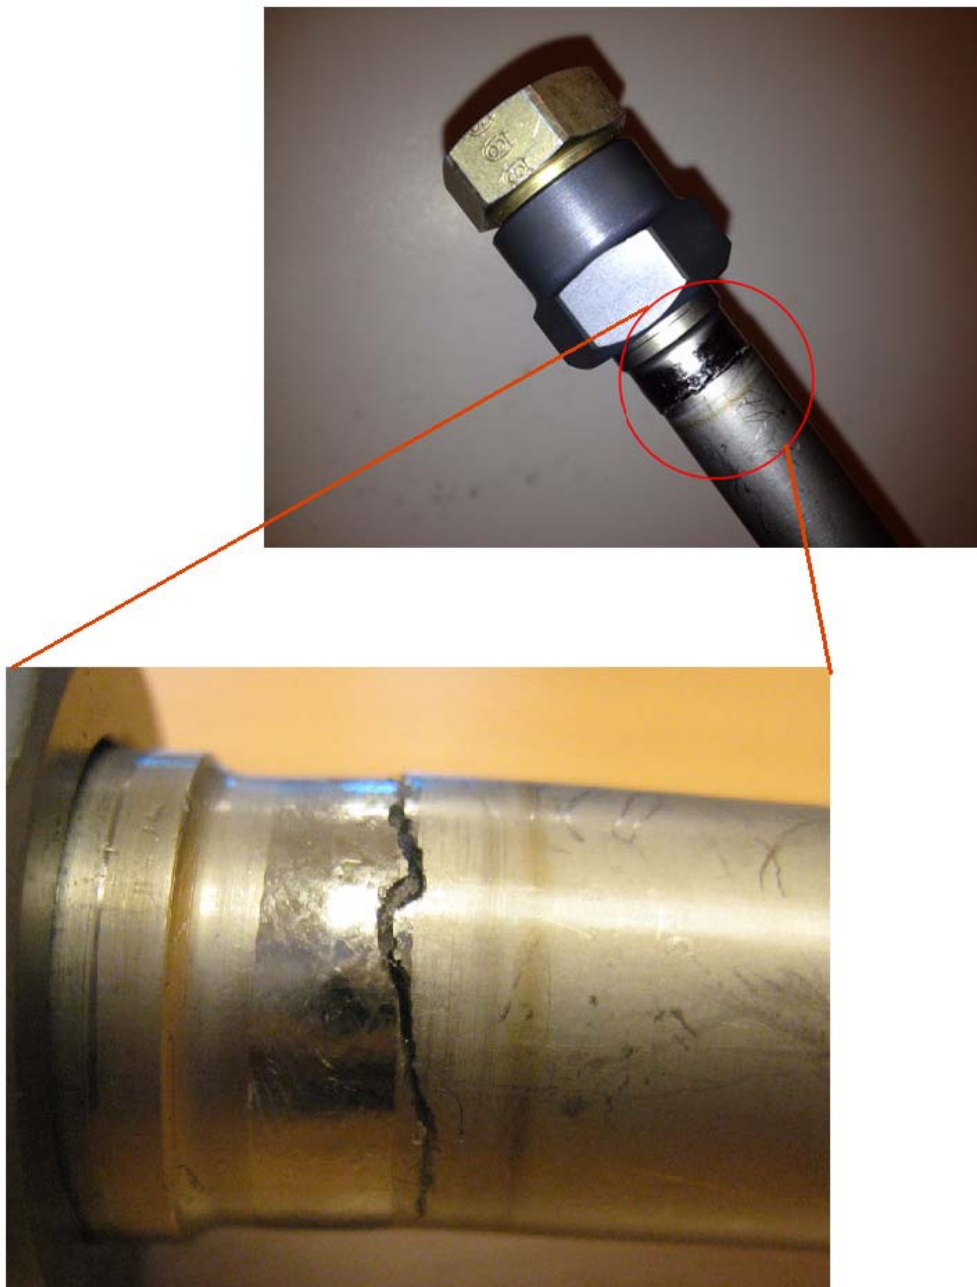
During initial inspection of the airplane, hydraulic tube P/N 271N6444-1237 located in the right wheel well, between the filter housing and an AC hydraulic pump, was found cracked. This hydraulic tube was a part of the right hydraulic system. See Figure 10 for details.

Figure 10: Cracked hydraulic tube

The crack to the hydraulic tube, P/N 271N6444-1237, located in the right wheel well, caused the loss of the right hydraulic system at top of descent. The crack is believed to have been caused by weld flaw.

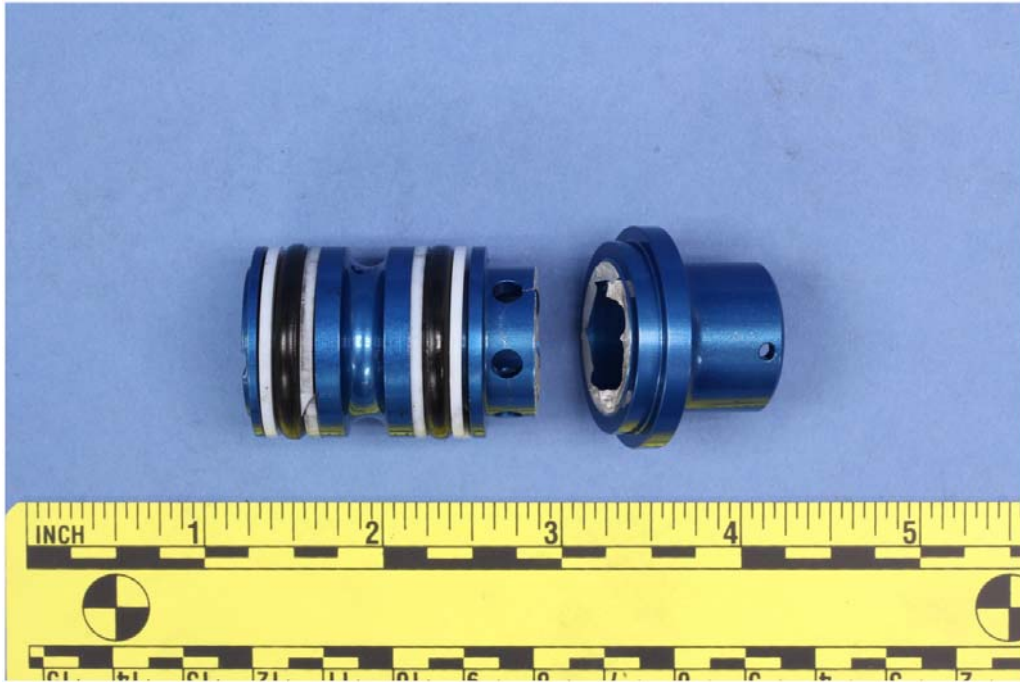
The NTSB<sup>12</sup> took part in the investigation as the State of manufacture and performed fracture analysis of the fractured Blocking and Thermal Relief Valve Housing (see Figure 11).

Figure 11: Fractured Blocking and Thermal Relief Valve Housing

The analysis showed that the valve housing cracked along the edge of a cylindrical channel that contained six ports (holes) spaced at 60° intervals around the circumference of the valve. Figure 12 shows part of the fracture surface of the Blocking and Thermal Relief Valve Housing under magnification using an optical microscope. On the left and the right side of the picture two of the six shuttle valve ports are shown, marked as “Ports on sidewall” and highlighted in red, and the fracture surface between those ports. The fracture initiated along the outer circumference (white curves arrows) and progressed radially inwards by fatigue up to the yellow-dashed line. At the yellow-dashed line, the orientation of the fracture surface changed to one consistent with an overstress fracture. Similar damages were observed between other ports along the circumference of the thermal relief valve housing.

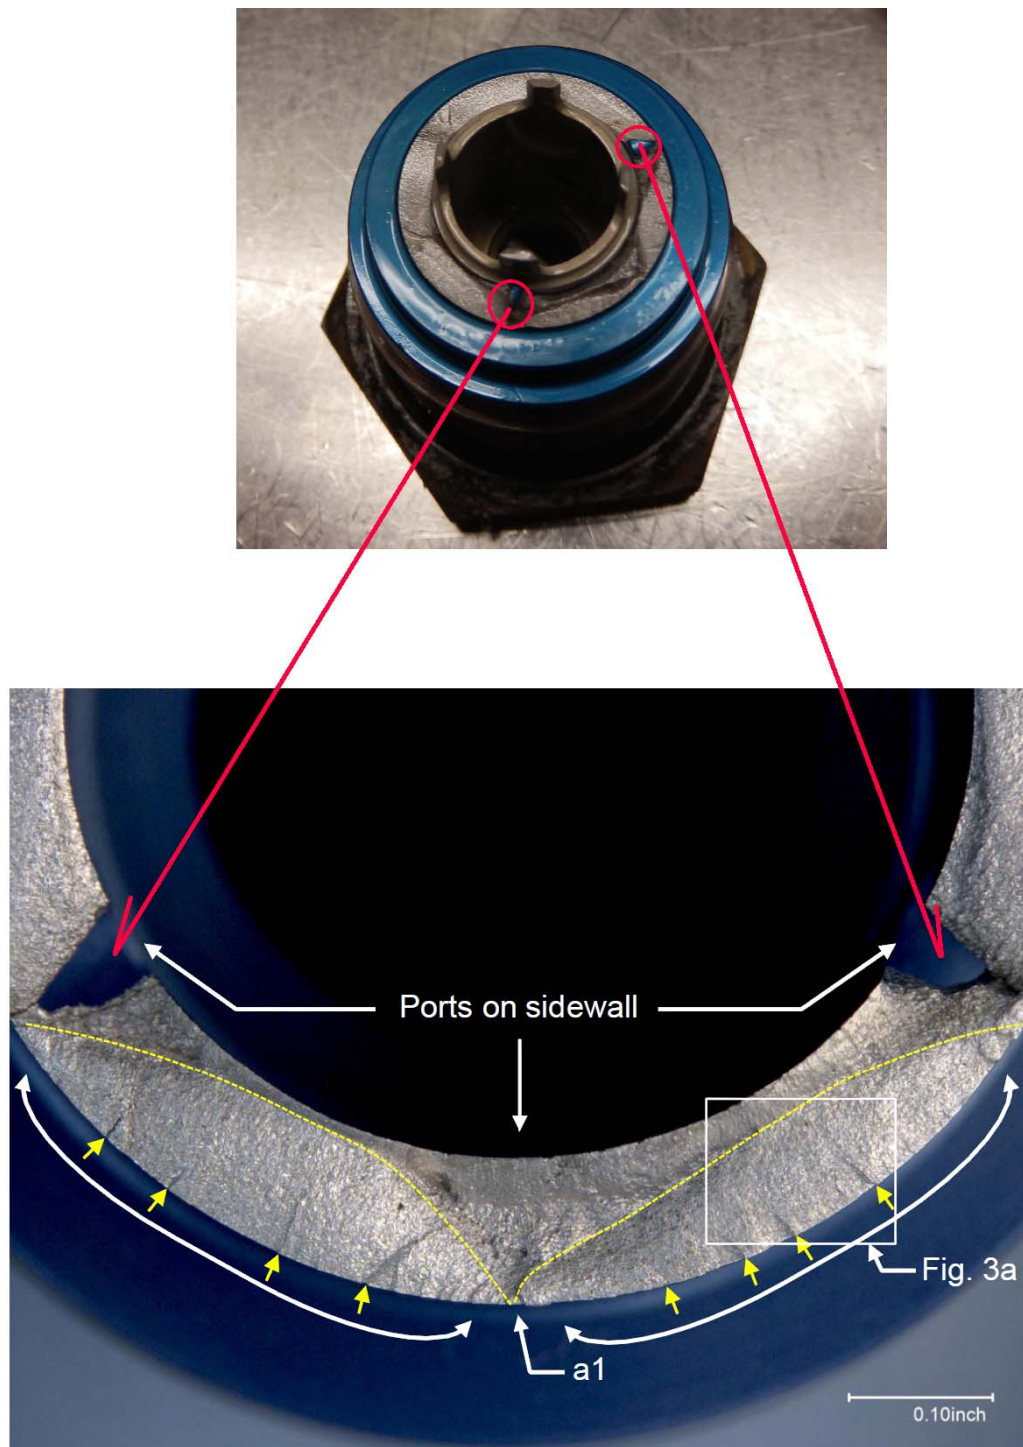
Figure 12: Enlarged view of the thermal relief valve housing fracture surface
