**Accident Investigation Board
Denmark**

FINAL REPORT

HCLJ510-2011-43

Accident to De Havilland DHC 8-106
Registration TF-JMB
Nuuk Airport (BGGH), Greenland
The 4th of March 2011

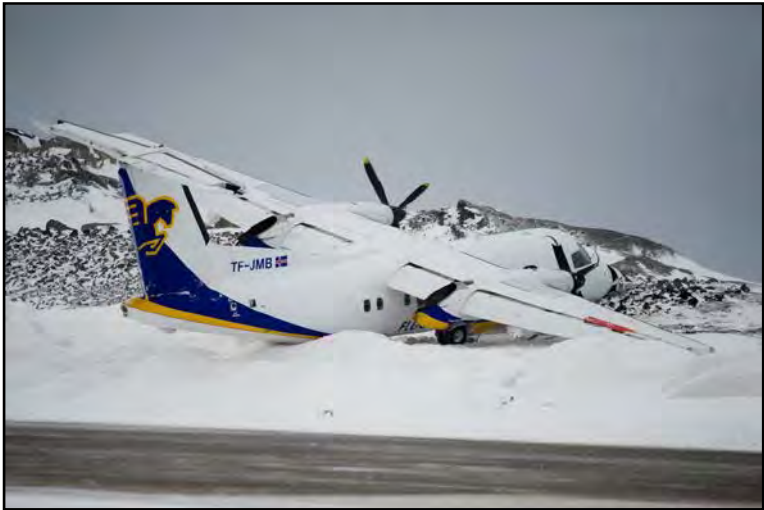
The right nacelle, the right wing, the flaps and aileron were damaged as a result of the runway contact.

The right main landing gear was substantially damaged due to the collapse of the gear.

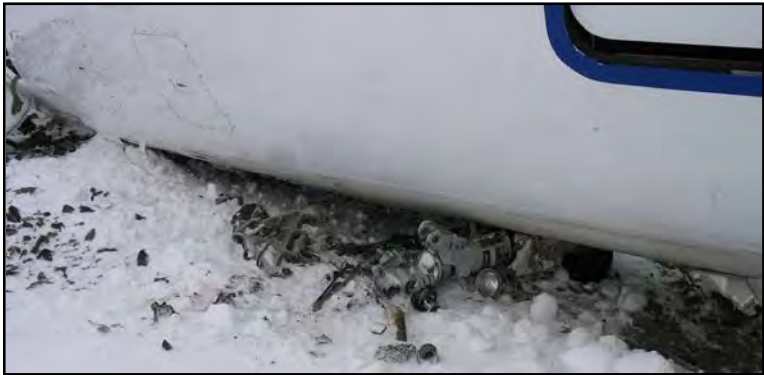
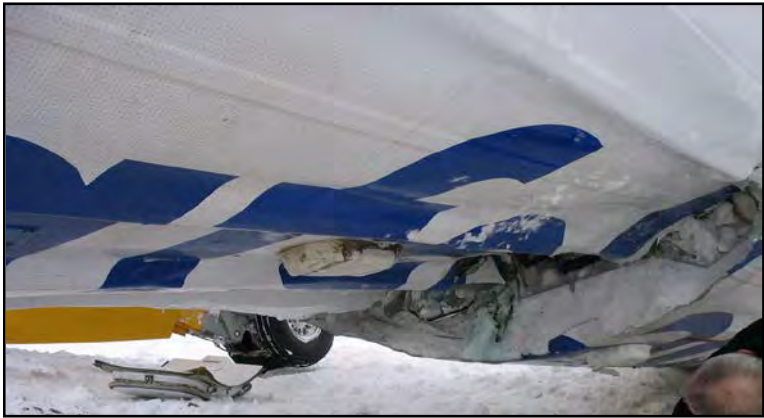
As a result of hitting the rocks, the nose landing gear was destroyed and the aft fuselage suffered substantially damage.

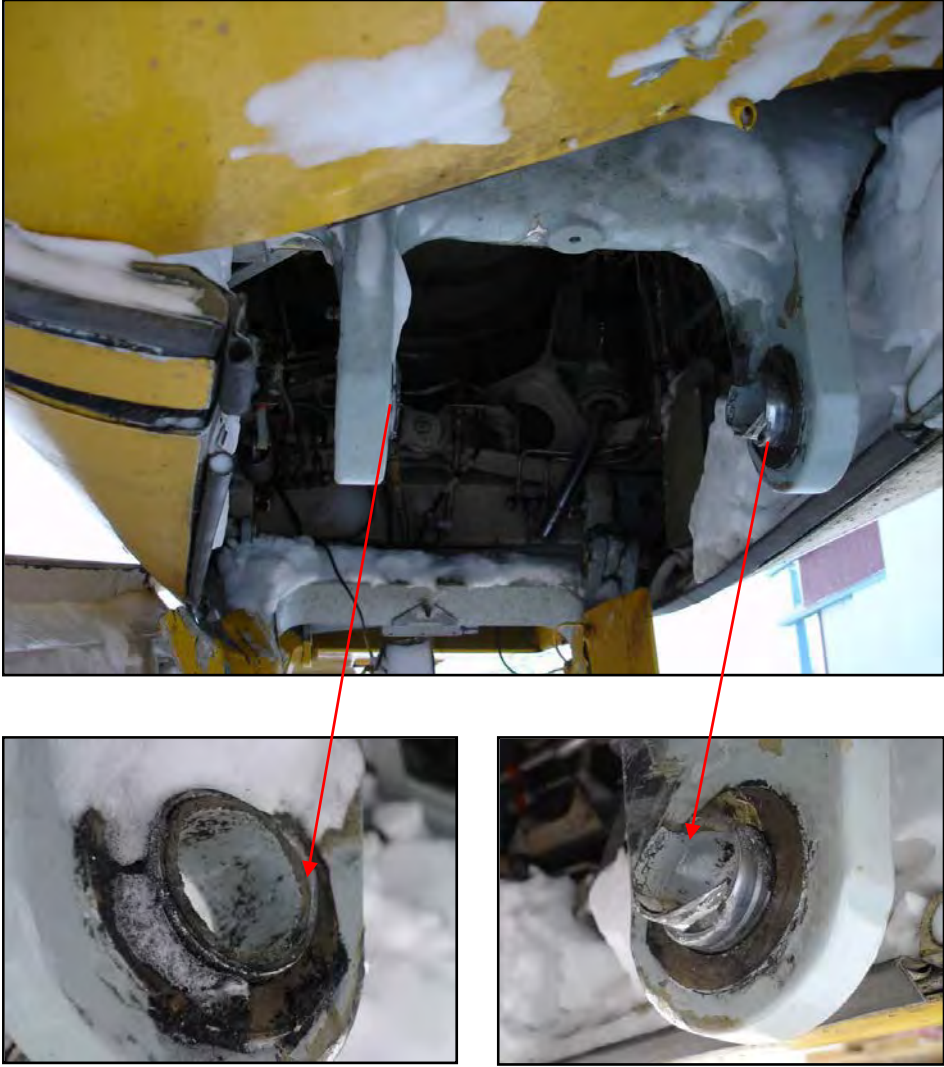
The fuse pin of the right main landing gear was found sheared at two places.

Both ends of the fractured fuse pin were found at place in the junction.

Due to fracture of the fuse pin, the shock strut was separated from the main gear yoke.

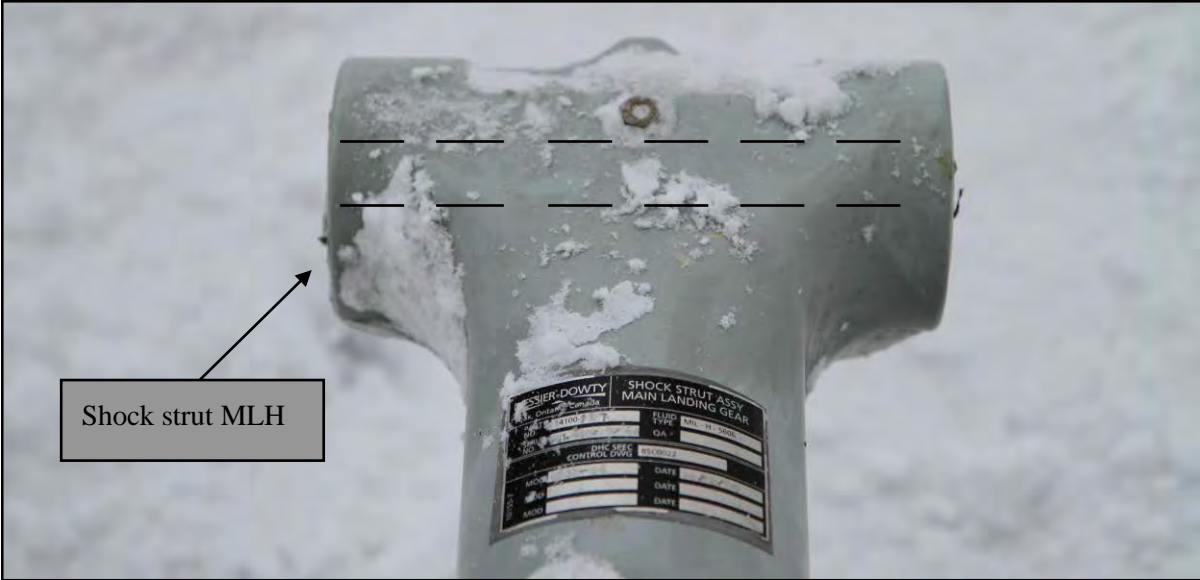
The rest of the fuse pin was found inside the head of shock strut to yoke.

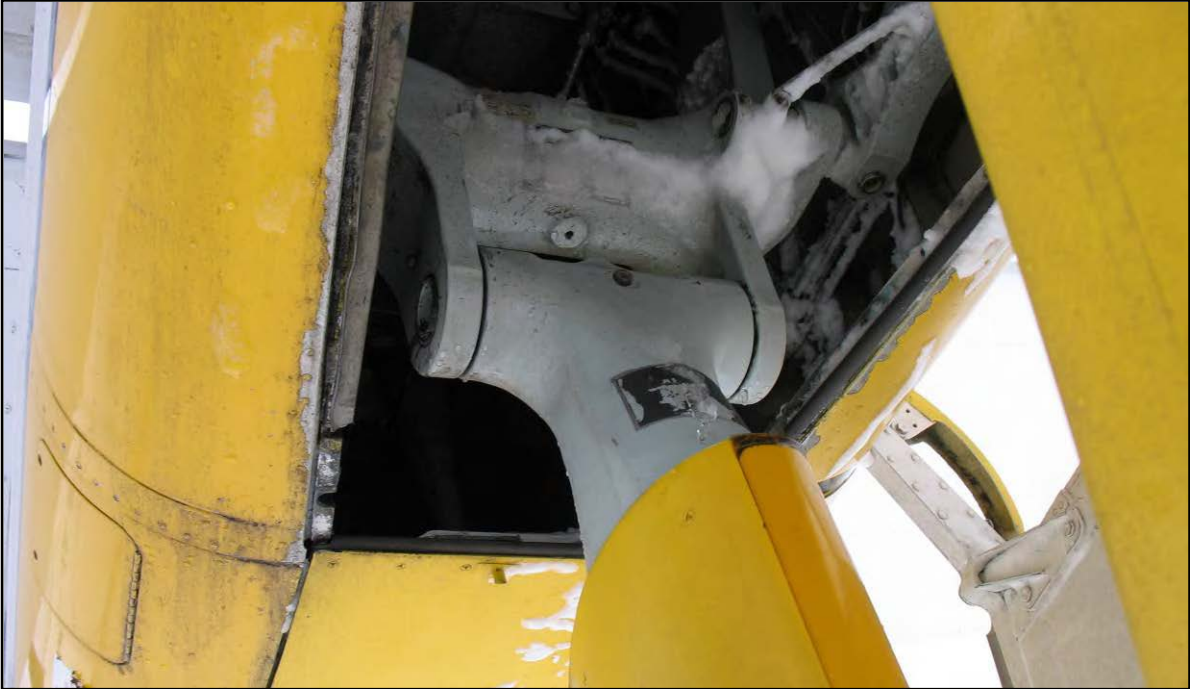
The undamaged left main landing gear – see below.

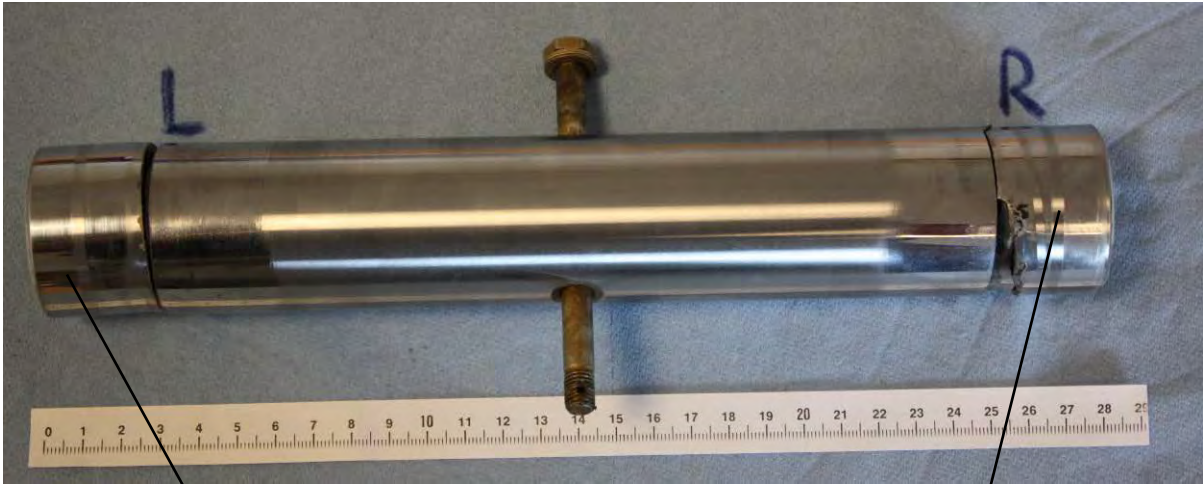
Fig. 1

The mid-section of the fuse pin, (fig. 1 with the bolt) was found inside the head of shock strut to yoke.

The head of the bolt indicates the forward direction (flight direction). The two ends (L & R) of the fuse pin were found inside yoke junction to shock strut.

A hint of inflection on the upper side of the fuse pin can be seen, fig 1. The remaining of the fracture in the nature of a clean shear - see figure 1, 2 and 3.

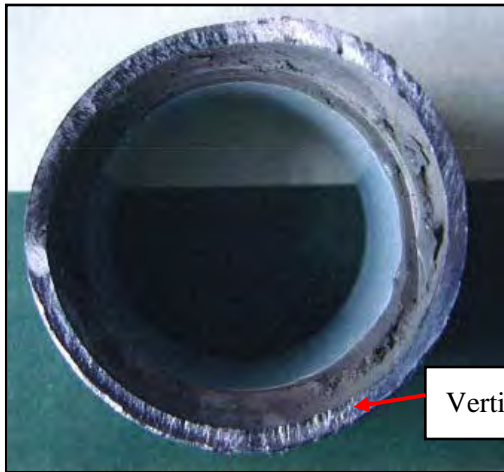
Fig. 2

The surface of the fractures from those pieces found in the gear yoke, showed marks coming from vertical upward force. This force triggered the fracture. See fig. 2 and 3.

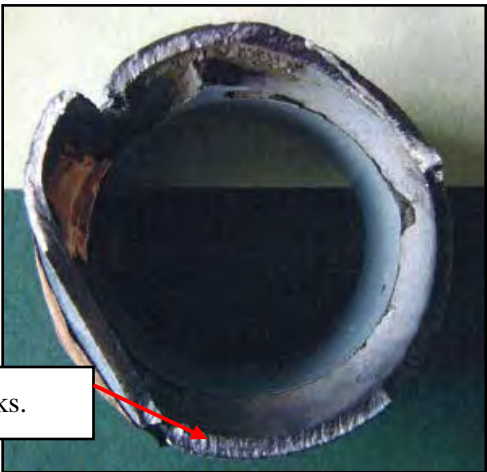
Fig. 3

Vertical upward marks.

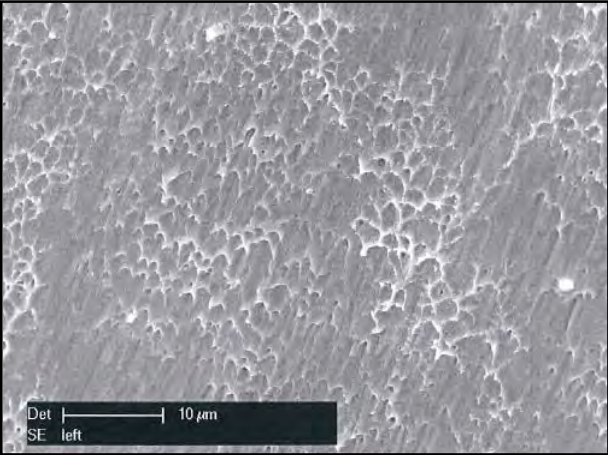
Fig. 4

The investigation only found areas there were smeared, which did not give fractographic information and areas with dimples. Examples of areas that were found dimpled are shown in the fig. 4 (distinct shear dimples) and fig 5 (dimples characterize as overload breakage in wholesome materials).

There was no evidence of fault or pre-existing cracks in the fuse pin.

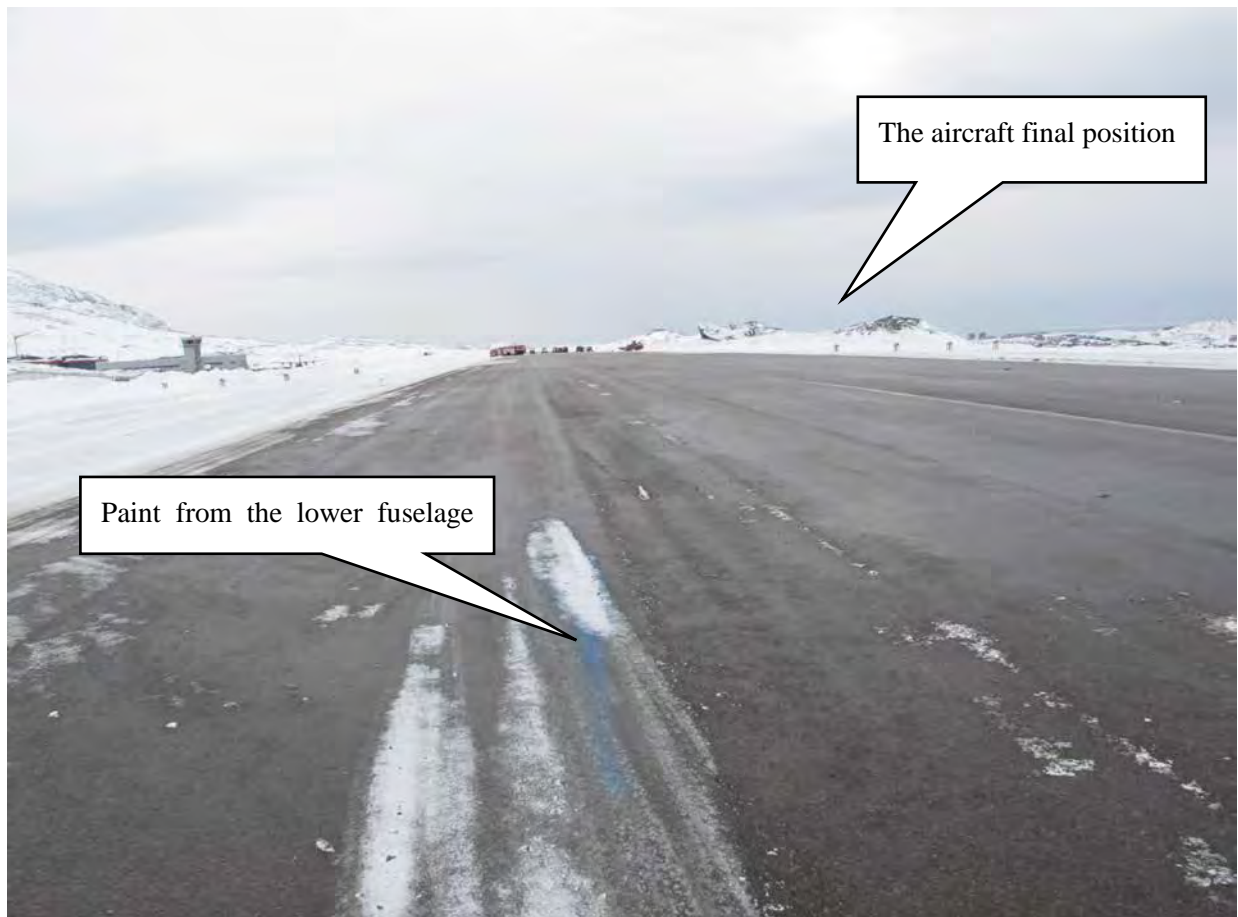
1.12.3 The touchdown

The aircraft touched down on runway 23 at time 16:09 hrs.

At touchdown the right MLG fuse pin sheared; consequently the right MLG collapsed and the fuselage made contact with the runway.

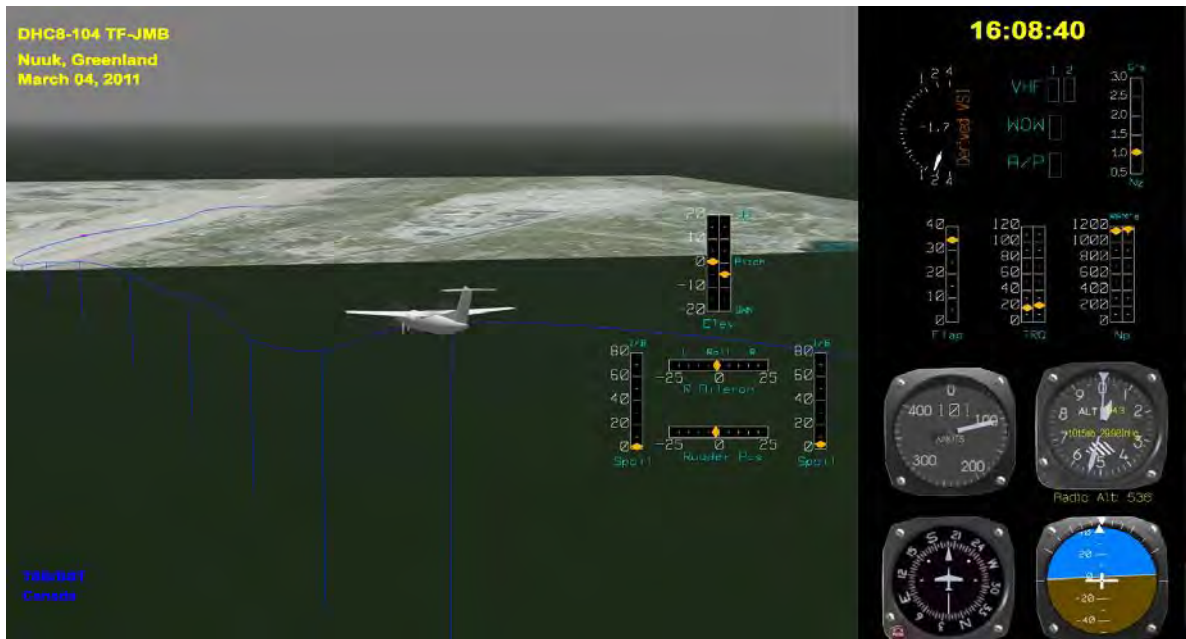
Time 16:08:40 – approximately 530 feet RA – airspeed 17 knots below Vtgt

The Vtgt was 107 knots, and the actual CAS momentarily decreased to 90 knots.

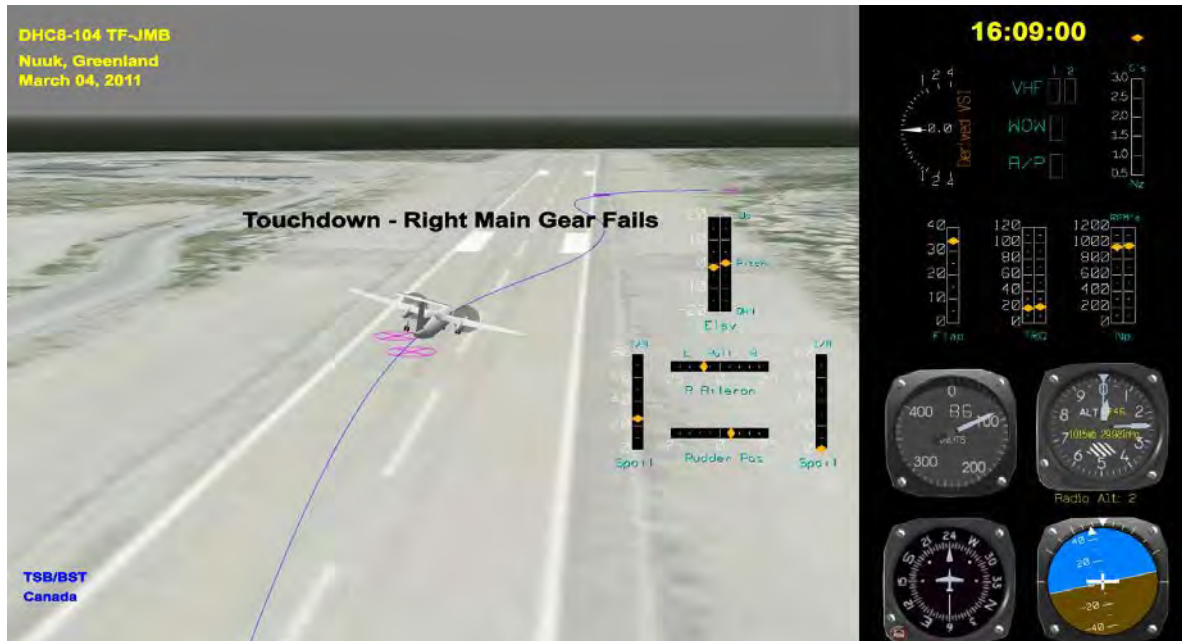
Time 16:09:00 – touchdown

The RA had dropped from 14.7 feet to 1.2 feet in one second. The average rate of descent from RA 14.7 feet to RA 1.2 feet was 13.5 fps (810 fpm).
