SERIOUS INCIDENT

Aircraft Type and Registration:	Airbus A300-B4-622R, TF-ELK
No & Type of Engines:	2 x Pratt & Whitney PW4158 turbofan engines
Year of Manufacture:	1989
Date & Time (UTC):	10 January 2011 at 2150 hrs
Location:	East Midlands Airport
Type of Flight:	Commercial Air Transport (Cargo)
Persons on Board:	Crew - 2 Passengers - 1
Injuries:	Crew - None Passengers - None
Nature of Damage:	Tailskid and fuselage skin
Commander's Licence:	Airline Transport Pilot's Licence
Commander's Age:	45 years
Commander's Flying Experience:	5,282 hours (of which 4,600 were on type) Last 90 days - 103 hours Last 28 days - 45 hours
Information Source:	AAIB Field Investigation

Synopsis

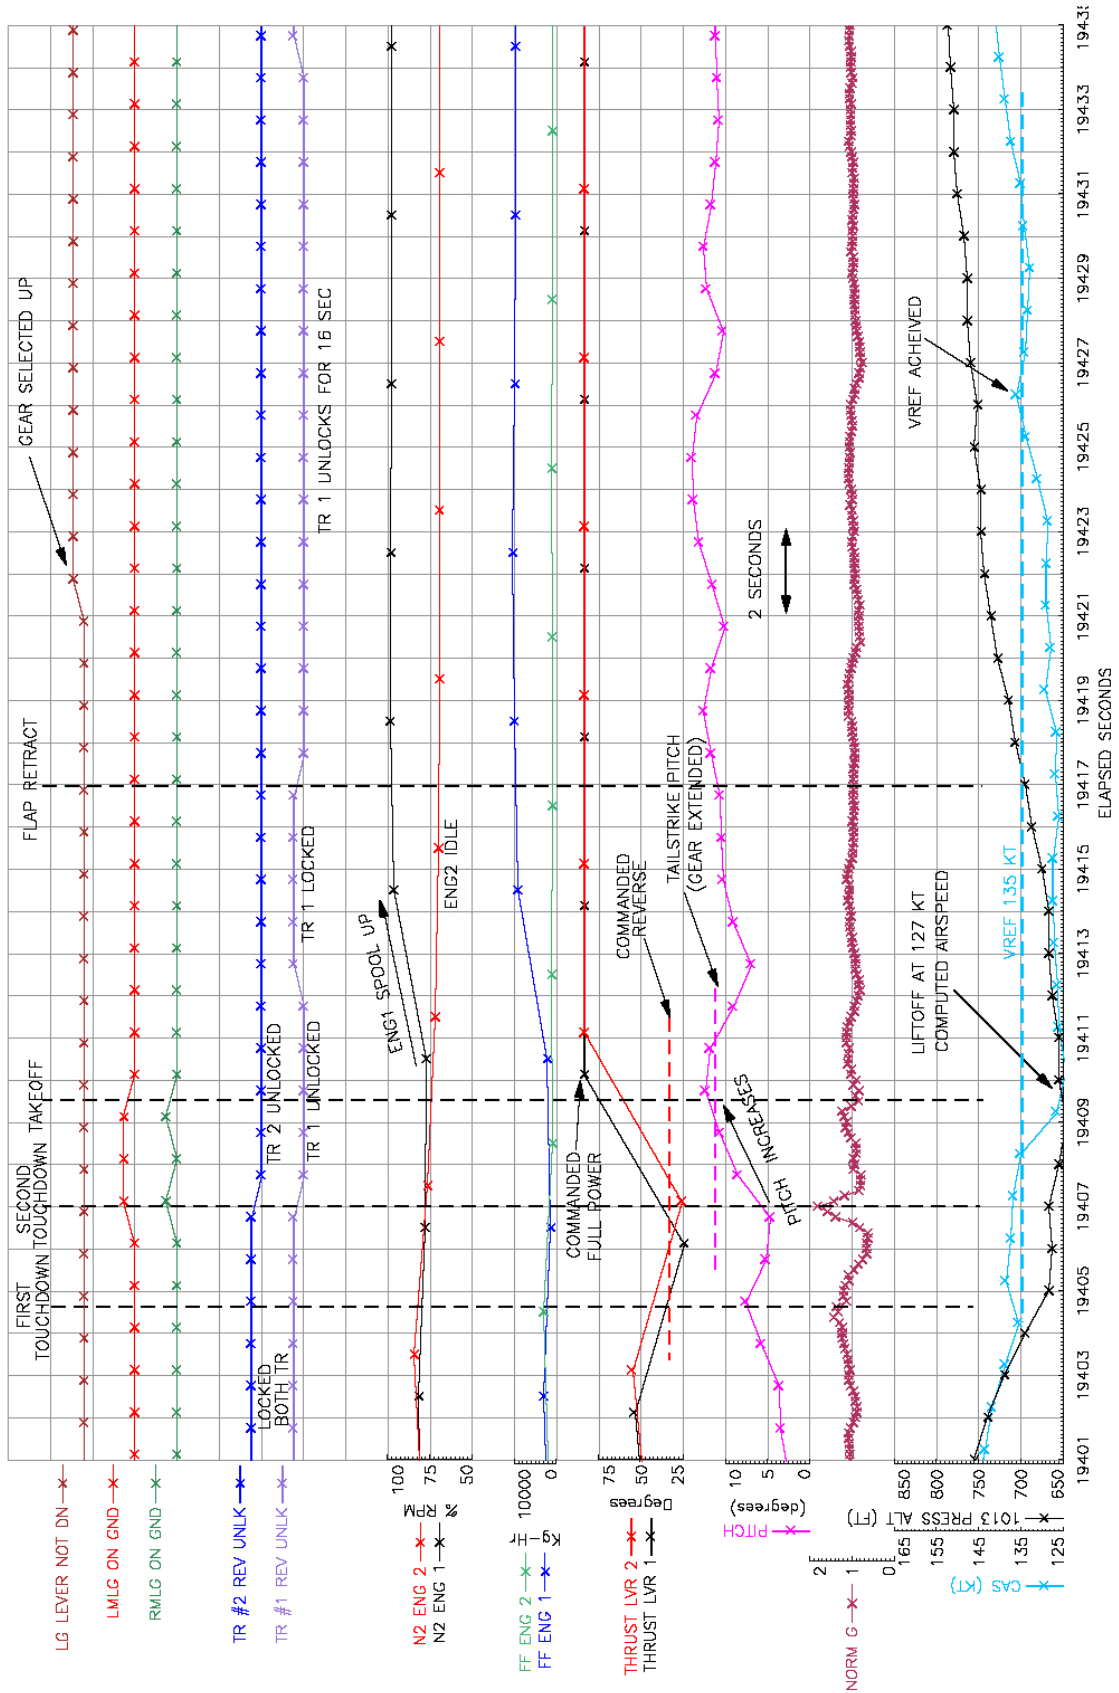
Figure 2

The aircraft touched down on Runway 09 at a computed airspeed (CAS) of 135 kt and groundspeed of 138 kt (Figure 2). The aircraft bounced, characterised by the normal acceleration reversal; this was followed by a second, heavier, touchdown at 1.8g. At some point between the first and second touchdown, the recorded No 1 engine throttle resolver angle reduced to 24.5°. At almost the same time as the second touchdown, the No 2 engine throttle resolver angle reduced to 26°. According to the aircraft manufacturer, a throttle resolver angle of less than 32.4° will activate the thrust reverser deployment, and any angle below 30° represents commanded reverse thrust above idle. Due to the sampling rate of the engine speeds, it is unknown whether the engine speed advanced in line with the throttle control lever position.

The recorded landing gear squat switches did not register 'on ground' for the first touchdown² and one second after the second touchdown, both reversers became unlocked but neither achieved the deployed position. The throttle control levers were then advanced to the takeoff thrust position; again, the exact timing could not be confirmed due to the four second sampling rate of lever position.

TF-ELK touchdown and go-around at East Midlands Airport: relevant FDR parameters

The main wheels remained on the ground for approximately two seconds, during which the aircraft pitched up from 5° to 12.5°, finally lifting off at an airspeed of 127 kt³. At no point did the nose landing gear oleo compress. The point at which the tailstrike occurred could not be identified from the recorded data, but the aircraft manufacturer confirmed that with the main landing gear oleos extended, a tailstrike can occur at a pitch attitude of 11.2°.

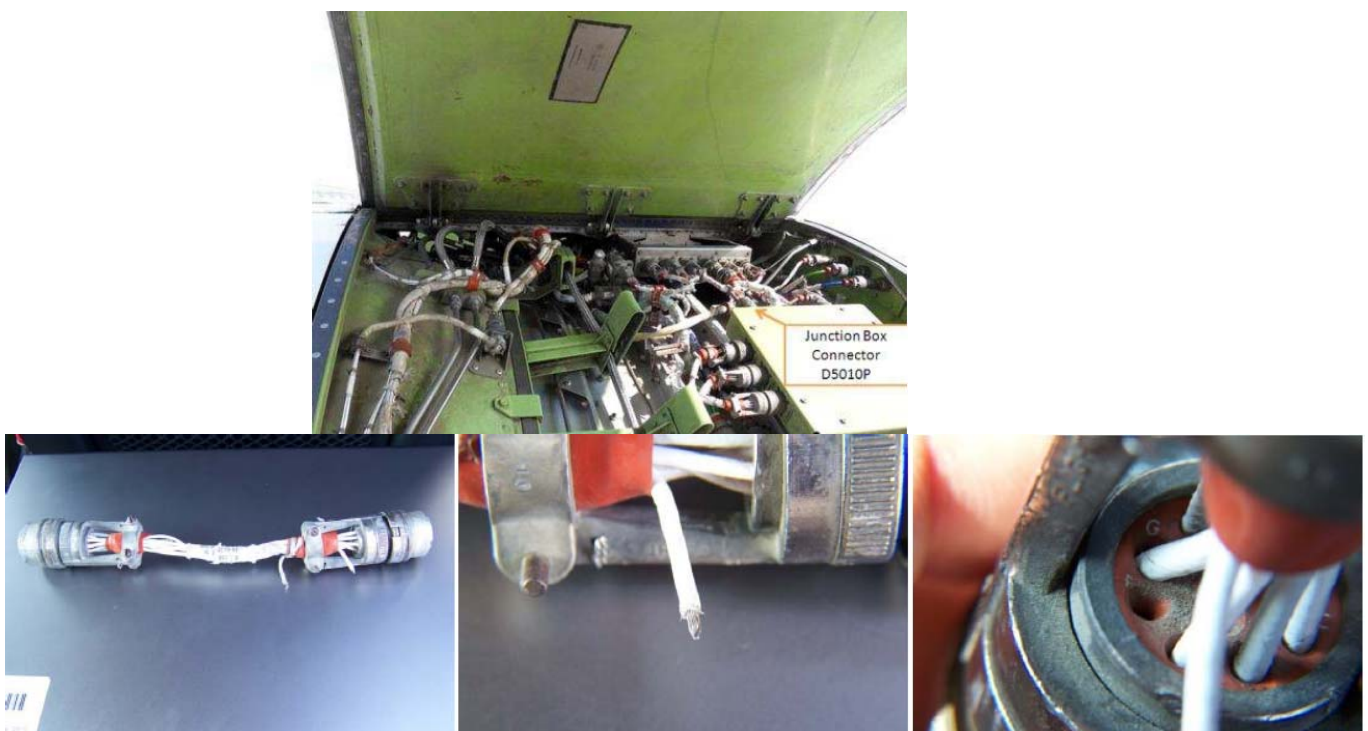
Figure 4

Loose wire at Pin F of connector D5010P in the auto-restow circuit

The most significant finding was the identification of a loose wire in the auto-restow circuit, which is designed not only to ensure the stowing of the thrust reversers during normal operation, but also in the case of an in-flight thrust reverser deployment. Loss of electrical signal to the PRSOV arming solenoid following the mid-stroke stow command, as a result of the loose wire, is considered the most likely reason for the No 2 thrust reverser stopping in the mid-stroke position. The loose connection is considered to have been an intermittent issue; had this been a permanent condition, the normal stowing function of the thrust reversers would have been compromised prior to the incident and this would also have been evident during the post-incident function checks and engine runs and following the aircraft's return to service.

This incident highlights the potentially serious consequences of attempting to go around after selection of reverse thrust. In this instance the failure of the No 2 thrust reverser to restow was most likely caused by a latent intermittent loose connection in the auto-restow circuit. However, even in the absence of this particular failure, the FCOM advises damage to the thrust reverser with equally significant consequences may still occur as a result of stow command being made while the reversers are in transit. The investigation identified a number of other anomalies with thrust

The loose connection on the auto-restow circuit was not detected during initial electrical continuity testing on the thrust reverser system, but was discovered after the aircraft had been returned to service. There were no TSM tasks specifically relevant to this circuit to facilitate identification of this fault. As a result of this incident, Airbus intends to update the TSM to include a specific electrical check of the auto-restow circuit.
