AIRCRAFT INCIDENT REPORT

Smoke in cockpit

M-01709/AIG-12

**N658UA
Boeing 767-300
United Airlines
200 Nm SSW of Keflavik, Iceland
July 20, 2009**

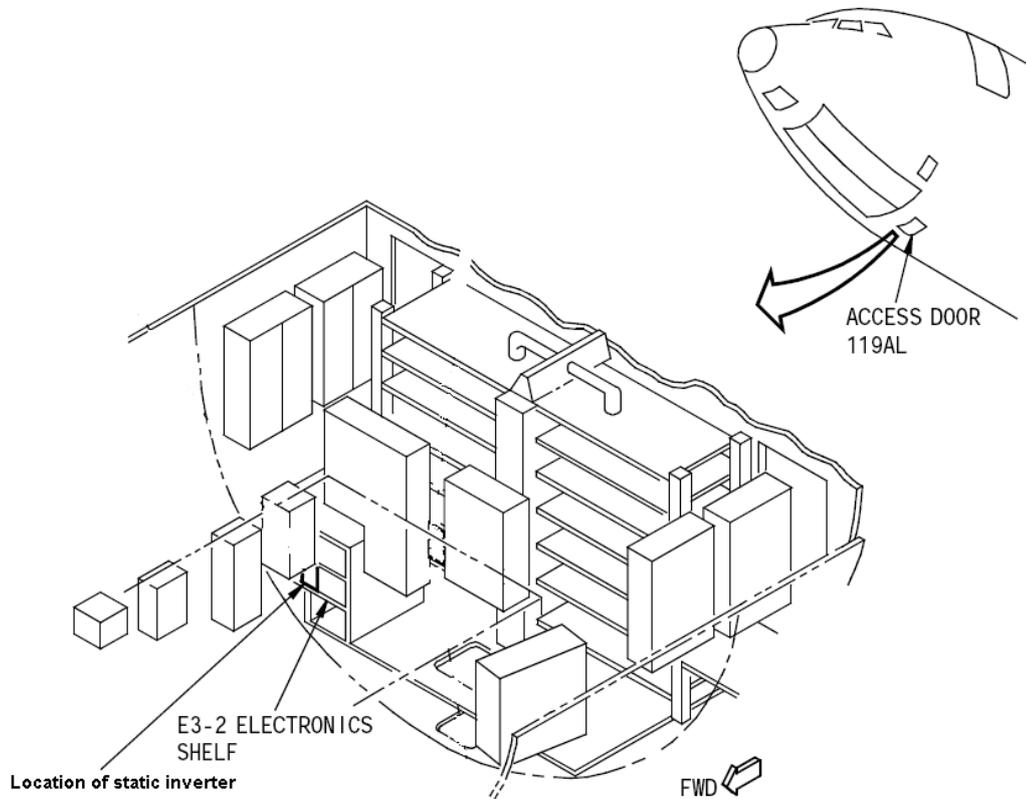
Emergency crews entered the aircraft main electronic equipment compartment with a thermal camera. A distinct electrical smell was noted and the source of the smoke was found to come from an area where the static inverter and transformer rectifier units are located. The thermal camera was also used to verify the location and look for hotspots.

Figure 1: Location of static inverter in main electronics equipment compartment.

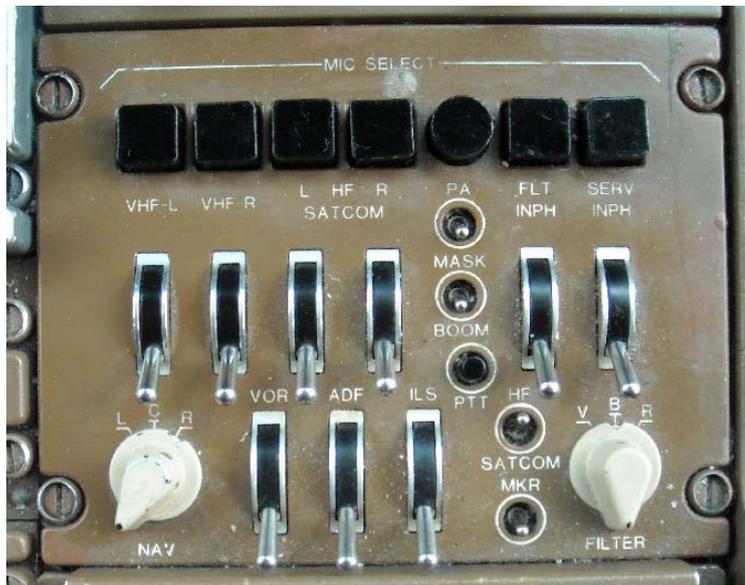
Figure 2: Audio Panel

Due to the design of the audio panel pilots have to be alert of which channel they have selected to transmit their message and which channels they have turned up the volume on for monitoring. According to the pilots they were frustrated by having to select different transmitting channels depending on whom they were talking to. During the event the crew communicated with air traffic control (VHF-L), each other (FLT INPH), cabin crew (SERV INPH), and passengers using the passenger address system (PA). That would have required them to switch between four different transmission selections and four associated volume controls.

The pilots noted after the incident that at times they were hindered in communicating with each other. They contributed this to the audio panel being designed in such a way that the flight crew must always press the push to talk switch even when communicating with each other. According to United Airlines it is part of their flight simulator training to train pilots in the use of the audio panels during emergency situation and to actively switch between transmitting channel selections.

- 2.3.1 The design of the audio panel and communication system installed in the incident aircraft can hinder communications during high workload events.

3.2.1 United Airlines is encouraged to review the design of the audio panels in use on their aircraft with respect to this incident. There are audio panels available that make flight crew communication easier during high workload events.

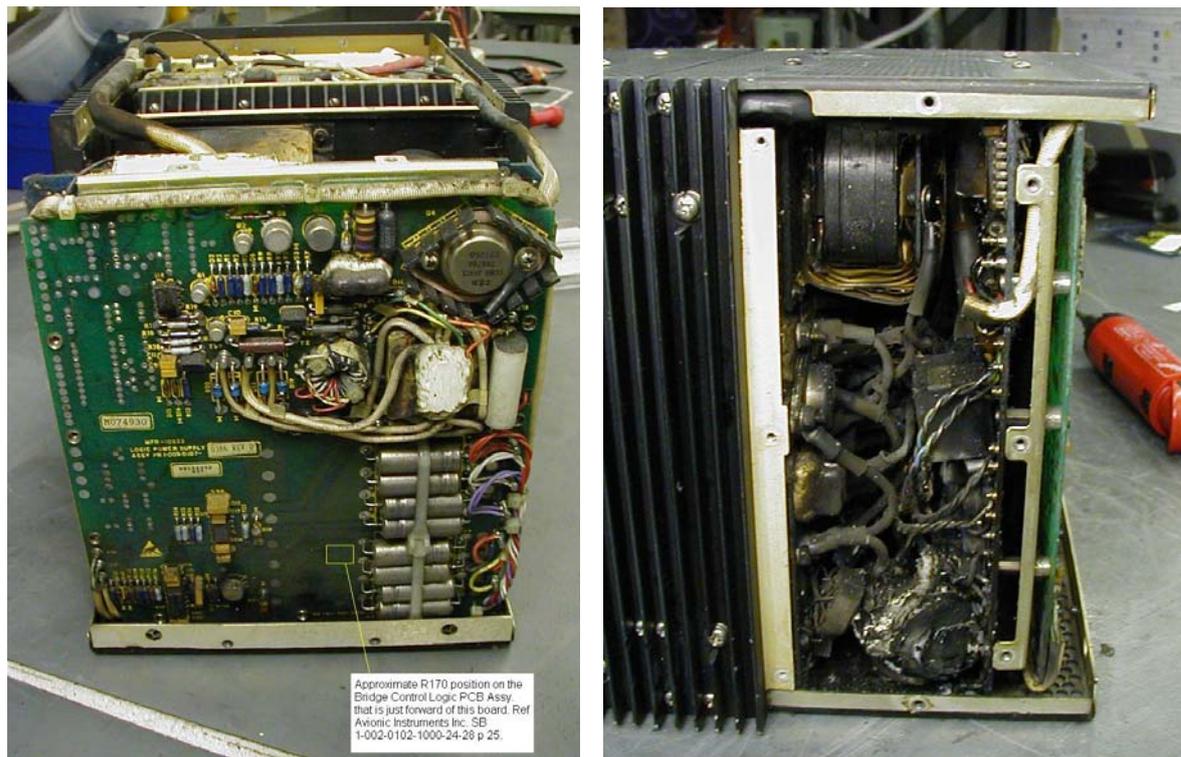
The left (p/n S282T001-1, s/n 2169) and right (p/n S282T001-1, s/n 1767) transformer rectifier units and static inverter³ (p/n S282T004-8, s/n CV000888) were removed from the aircraft by United Airlines technicians in Keflavik. The components were examined on-site by investigators from the Icelandic Aircraft Accident Investigation Board (IAAIB). The static inverter showed signs of overheating. It was suspected that the failure was caused by a known problem⁴ on certain model static inverters installed on many Boeing aircraft. The problem is due to overheating of a certain R170 resistor.

This situation can cause nearby capacitors to overheat and burn. The IAAIB has investigated a number of incidents involving overheated static inverters. In those incidents it has been shown that the overheating creates a significant amount of smoke.

United Airlines was allowed to examine the components and report their findings to the IAAIB. United Airlines reported that the static inverter showed signs of extreme overheating in the lower aft area. A shop technician familiar with these types of failures indicated that the static inverter failure was because of an overheated R170 resistor. The overheat damage in the failed static inverter can be seen in the figures below.

Figure 3: Overheat damage in location of R170 resistor.

- 2.1.1 A static inverter on N658UA failed causing smoke to enter the cockpit and cabin of the aircraft.

A Boeing service bulletin provides instructions to replace the static inverter on affected aircraft. Furthermore the manufacturer (Avionics Instruments Inc.) of the static inverter provides concurrent requirements to replace the R170 resistor with a new resistor and relocate it to another location on the PCB board in order to move it away from the sensitive capacitors.

3.3.1 United Airlines has a campaign in place to replace applicable static inverters on Boeing 747, 757, 767, and 777 aircraft.

3.3.3 The FAA has issued an airworthiness directive to mandate the replacement of applicable static inverters on Boeing aircraft.
