REPORT ON ACCIDENT

Power loss on take-off after touch-and-go landing

M-03506/AIG-19

Cessna 180H

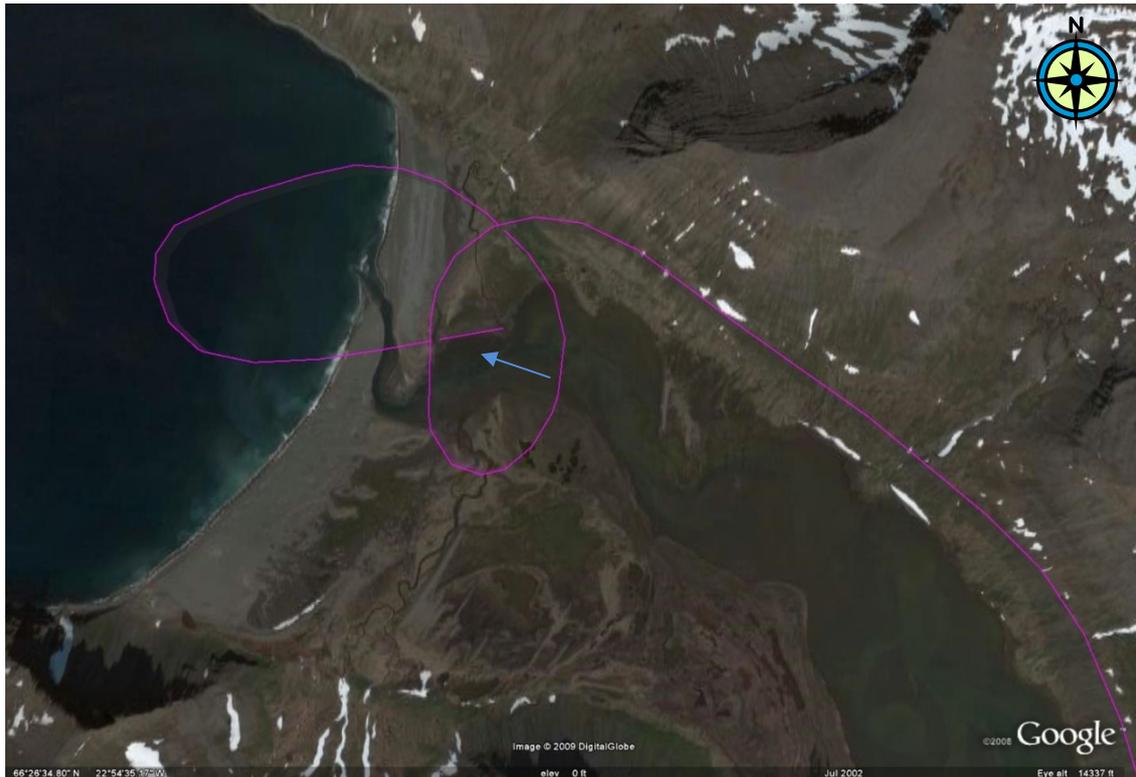
Figure 2: GPS track and reported wind direction shown by blue arrow

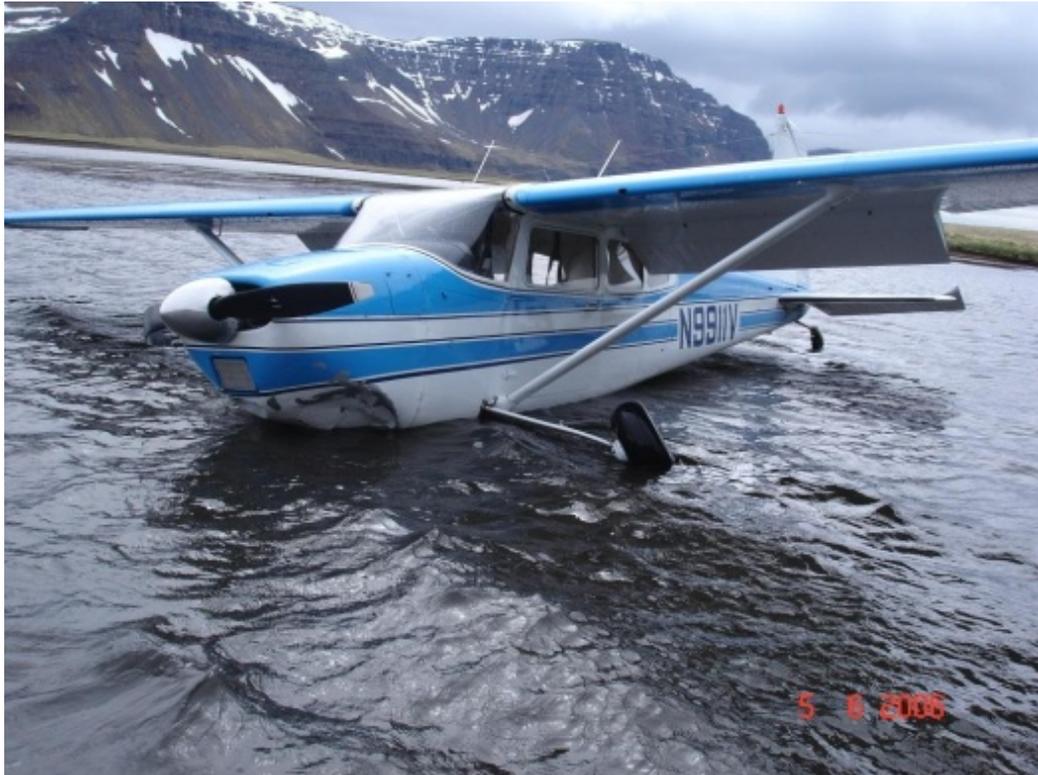
Figure 3: Aircraft at accident site

The aircraft touched down hard on the main landing gears in the knee-deep water beyond the landing area (see figure 3 above). The pilot secured the aircraft by switching off the master switch, turning the magnetos off, and putting the fuel selector valve to the off position. The pilot was not injured and left the aircraft unassisted.

The aircraft sustained substantial damage to the main landing gears, the landing gear attachment structure and fuselage, propeller, engine mounts and cowlings. The aircraft systems were systematically checked to find potential faults in the system. Each system and its detail examination is described in the subchapters below.

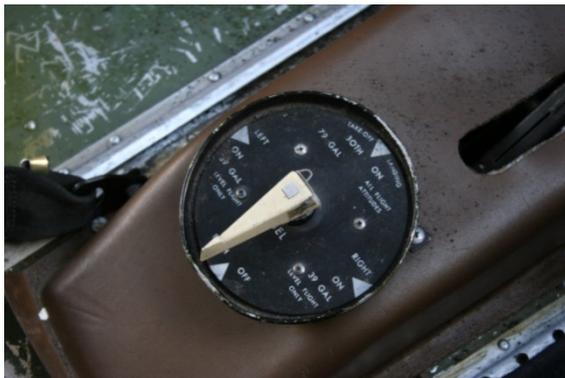
The fuel selector valve in the aircraft is shown in Figure 4. According to the pilot he placed the fuel selector valve to the "RIGHT ON" position when departing Isafjordur and it remained in that position until after the accident. When the AAIB arrived on scene the fuel selector valve had been set, by the pilot, to the "OFF" position. The homemade checklist the pilot was using did not contain an item for selecting "BOTH ON" before landing.

Figure 4: Fuel selector valve

The fuel system was inspected for leaks. A small leak was noted from the fuel strainer when the fuel selector valve was in the off position. The fuel selector valve did not completely seal when in the off position.

The fuel selector valve was disassembled and examined in detail. The fuel selector valve mechanism moved freely and was free of dirt. Seals and gasket looked normal. The fuel selector was re-assembled and installed in the aircraft.

The fuel selector valve in the aircraft was selected to the "RIGHT ON" (right hand wing tank) during the flight from Isafjordur airport. Cessna Owner's Manual landing checklist stipulates that the fuel selector valve must be in the "BOTH ON" position. The Owner's Manual contains the following note in a section on the fuel system:

According to the pilot he approximates that he was banking the aircraft 10-20 degrees towards the right wing. During the investigation it was established that with the aircraft level in pitch and at a right bank angle of 6.4 degrees and a fuel quantity of 15 gallons the fuel outlets of the right hand wing tank were uncovered.

When the pilot added power to the engine for take-off the engine would have demanded increased fuel. If both fuel outlets were temporarily uncovered then air would get into the fuel line towards the carburetor causing fuel starvation and possibly engine stoppage.

1. Installed an [ice detection system \(ICEMAN SE\) from Lamar Technologies](#) that gives the pilot a warning of ice build-up in the carburetor.
2. Reviewed and updated the aircraft checklist.
3. Installed [Micro Aero vortex generators](#) to improve low speed performance of the aircraft.

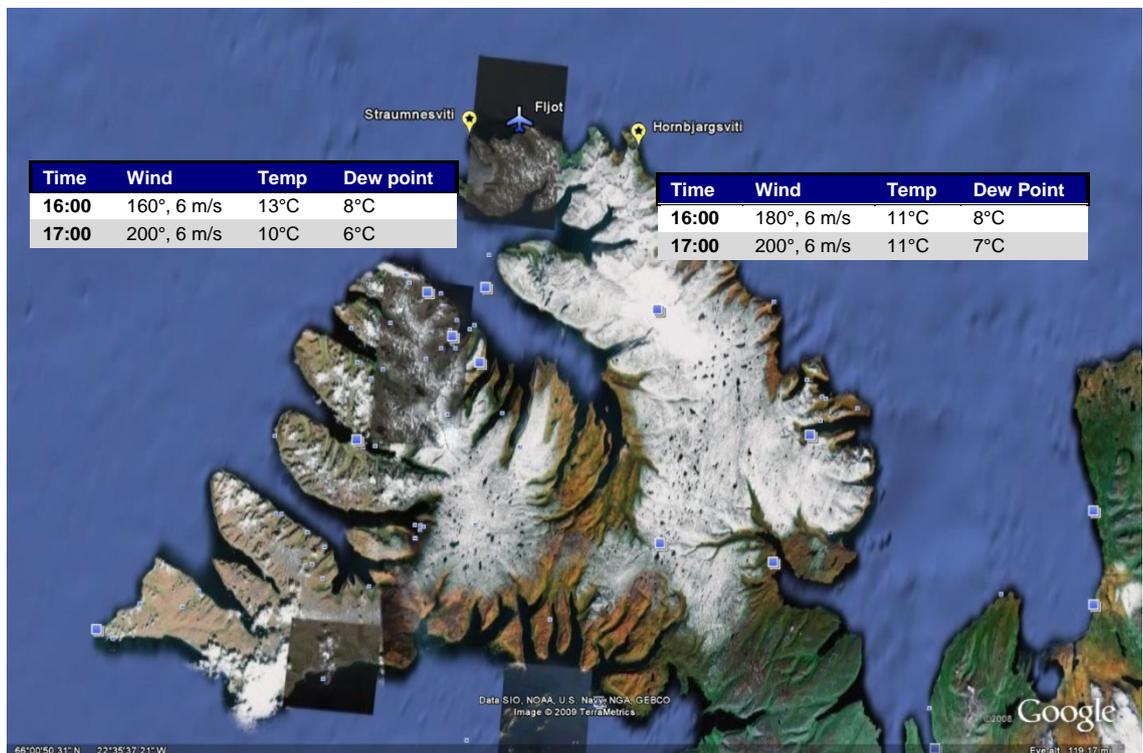
Figure 5: Weather information from nearby weather stations

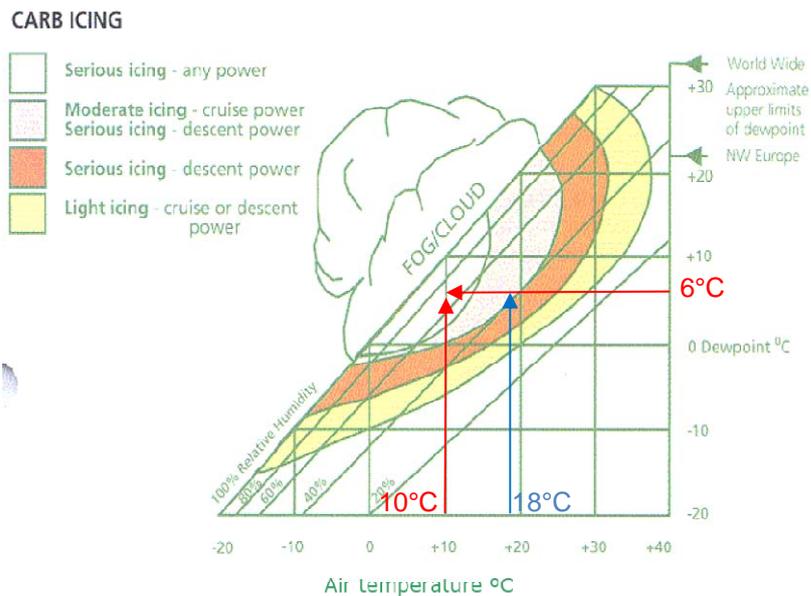
The temperature and dew point from the nearby weather station Straumnesviti are plotted (temperature in Fijot plotted in blue) on the carburetor icing chart² below. Based on that, the ambient conditions were likely conducive to carburetor icing. The pilot did not apply carburetor heat to the full on position but according to the aircraft manufacturer the carburetor heat shall be applied fully and before closing the throttle.

Figure 6: Temperature and dew point from Straumnes and Fijot indicate possible carburetor icing.

- 2.4.1 According to the carburetor icing chart the ambient conditions were conducive to carburetor icing.
