**DATA SUMMARY**

Date and time	<b>23 January 2005; 13:06 LT</b>
Site	<b>Madrid-Barajas Airport</b>

Registration	<b>TF-ATI</b>
Type and model	<b>BOEING B747-300</b>
Operator	<b>Iberia, L.A.E.</b>

## Synopsis

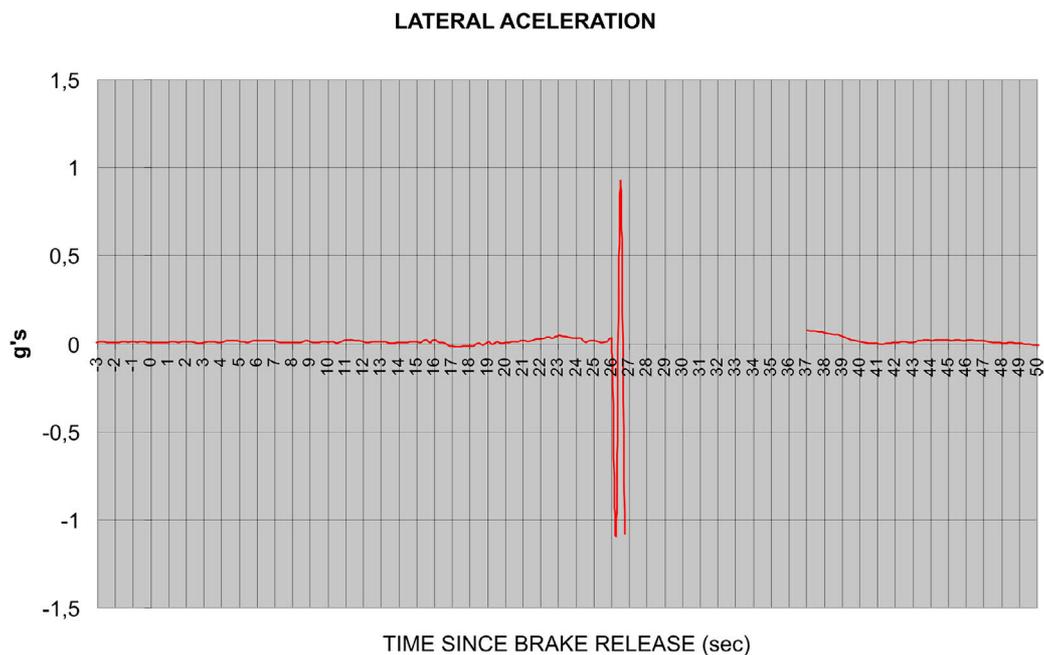
Figure 1. Graph of lateral acceleration

- 13:06:30 The takeoff run is initiated with reduced power, quickly reaching a longitudinal acceleration of 0.23 g.
- 13:06:54 Some 24 seconds later, at an IAS of 98.4 kt, the aircraft reduces takeoff power and starts to brake.
- 13:06:55 The aircraft's speed is still increasing during the following second, reaching a maximum of 98.9 kt IAS; its deceleration reaches 0.27 g and its pitch angle exceeds the  $-0.9$  degrees maintained during the acceleration, to reach an angle of  $-1.3$  degrees.
- 13:06:56 Two seconds later, the speed has reduced considerably to 62 kt (though this reading may be spurious), with the reverse thrust on engines 3 and 4 already engaged. Longitudinal and lateral acceleration readings, which are recorded every quarter of a second, fluctuate between  $\pm 1g$  twice in this second.

The data from the recordings of LATG, LATA, LATB and LATC are plotted in one single time sequence on Figure 1.

A check of the recorder's Parameter Data Frame revealed that the amplitude, or range, of the lateral and longitudinal acceleration parameters is limited to  $\pm 1g$ . Actual absolute values of these parameters experienced by the aircraft in excess of 1 g would not have been recorded.

It should be noted that the lateral acceleration readings while taxiing show values above  $\pm 0.2$  g at time marks 12:56:40 and 13:00:00, when the airplane was moving in a straight line on taxiways at speeds, not recorded, below 50 kt.

Later, during the takeoff run, the crew felt a vibration prior to reaching 40 kt. This vibration got stronger and became very violent beyond 80 kt. DFDR data confirm the vibration, with lateral and longitudinal acceleration readings of  $\pm 1g$ , which are the maximum the accelerometers can record. It is very possible that the actual accelerations were in excess of this magnitude. Just as these parameters were being recorded, and possibly because of their elevated value, the DFDR stopped recording for some 12 seconds, thus precluding the availability of data from the braking conditions experienced during the aborted takeoff.

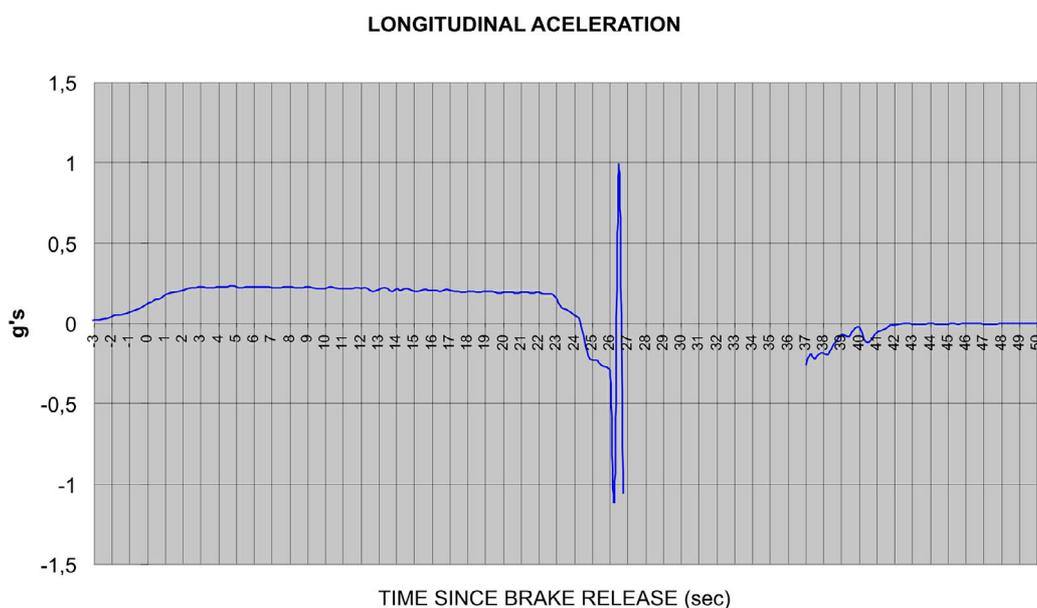
Figure 2. Graph of longitudinal acceleration

The progression of the longitudinal accelerations is likewise shown in Figure 2.

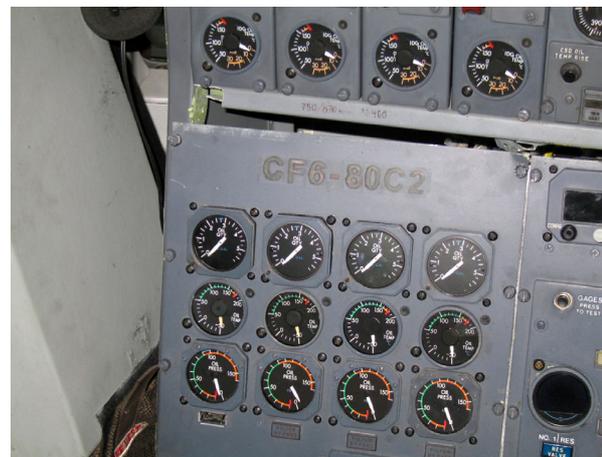
Figure 3. Flight Engineer's panel

The aircraft suffered various forms of damage in the cockpit, with dislodged instrument panels, instruments outside their respective panels or even on the floor, overhead panels and fairings that had fallen, both in the cockpit and in the main cabin. The ceiling support beam between rows 43 and 44 was cracked.
