AIRCRAFT INCIDENT REPORT

M-03303/AIG-20

TF-FIK
Boeing 757
Near Faro, Portugal
8 July 2003

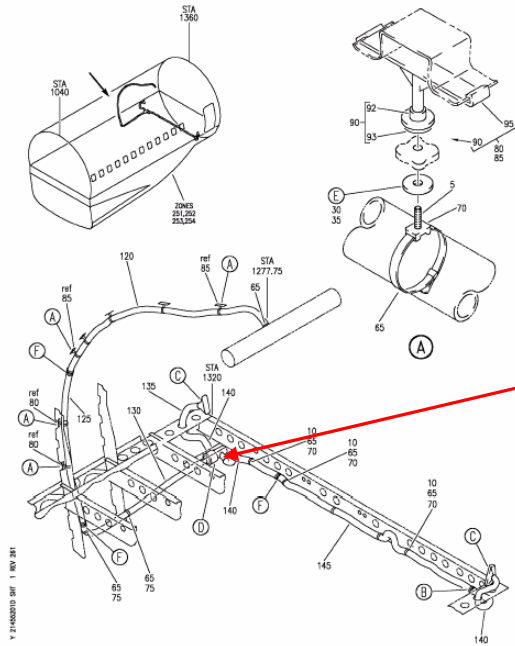
HEATER SYSTEM INSTL-DOOR 3 AREA
FIGURE 10 (SHEET 1)

During inspection of the aircraft at Faro it was revealed that the smoke came from right door number 3 duct heater (P/N 116817-3) that had burned over (duct heater is an electrical heater located in the air conditioning duct below the floor at each door in the Boeing 757 aircraft). The heater was deactivated and the aircraft was dispatched for a ferry flight to Keflavik in accordance with the aircraft Minimum Equipment List (MEL).

The duct heater is located in the air conditioning duct below the floor of the Boeing 757 aircraft

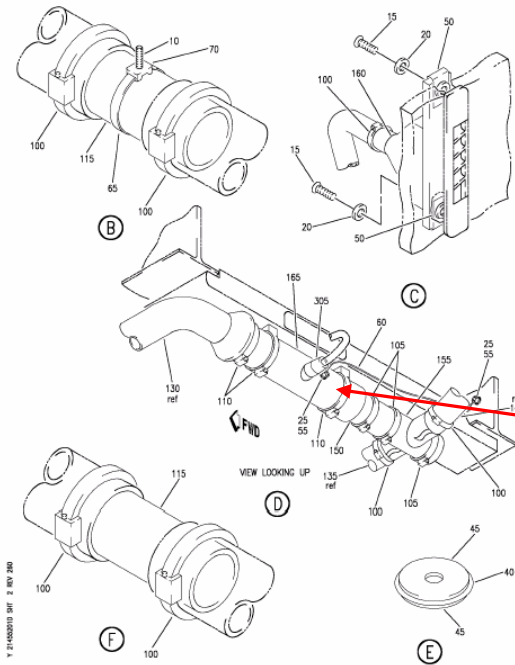
HEATER SYSTEM INSTL-DOOR 3 AREA
FIGURE 10 (SHEET 2)

A thermostat and a fuse control are built into the duct heater unit and designed to operate if the heater's air temperature exceeds 250 F or if the surface temperature exceeds 300 F. Boeing Aircraft Company and the manufacturer of the heater (Electrofilm Mfg Co) inspected the failed part to determine the specific fault and to understand if the protective features of the unit were functioning. (See a drawing in Appendix A of the duct heater and its location in the aircraft).

Electrofilm's conclusion is that a metallic object appears to have impacted the intake end of the duct heater tube with sufficient force to bend the tube edges and pierce the power lead insulation causing an arc short. This condition circumvented both the thermostat and fuse controls. The duct heater continued to operate in this condition until shut down. The burn pattern also indicates, according to Electrofilm, that the incident occurred in a low airflow condition.

Duct heater and tube
