AIRCRAFT INCIDENT REPORT

M-03003/AIG-19

**LY-ARS
Piper PA30
At Reykjavik Airport
29 June 2003**

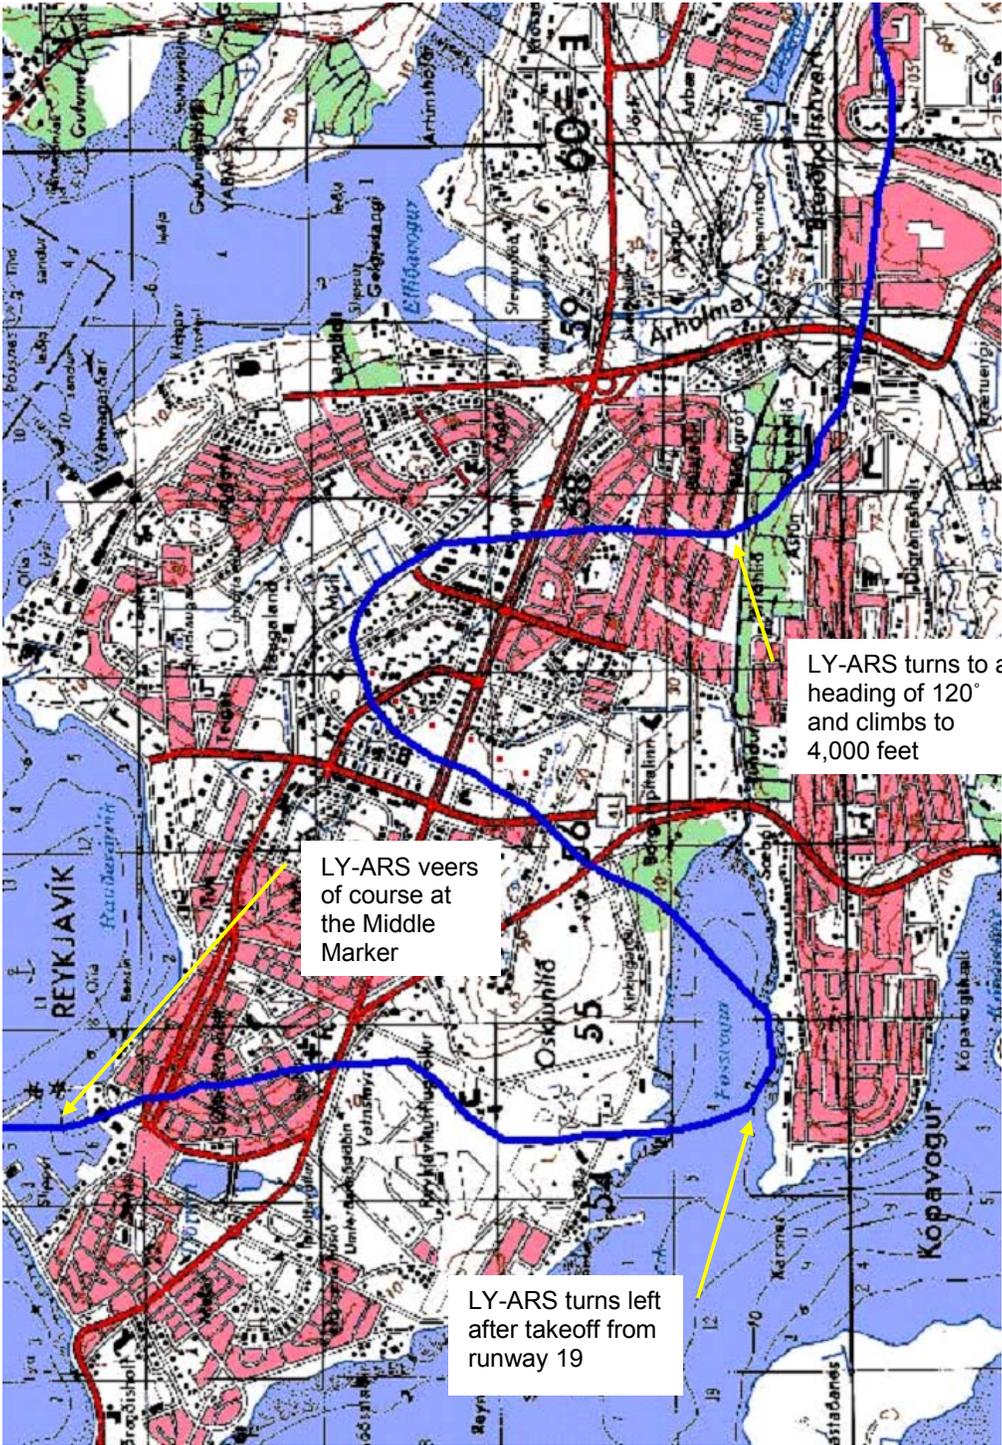
Appendix B - LY-ARS radar plot

right to manoeuvre the aircraft for a landing on runway 19. The LY-ARS radar plot shows that the aircraft starts to deviate to the left from the extended centreline of the runway at or just before the Middle Marker (MM) (see appendix B).

As the aircraft was breaking out of clouds at the Middle Marker the commander looked up from the instruments and started looking for the runway. The radar recording shows the aircraft turning slightly to the left at this time. When the commander saw a runway in front of the aircraft it had veered of its course and he assumed that this was the runway he had been cleared to land on. When the aircraft neared the airport the commander discovered that he was approaching the wrong runway and instead of performing a go-around he manoeuvred the aircraft towards the runway he was cleared to land on. The aircraft landed past the midway point of the runway and the commander elected to take off again as he considered the remaining runway not sufficient to safely stop the aircraft.

In the opinion of the AAIB the commander should have performed a missed approach at the Middle Marker (MM) when visual reference with the runway was not established. The pilot looked up from the instruments, approaching the Middle Marker (MM), and got visual contact with the ground. He then continued the approach and allowed the aircraft to veer left of course while trying to get visual contact with the runway.

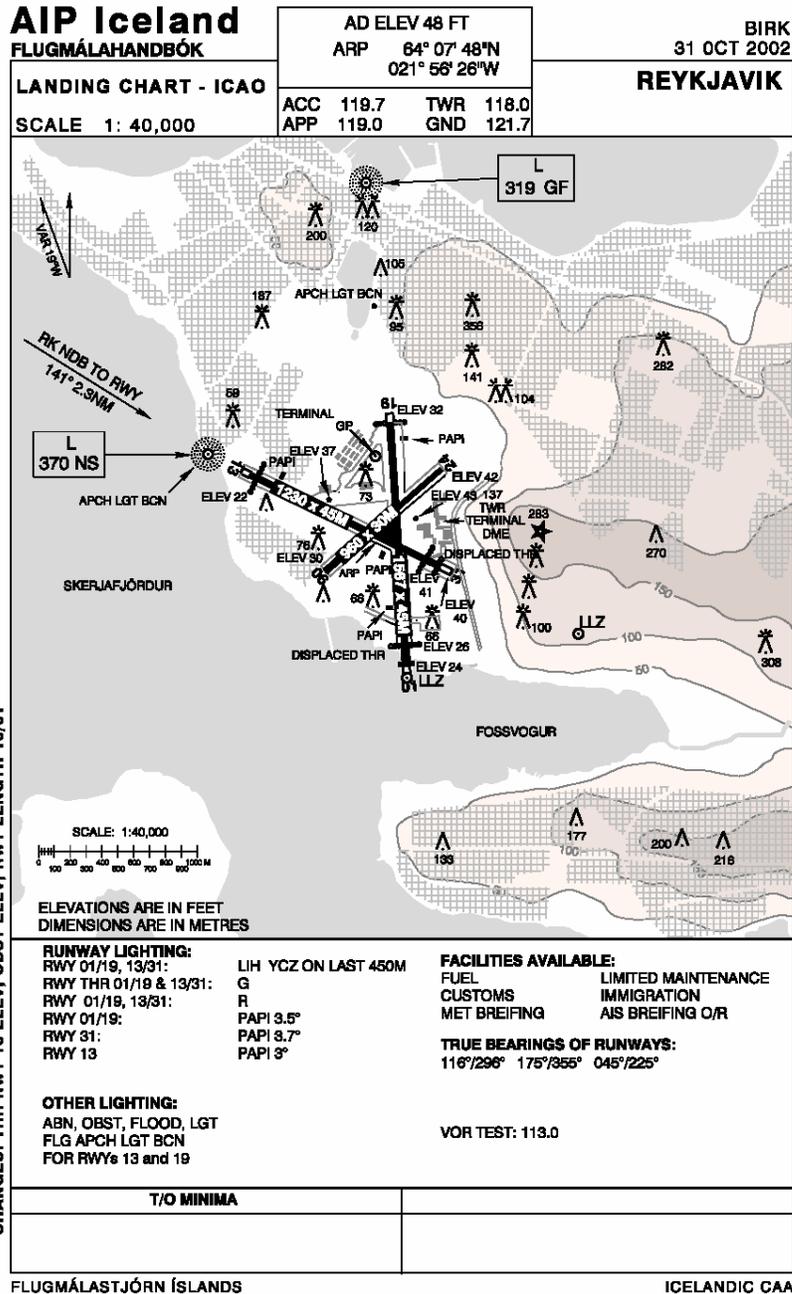
Appendix C - AIP Iceland, chart of Reykjavik Airport

The controller at Reykjavik Tower was looking towards the area where he expected the aircraft to appear on the approach when he saw the aircraft flying east of the extended centreline for runway 19. According to the controller the aircraft was on a south-easterly heading when it turned right, flew over runway 24 and landed at 19:05 hrs on runway 19, just after passing the intersection of runway 13/31 (see Appendix C for a chart of Reykjavik Airport).
