AIRCRAFT INCIDENT REPORT

M-04303/AIG-26

**OY-RCA / N46PW
BAe-146 / Piper PA46T
63°N, 028°W
1 August 2003**

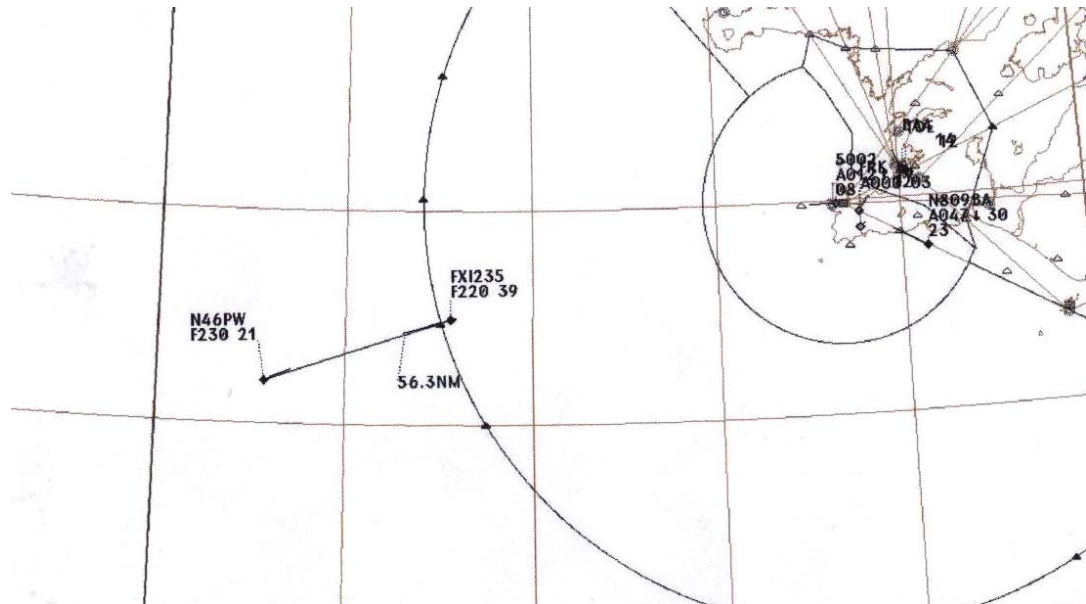
Appendix A - Radar plot 1

Replay of the ATC radar data showed OY-RCA at 16:04:49 level at FI-220 and N46PW level at FI-230. The aircraft were 56.3 nautical miles apart on opposite tracks (see appendix A for radar plot 1). The crew of OY-RCA did not report levelling and was not required to make such a report.

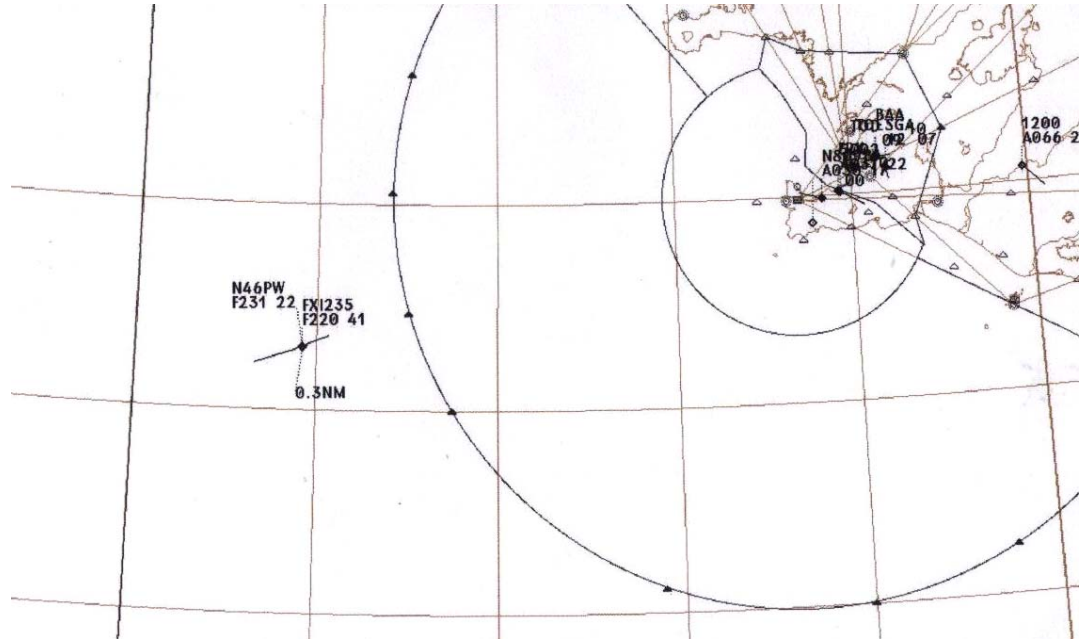
Appendix C - Radar plot 3

The ATC radar data showed the aircraft pass each other with 1000 feet vertical separation at approximately 16:10:06 hrs (see appendix B for radar plot 3).
