AIRCRAFT ACCIDENT REPORT

**Report by the British Air Accidents Investigation Branch
into the incident to Boeing 747, TF-ATD
at Teesside International Airport, Co Durham**

**TF-ATD
BOEING 747
Teesside Airport
16 October 2002**

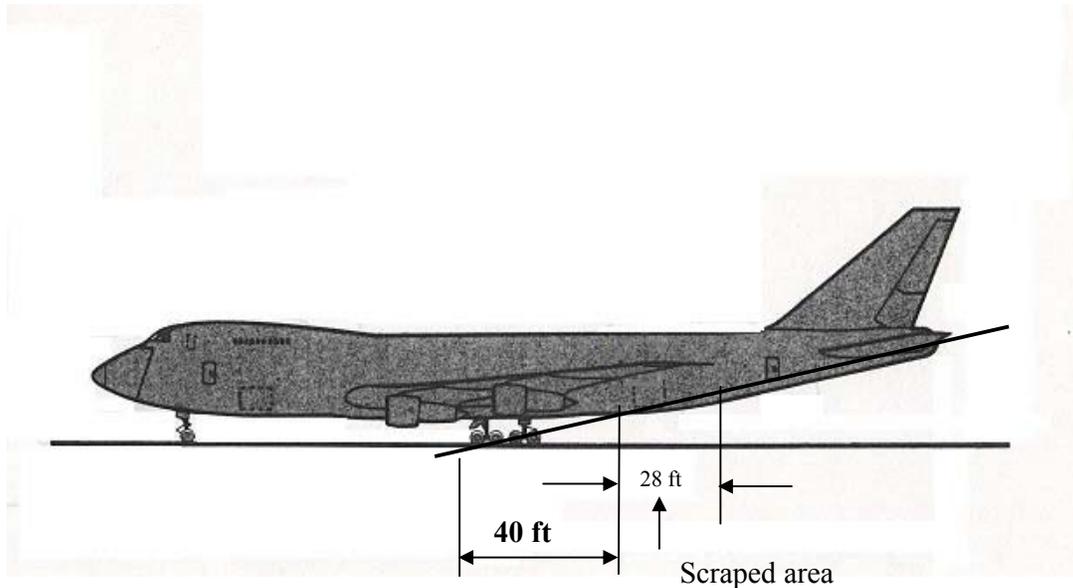
The underside of the rear fuselage had suffered abrasion damage, severe enough to expose the edges, in a few places, of two fuselage frames. The rear toilet drain mast had been flattened to the fuselage and the left-side cabin outflow valve, located aft of the damaged area of the fuselage, and which stood proud of the skin, had been ground away on its lower corner. The right cabin outflow valve had escaped damage however, which confirmed the left roll attitude at touchdown.

The damage to the fuselage underside extended over an area approximately 28 feet in length, as indicated in the above illustration. The aft limit was immediately ahead of the rear pressure bulkhead, which is at Fuselage Station 2360. (Note: Fuselage Station numbers refer to the distance in inches aft of a defined datum ahead of the aircraft nose.) A subsequent inspection inside the fuselage, under the floor in the aft cargo area, revealed some minor damage to some of the fuselage frames. The forward limit of damage was approximately 40 feet aft of the wing gear. Thus the 'slant distance', (ie with the aircraft in its touchdown attitude) between the rear pair of wing gear landing wheels and the aft limit of fuselage damage was around 70 feet, or 21.5 metres. Since the distance between the start of the scrape mark on the runway and the first of the tyre marks was 28 metres, or around 90 feet, as noted earlier, it follows that the rear fuselage contacted the ground fractionally before the wheels.

The 'grounding line,' as shown in the illustration, which would vary slightly with oleo compression, is around 12°; this compared favourably with the DFDR data, as discussed later in this report.

The scratches on the fuselage underside were angled relative to the longitudinal axis of the aircraft, which, when measured, indicated that the aircraft was yawed 8.25° to the left of its ground track.

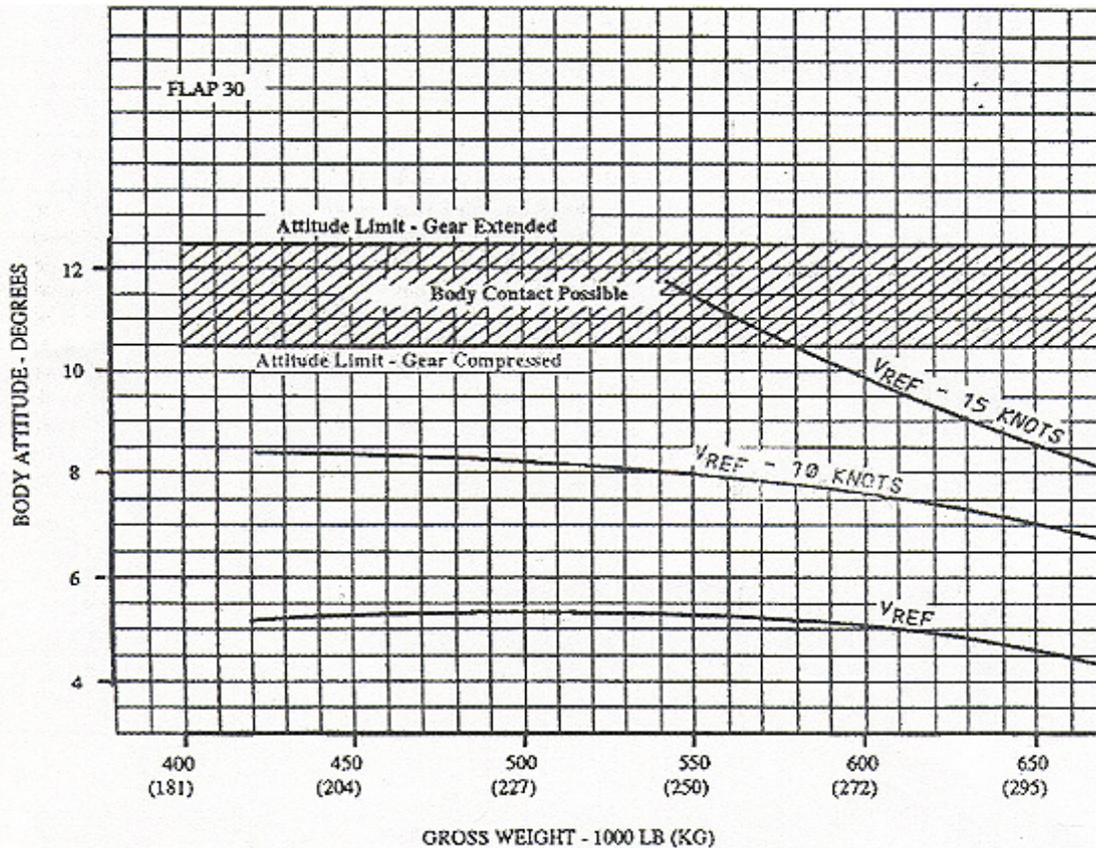
Figure 2-33 TOUCH DOWN ATTITUDE FLAP 30

The graph shown below illustrates the relationship of body attitude and speed for the gross weight of the aircraft, which on the accident flight was 254.3 tonnes. The aircraft was 20 kt below V_{REF} at touchdown.

From the ‘Touch Down Attitude Flap 30’ chart supplied by the manufacturer and included in the Recommended Landing Technique section above, the relationship between low airspeed below V_{REF} and the attitude limit with the landing gear compressed is illustrated. At an airspeed of 14 kt below V_{REF} the aircraft is placed in the ‘body contact possible’ area of the graph.

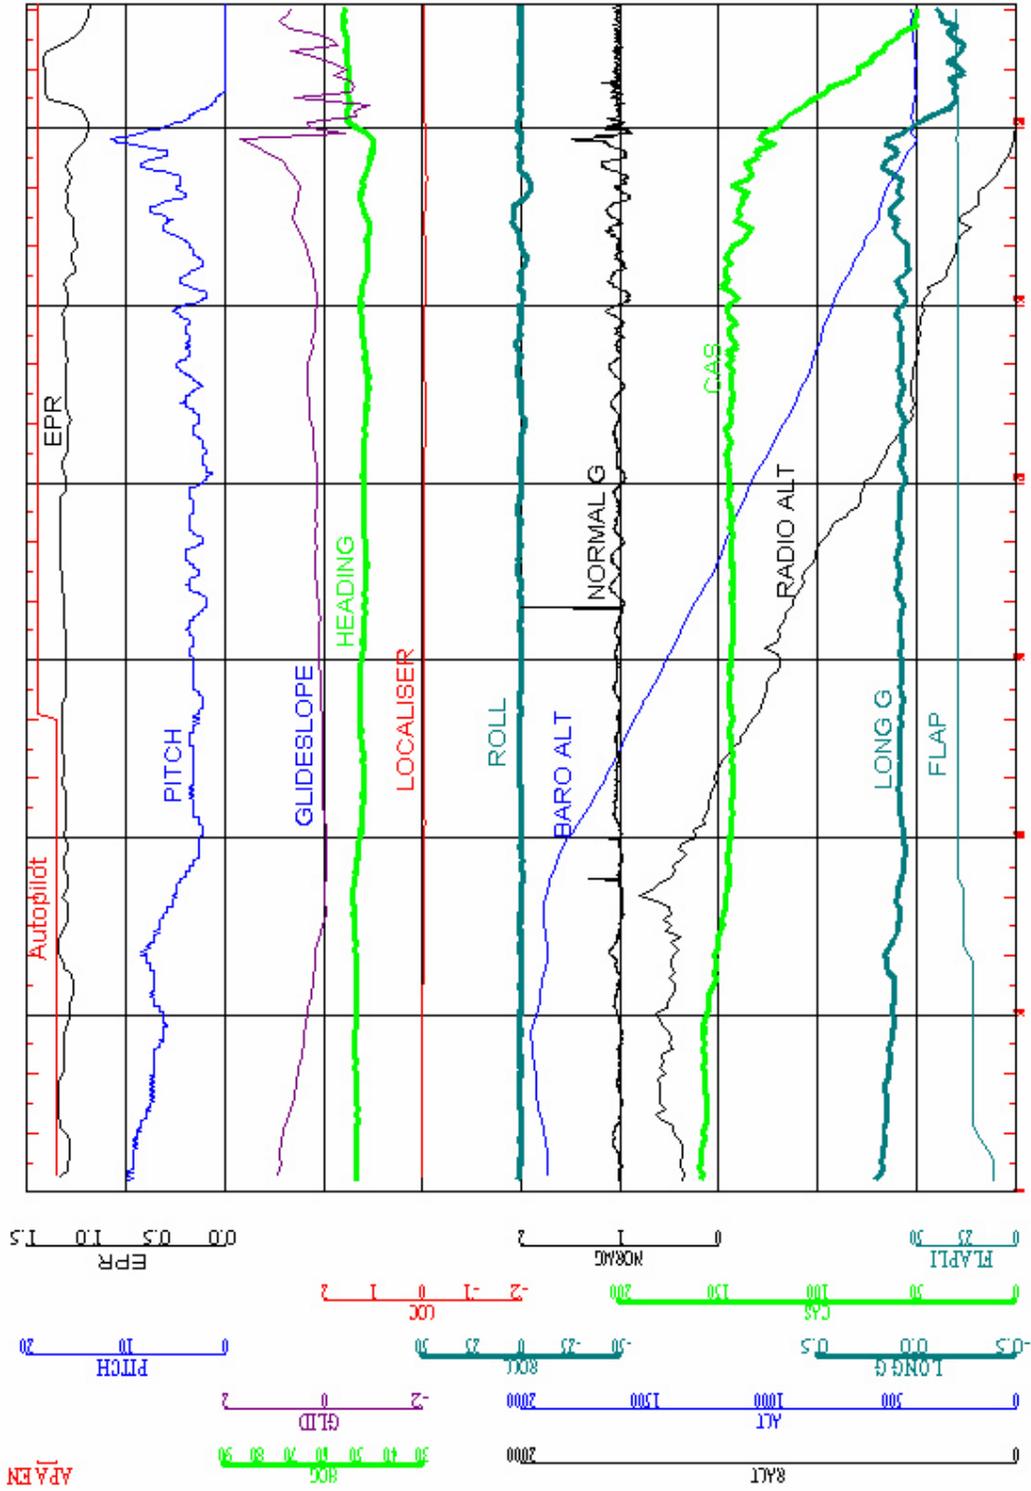
Appendix 1 Figure 1 shows a graphical time history of selected FDR parameters beginning three minutes before landing. Figure 2 is an expanded graph of the data with relevant annotations from the CVR recording.

From Figure 1 it is clear that the aircraft was tracking the glidepath and localiser signals until about 400 feet agl. At 400 feet there was a small reduction in engine power, the barometric altitude indicated an increase in rate of descent and the ILS glidepath signal showed the aircraft beginning to deviate below the glidepath. The aircraft remained below V_{APP} , but above V_{REF} until 300 feet when the airspeed increased to 148 kt remaining at around 146 kt to 250 feet. Thereafter, pitch attitude increased and the airspeed started to reduce. Coincident with the flight engineer's 200 foot call the GPWS initiated the first of two Mode 5 aural "GLIDESLOPE" warnings. The aircraft pitch attitude continued to increase and the glidepath deviation stabilised for about 7 seconds at about 1/2 dot 'fly up' demand. As the pitch attitude increased, the airspeed reduced and at 100 feet agl the speed was 136 kt. There was a small increase in power at about 90 feet agl; however, the pitch attitude continued to increase and the airspeed decayed further. Airspeed continued to decay to 129 kt at 36 feet with the aircraft 1/2 scale deflection below the glide-slope and thrust reducing. At about that time the CVR recorded the non handling pilot call "watch the speed". From 20 feet above the runway the fuselage nose-up pitch angle increased rapidly from 7° and at 5 feet above the runway, the airspeed was 121 kt with the thrust set at idle.

The aircraft touched down with a pitch attitude of 11.5° (nose-up) on a heading of 43° M (about 8° left of runway heading), at a speed of 129 kt (12 kt below V_{REF}). The speedbrake was activated within 0.5 seconds of touchdown and reverse thrust was deployed 2 seconds later. After touchdown the aircraft quickly turned onto runway heading, decelerated normally and stopped within 25 seconds.

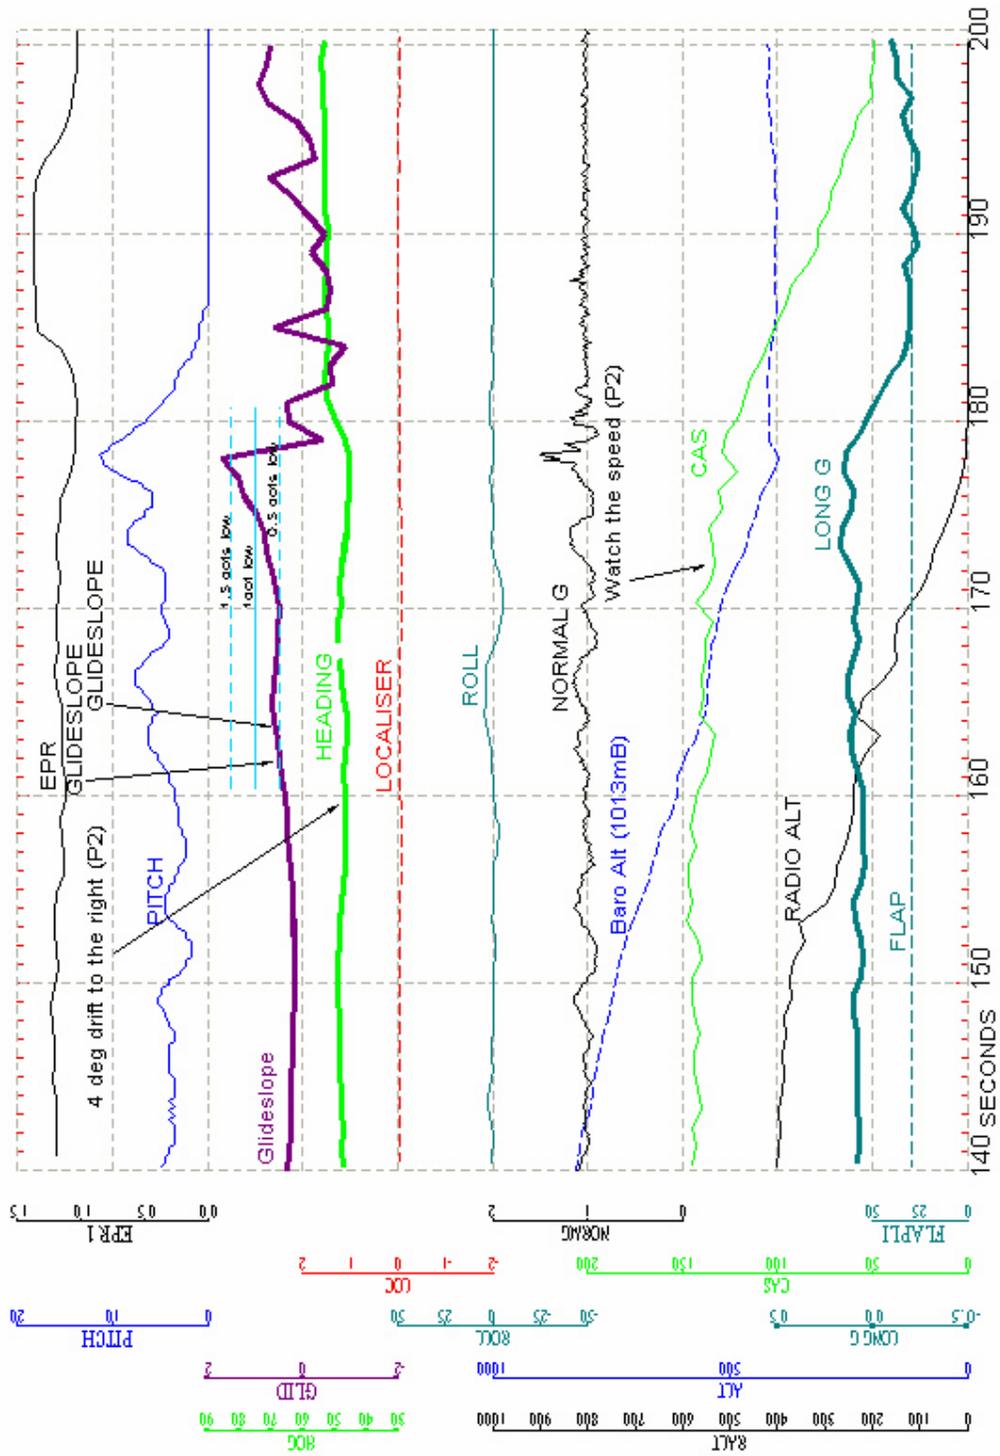
Appendix 1 Figure 2

Although the recorded body accelerations showed no clear evidence of turbulence on approach, there were a number of fluctuations in recorded airspeed between 150 feet agl and landing. Some of the fluctuations were explainable by pitch attitude changes and ground effects. However some were not. Furthermore, the commander commented on the CVR that he was aware of "a shear" at 100 feet agl.
