Report on marine incident

RNSA no: **2014-S082**

Ships name: **Samskip Akrafell (IMO 9271963)**

Incident: **Runs aground, officer on watch (OOW) falls asleep**

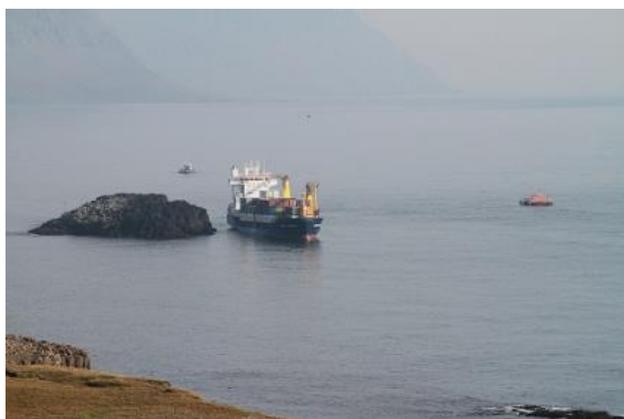
**Photo 1** Samskip Akrafell at the grounding site © RNSA

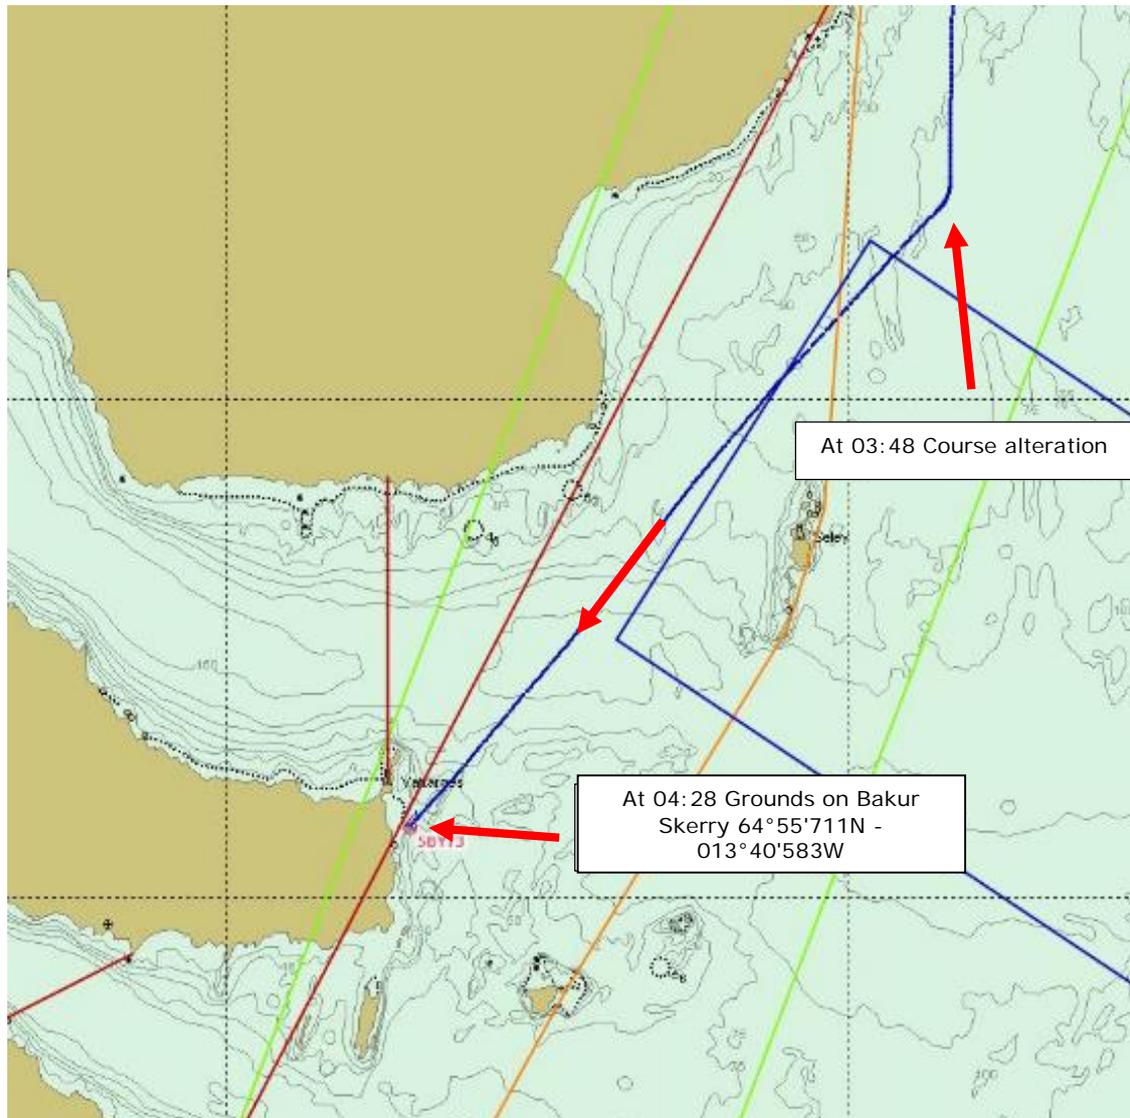
At 03:48 UTC when the vessel was located south of Gerpir Point, the course was set between Seley Island and the mainland but on that route the OOW (*Chief Officer*) fell asleep. According to the AIS track (*Figure 2*) from the Maritime Traffic Service (MTS), a course alteration was made at 03:48 UTC and after that the course 220° was maintained. At 04:28 UTC the vessel grounded at 64°55'711N and 013°40'583W on shallows east of Bakur Skerry outside Vattarnes Point south of the entrance of Reydarfjörður. (*See Figure 1*)

Figure 2 AIS track chart and grounding site of Samskip Akrafell/VSS

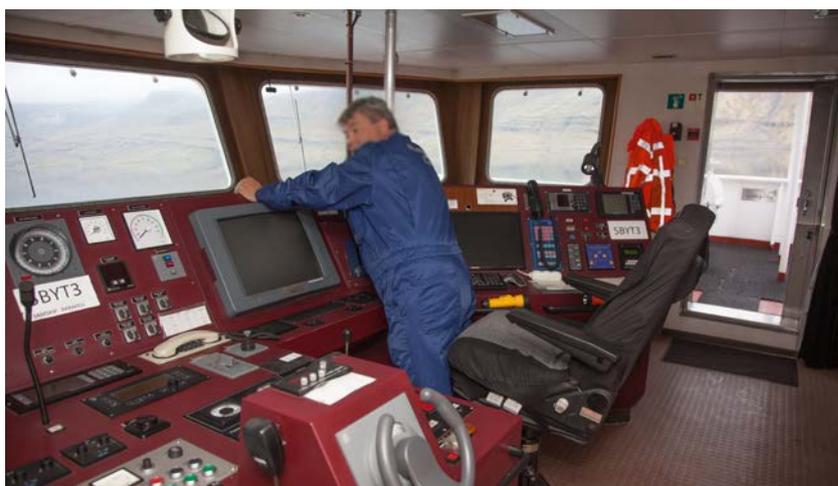
- that the OOW was alone on the bridge and said he had not fallen asleep, but had become absent-minded. He believed that this happened because he was tired;
- that the OOW was in charge of the navigational watch from 18:00-20:00 (UTC +2) the day before and after cargo inspection he had gone to bed around 21:15. At 03:30 (UTC +2) he woken up and assumed the navigational watch at 04:00 (UTC +2);
- that the last course alteration had been made at 03:48 UTC and after that the OOW had navigated carefully until he passed Seley Island. After that he had become absent-minded, his situational awareness degraded, until he felt the impact when the vessel ran a ground. The figure 3 (*scenario*) shows where and how the OOW had been standing on the bridge when the ship grounded. He said he tilted over the console when he became absent-minded and had been in that position at the time of grounding;

Figure 3 The position of the OOW at the time of grounding (*scenario*)

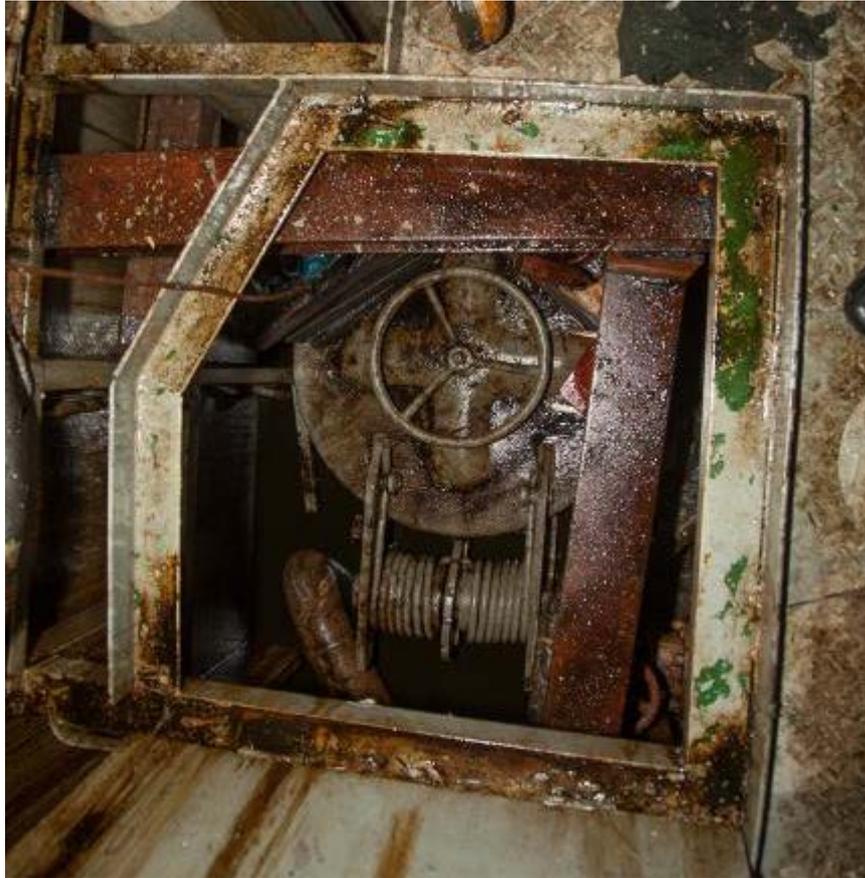
Figure 6 The hatch to the pipe tunnel

- that it was not clear why the watertight hatch to the tunnel was open during the final voyage;
- that the ITSB retrieved information from the vessel's VDR (*Voyage Data Recorder*);
- that the OOW joined the ship in November 2013 and had seagoing service experience as a deck officer since 2001;
- that all crew members underwent an alcohol test which was found to be negative.

The Board also notes that the pipe tunnel watertight hatch should have been closed during a voyage, according applicable rules.

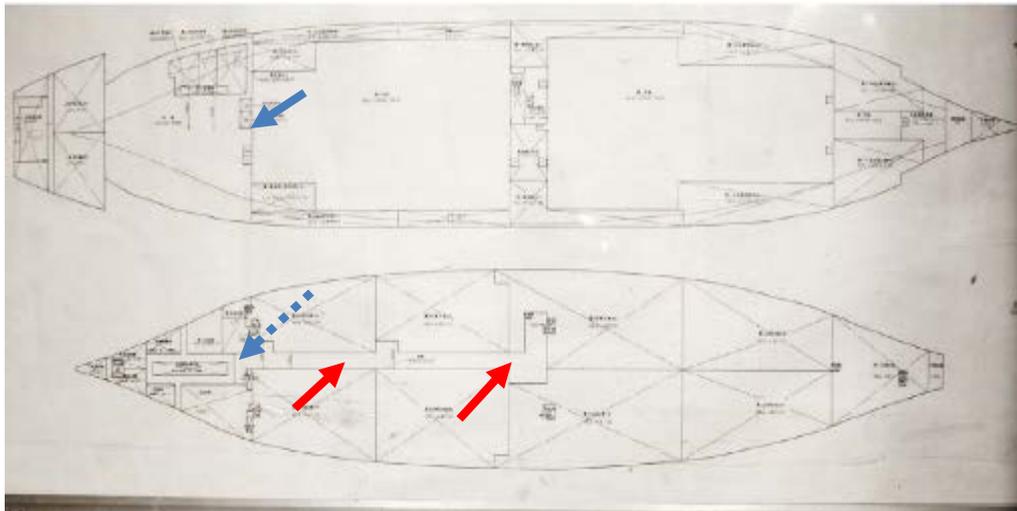
Figure 7 The blue arrows indicate the location of the hatch openings and the red ones indicate the pipe tunnel

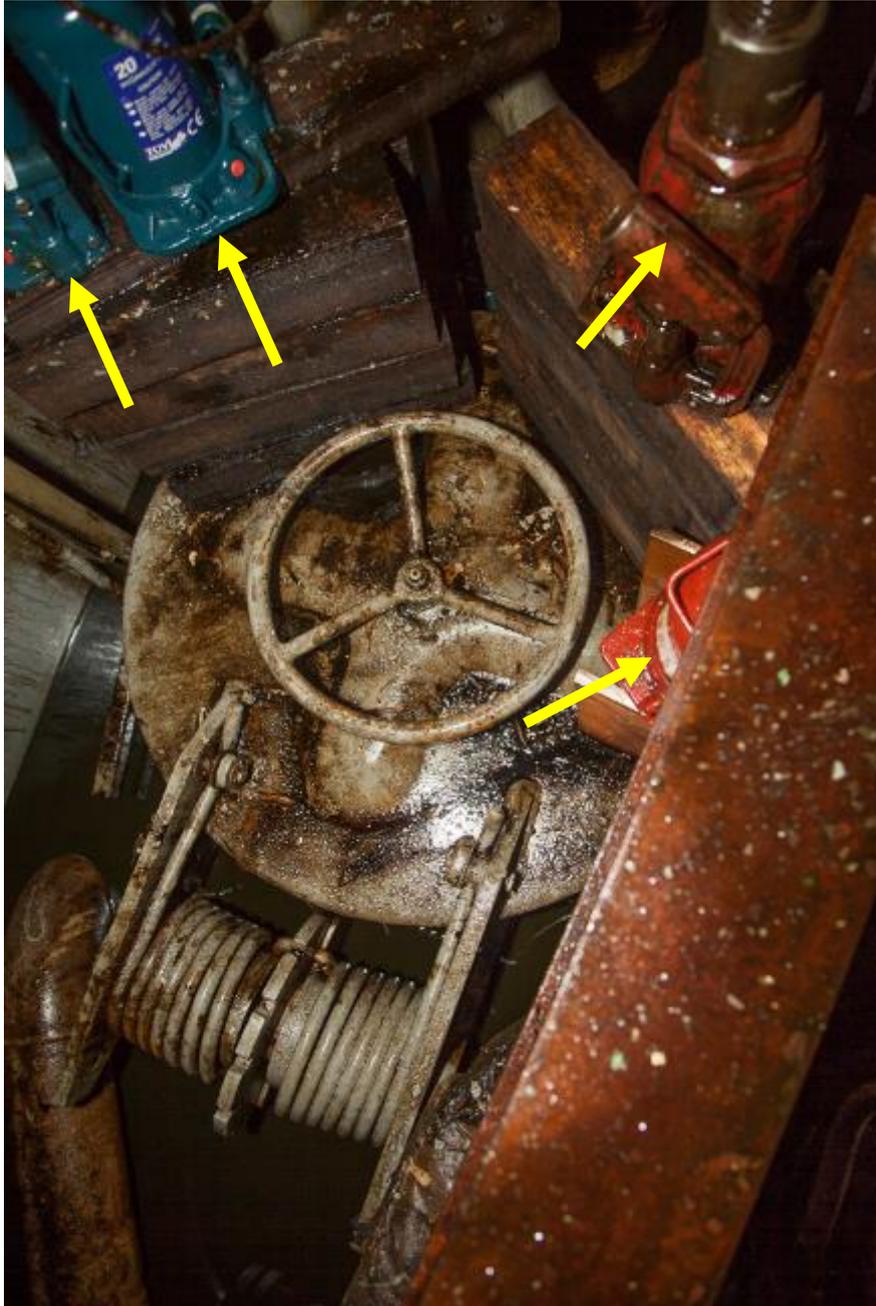
Figure 8 Jacks and wooden blocks beneath them on top of the hatch cover

- that since pumping from the engine room proved difficult, it was necessary to send divers down to contain the leak by the hatch. In order to tighten the hatch, the divers had to fit wooden blocks and use four powerful jacks to press the

hatch down (*Figure 8*). Upon completion of that operation, pumping proved successful;
