## STAÐA MÁLS

Case no.: **18-104F018**

Location: **Keflavik Airport (BIKF)**

Description: **FOD caused a MLG tire to burst**

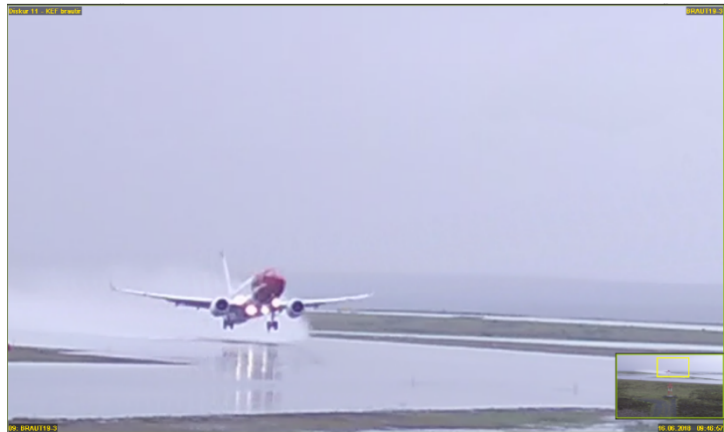
ATC<sup>1</sup> contacted the flight crew to notify them that tire rubber had been found on RWY 01 at BIKF after they took off. The flight crew informed ATC of their hydraulic problems. Subsequently ATC also relayed information that a metal piece had also been discovered on the RWY.

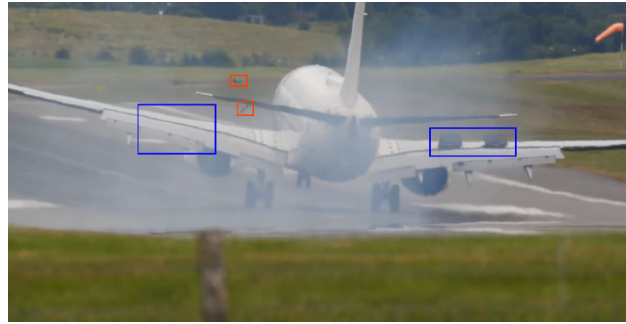
During the landing at Birmingham, the left wing ground spoilers did not deploy. In addition tire debris was released from the LH MLG after it touched down at the runway.

The LH inboard tire was found burst and the airplane incurred damage in the area around the LH wheel well.
