Case no.: **18-170F021**

Date: **20. June 2018**

Location: **Akureyri Airport**

Description: **Missing nut on two fasteners on main rotor pitch links**

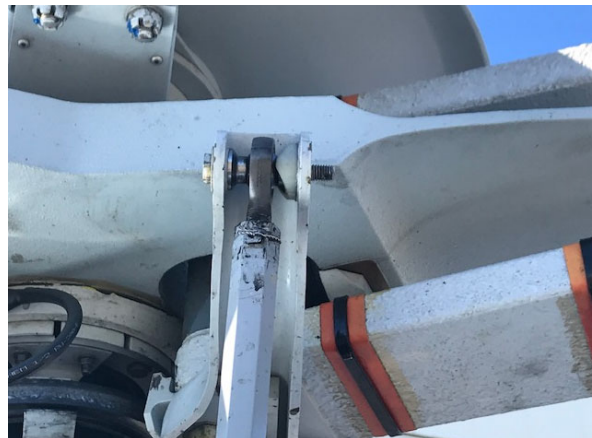
Aircraft TF-HDH, which is an Airbus EC130-B4 helicopter, arrived in Iceland in a container after being procured by its operator. The operator shipped the container to Akureyri Airport and contracted Arctic Maintenance, an EASA part 145 maintenance organization in Akureyri, to reassembly the helicopter and to make it airworthy.

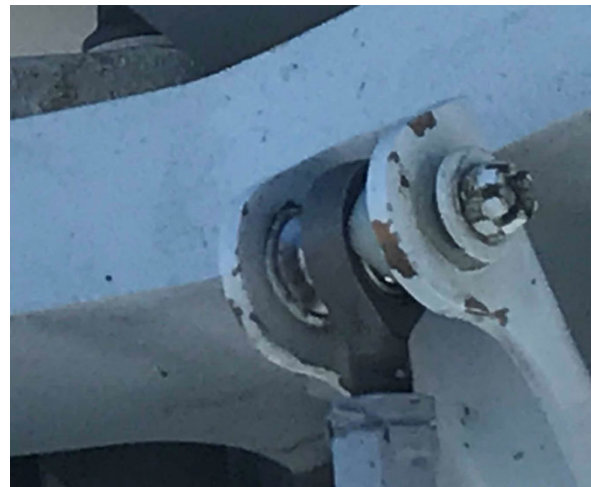
On June 20th, after having received the flight permit from the authorities, the helicopter was prepared for a track and balance flight. During the preflight check, the pilot discovered that the nuts were missing from two of the three pitch link bolts on the main rotor.

During this inspection it was discovered that on the third and last of the pitch links, the installed nut was loose. No further defects were found during the inspection.

The ITSB believes that the maintenance technicians forgot to torque the nuts on the pitch link bolts, as well as locking them using the locking features (bolt hole) in the shank of the pitch link bolt and the castellated nut. This most likely resulted in two of the three nuts for the pitch link bolts to fall off during the ground run on June 18th.

The investigation revealed that during the planning and preparation of the work package for the reassembly, the Part 145 maintenance organization failed to identify the reassembly task involving the pitch links as a critical task. Therefore, no secondary inspection was performed.

The defects were corrected and the helicopter subsequently released to service.
