Case nr.: **19-083F021**

Date: **8. June 2019**

Location: **At the farm Brúsastaðir, Þingvellir**

Description: **Mishap during landing**

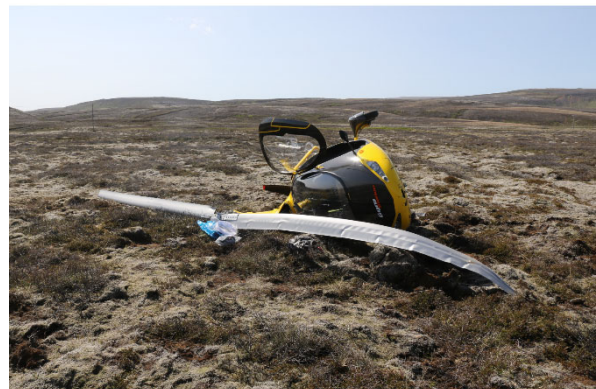
When the gyrocopter was just about to land on the road, a gust of wind pushed it to the right, resulting in it landing beside to the road. The road lies higher than the land around it. As the gyrocopter was about to land next to the road, it's main rotor, which was tilted aft due to the landing mode, hit the built up road. The gyrocopter flipped to the right and came to rest on its right side.
