Final report on aircraft accident

Case number: **2015-089-F-026**

Date: **12. November 2015**

Description: **Aircraft collided with the ground during a training flight**

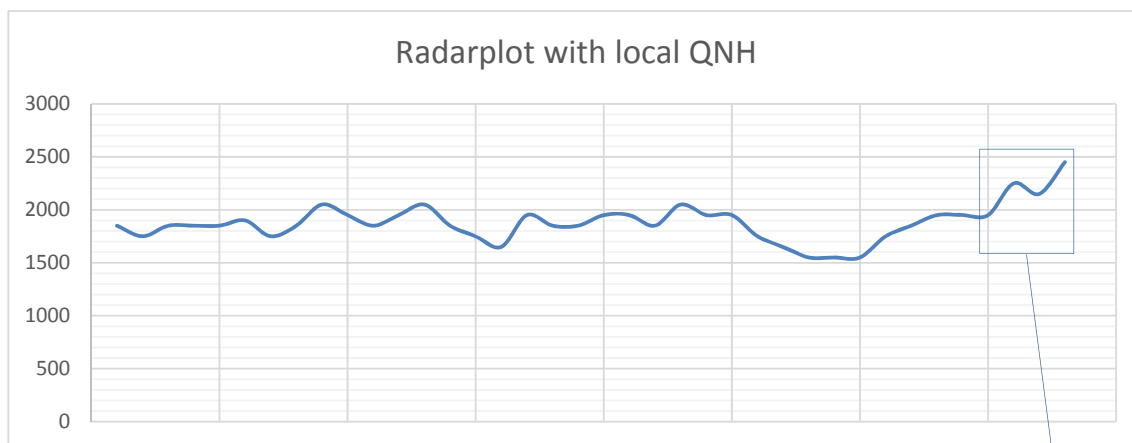
Figure 5: The aircraft's altitude, based on local QNH

According to the last four recorded radar signal, the aircraft was flown from approx. 1950' to 2250' and then from 2250' to 2150' and then from 2150' to 2450'⁷, which was the last recorded radar signal.

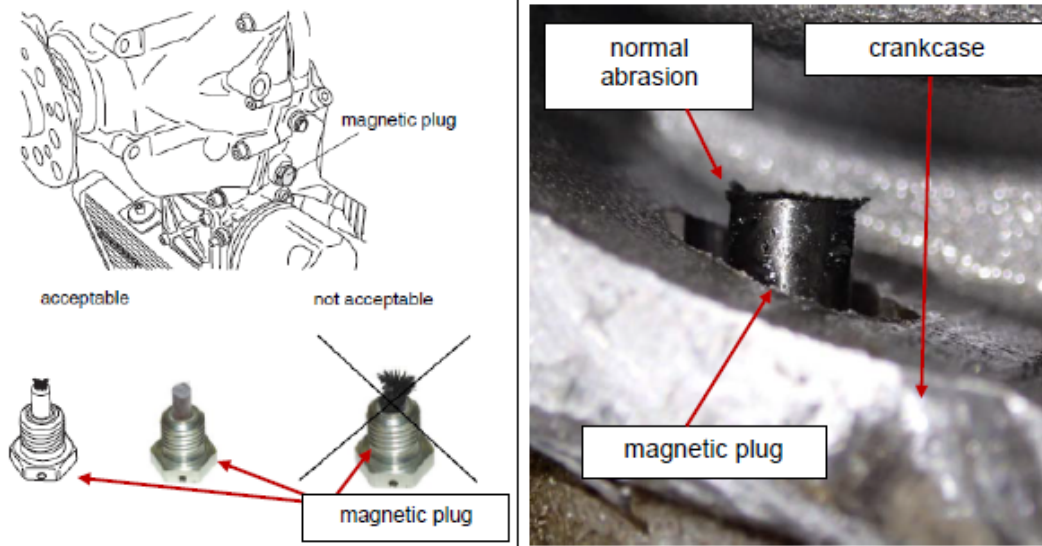
A visual inspection was made of the magnetic plug. There was no abnormal accumulation of chips on the magnetic plug.

Figure 7: Magnetic plug inspection

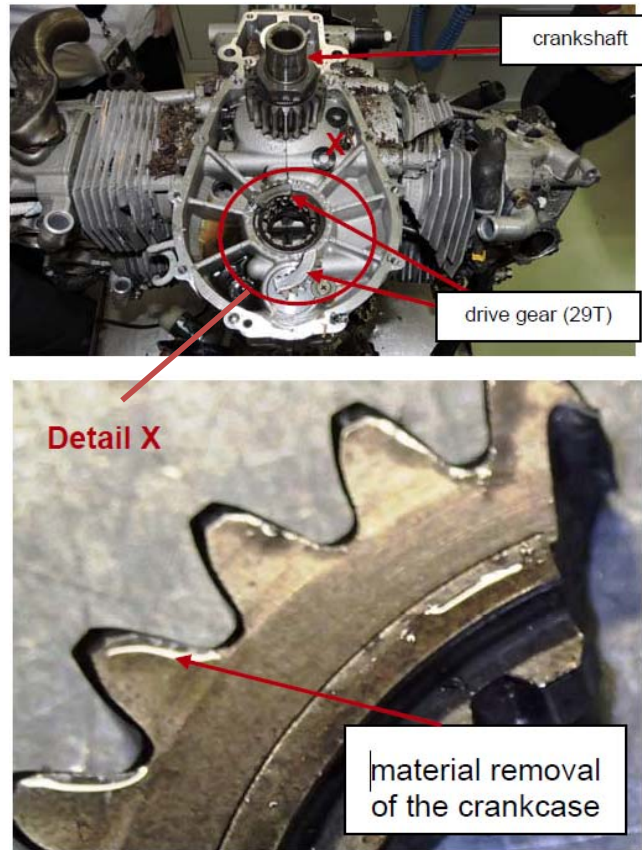
A high level of damage was visible on the crankcase as a result of the crash.

These marks indicate that the crankshaft was slowly turning at the time of the impact.

The investigation of the engine revealed that free movement existed in all connecting rods of the crankshaft before impact. There were no indications or damage visible on the connecting rods that would indicate a seizure. In addition, the main bearings and the support bearings of the crankshaft and crankcase were free of defects and there was no indication of malfunction.

Figure 8: Crankcase inspection

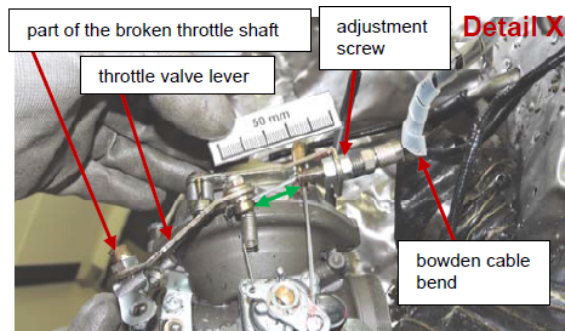
The Bowden throttle control cable was bent approximately 90° in the area of the adjustment screw as a result of the crash (see Figure 9). This was also an indication that the engine power was at idle at the time of impact, regardless of the throttle lever position found at the accident site.

Figure 10: Throttle control cable

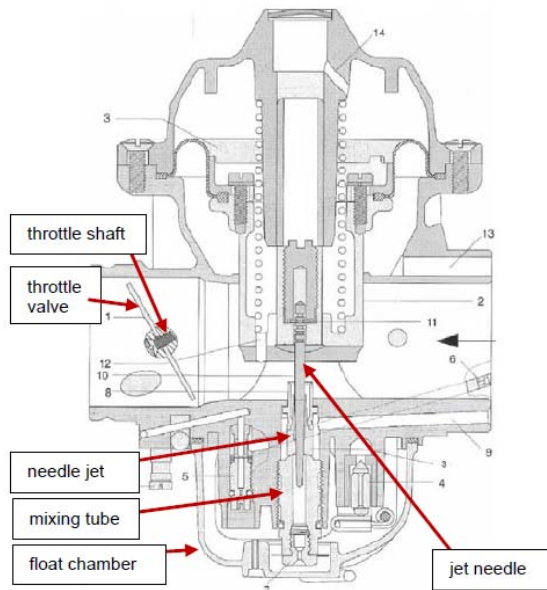
Based on the detected carburettor - Bowden cable bent the throttle position and also the jet needle position, it can be assumed that the engine was operating at idle at the time of the impact.

Figure 11: Carburettor

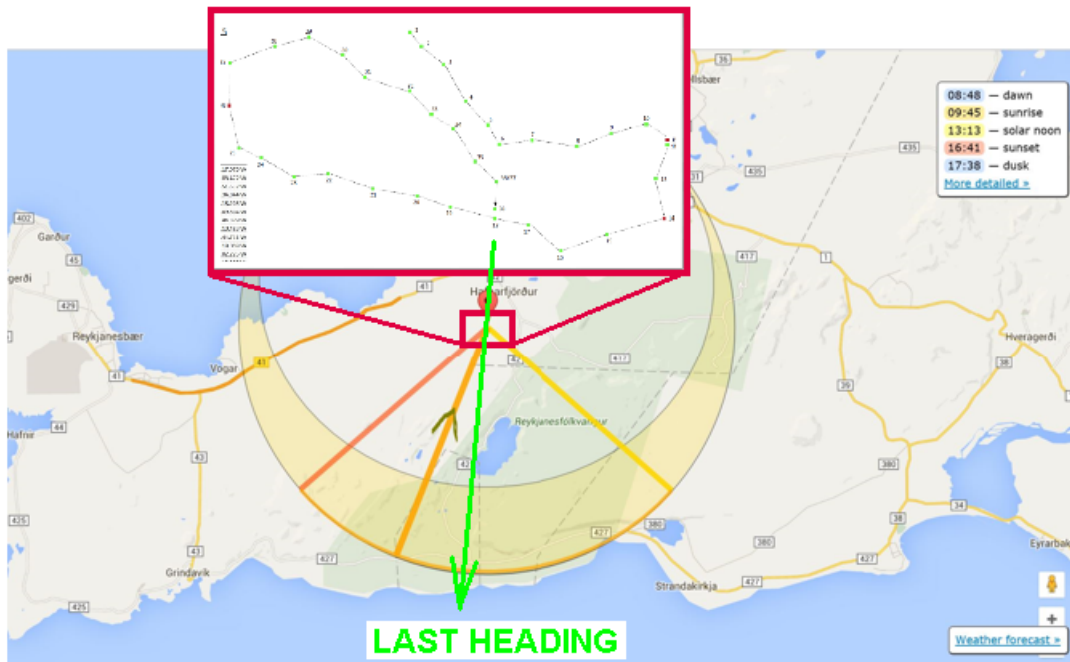
As can be seen in Figure 15, the sun was shining and low in the sky around the time of the accident. The last plotted heading of the aircraft was towards the sun (see Figure 15 and Figure 16), possibly interfering with the pilots' instrument reading.

Figure 16: Last known heading towards the sun

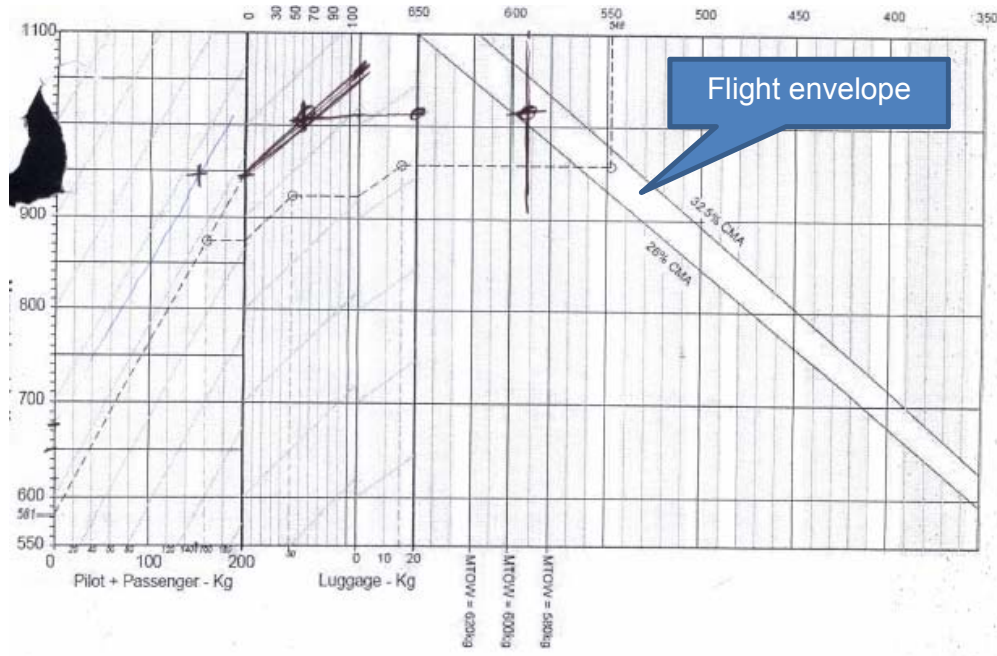
By looking at the Weight and Balance sheet that the pilot filled out, the 676.4 kgm of empty Weight moment is used. Total of 400 kg empty Weight, 150 kg of pilot and passenger Weight, and 60 liters of fuel (which equals to 43 kg of fuel). The Weight and Balance sheet was made manually before the flight and indicated that the aircraft loading was within limits. By filling out the Weight and Balance sheet with a computer, it may be seen that the center of gravity is at the forward limit of the flight envelope (see Figure 23 and Figure 24).

Figure 23: The Weight and Balance sheet – Hand drawn

Due to how narrowly the manufacturer’s W&B envelope is presented on the W&B sheet, it is easy to make errors while preparing the sheet. This makes locating accurately the center of gravity difficult and allows cumulative errors to occur.

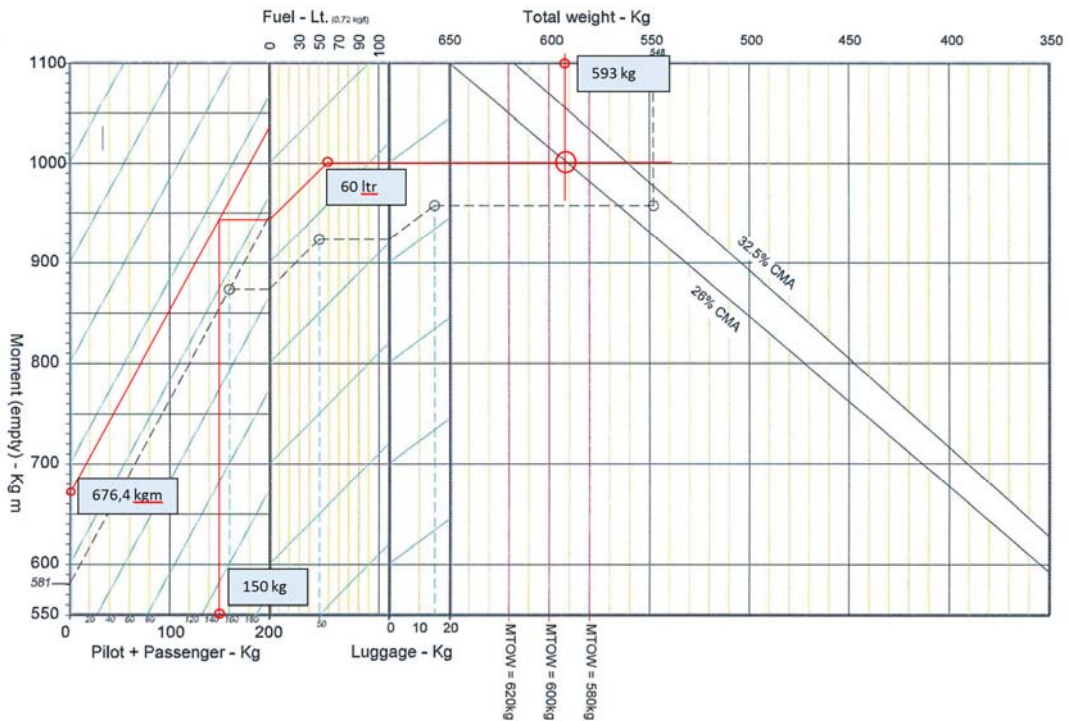
Figure 24: The Weight and Balance sheet – Computer drawn

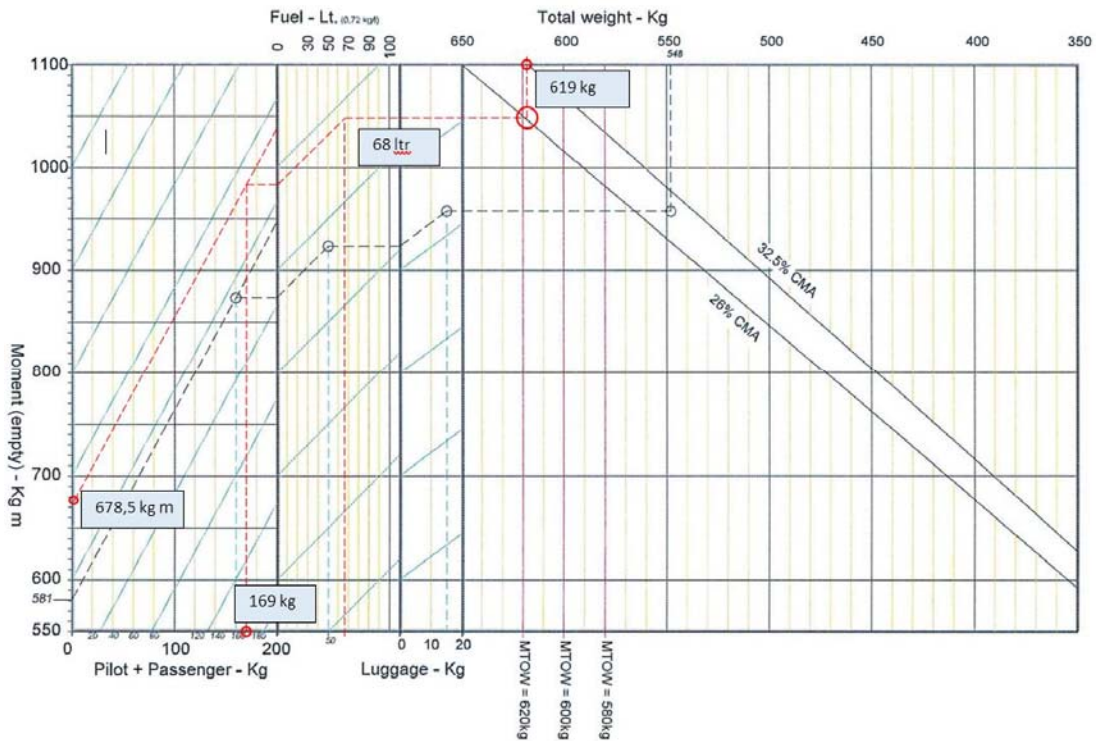
Figure 28: Corrected Weight and Balance sheet

From the calculations above, it is apparent that the aircraft was within the Weight and Balance boundaries but slightly closer to the limits than depicted on the Weight and Balance sheet prepared by the Instructor/student.

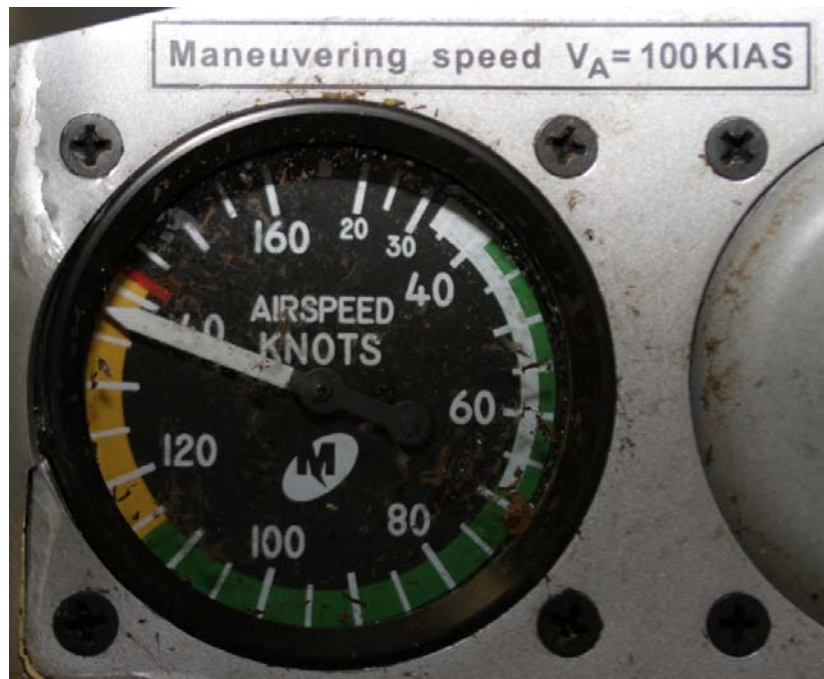
Numerous inconsistencies were found between the airspeed limitation given in the aircraft's handbook and those marked on the airspeed indicator of the accident aircraft.

Figure 33: Airspeed indicator markings on instrument

The reason for this difference is that the table in the AFM is given for the Tecnam P2002JF variant with a MTOW of 580 kg.

The table of Airspeed Indication Markings for MTOW of 620 was missing in the AFM supplement valid at the time of the accident. This has been corrected in the 3rd edition – Rev. 14, dated November 11th 2019.
