Case nr.: **20-128F023**

Location: **Keflavik Airport (BIKF) - Iceland**

Description: **N810NW Diverted due to engine failure**

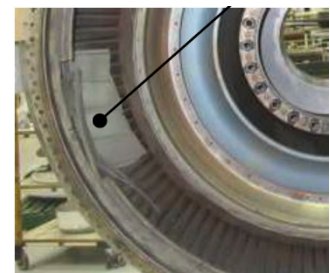
A borescope of the engine revealed that the problem was a known failure found at the outer transition duct segment. The engine manufacturer started a campaign for replacement of OTD followed by an AD issued by the FAA, 2020-25-09, that had been released with an effective date of 14-Jan-21.

The investigation also revealed that a redesign of the OTD, was made, as Service Bulletin PW4G-100-A72-261 on 18-Nov-2020 to improve durability.
