Case nr.: **20-084F015**

Location: **Isafjordur Airport**

Description: **Landing gear collapsed during take-off run**

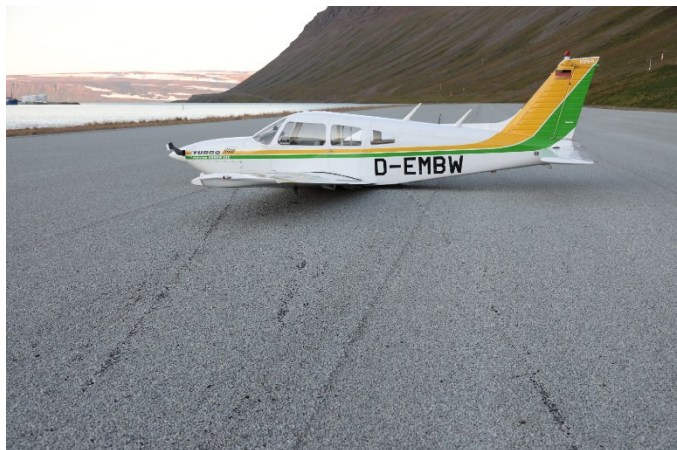
After a flight from Germany to Iceland, a private pilot with one passenger were planning to fly from Isafjordur Airport to Reykjavik Airport in Iceland. At Isafjordur they decided to unload and reload the aircraft (to clean up after the long flight from Germany)

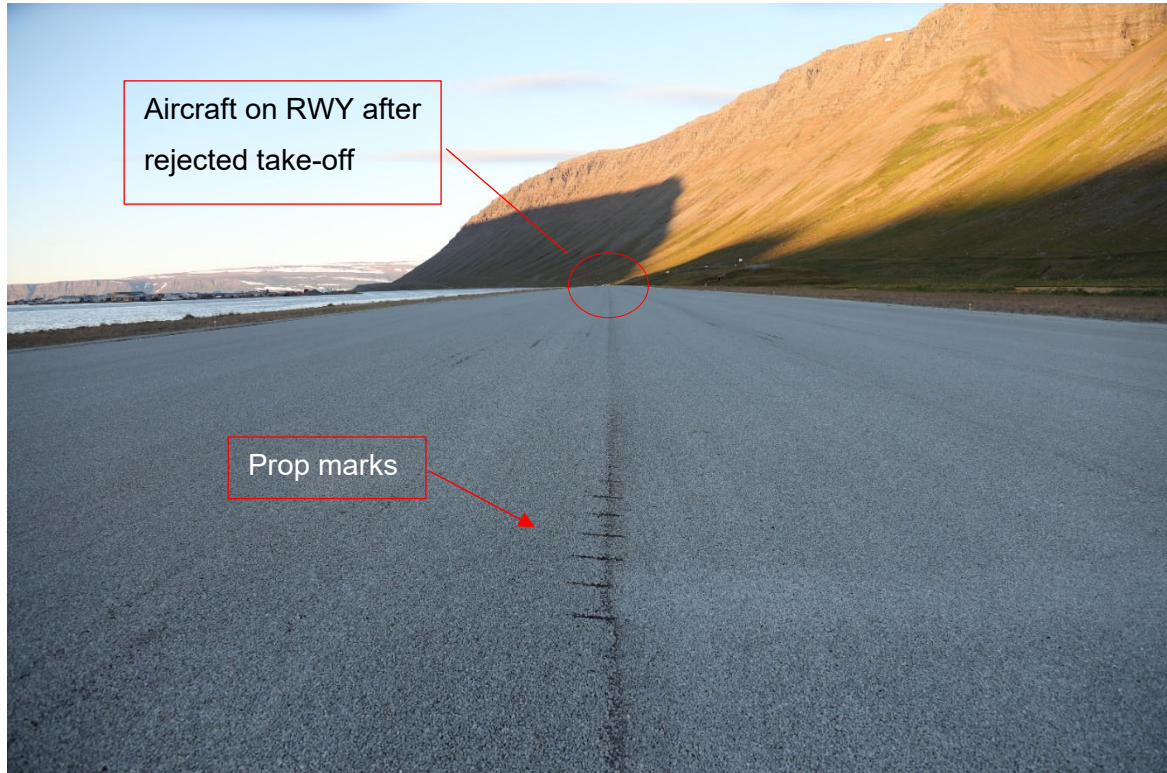
After few seconds, the pilot decided to abort the takeoff and the aircraft came to a rest on the RWY, see picture 2.

During the on-site investigation the handle was found in UP position and when the aircraft was lifted, the landing gear was selected down and worked correctly.

The investigation revealed that the landing gear was in UP position during the landing roll and the pilot most likely missed this during the check list reading.
