Final report on aircraft serious incident

Case no.: **21-052F010**

Location: **Keflavik Airport (BIKF)**

Description: **Loss of power shortly after take-off**

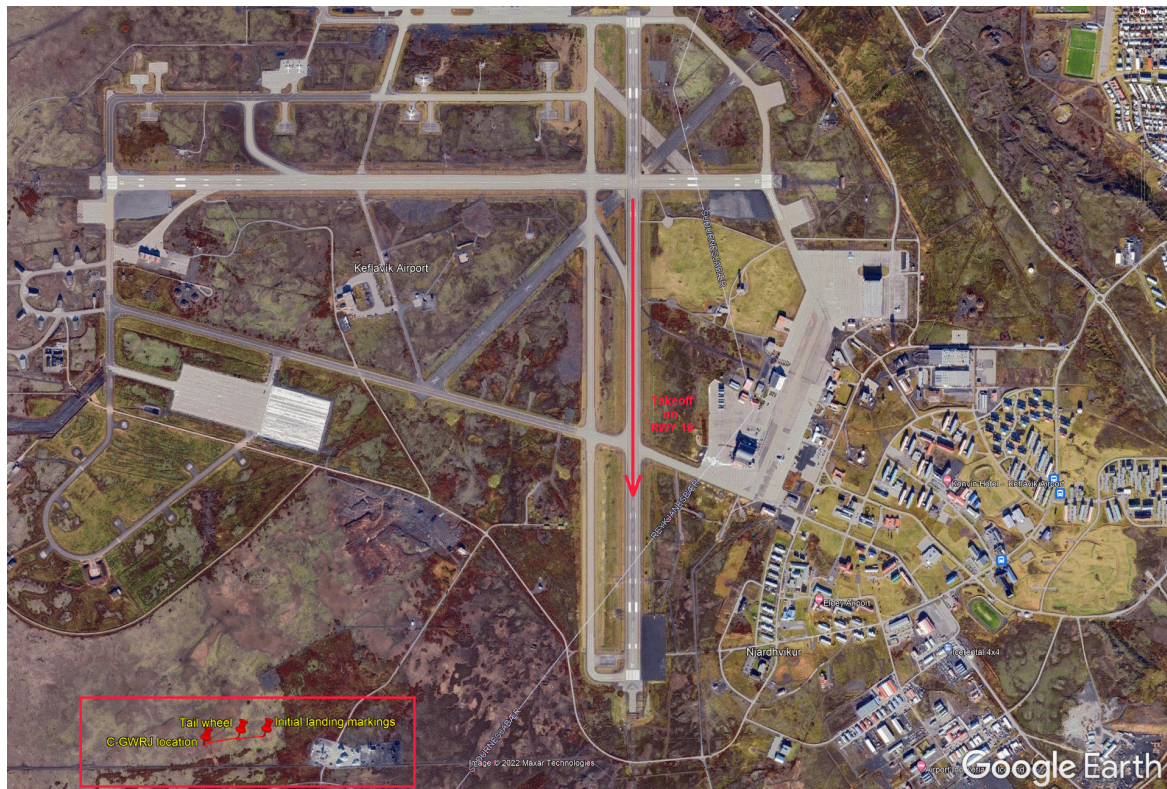
Figure 1: Take-off at Keflavik Airport (BIKF) and the emergency landing site

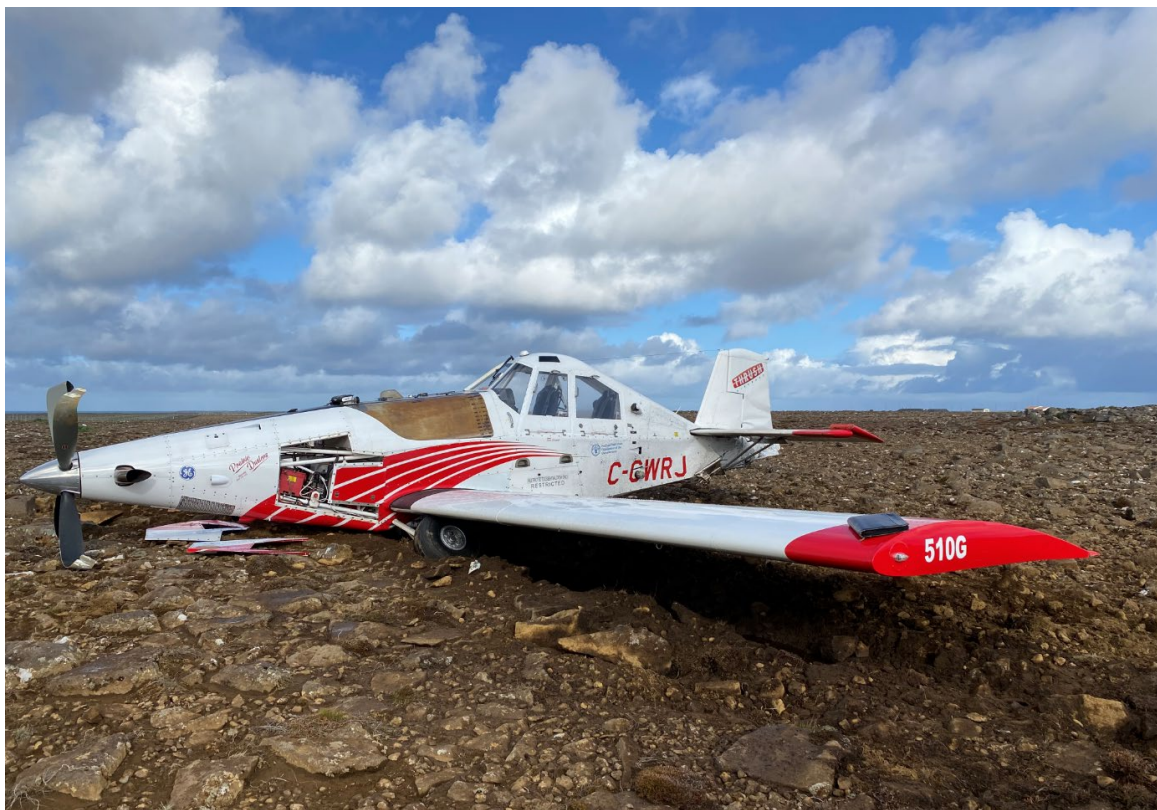
Measurements at the emergency landing site revealed that the aircraft had skidded around 280 meters on a westerly heading, while turning on its vertical axis to the left during the skidding, breaking off the tail wheel, collapsing the main landing gears and coming to rest on a TRUE heading of 155°.

Figure 2: C-GWRJ at the accident site

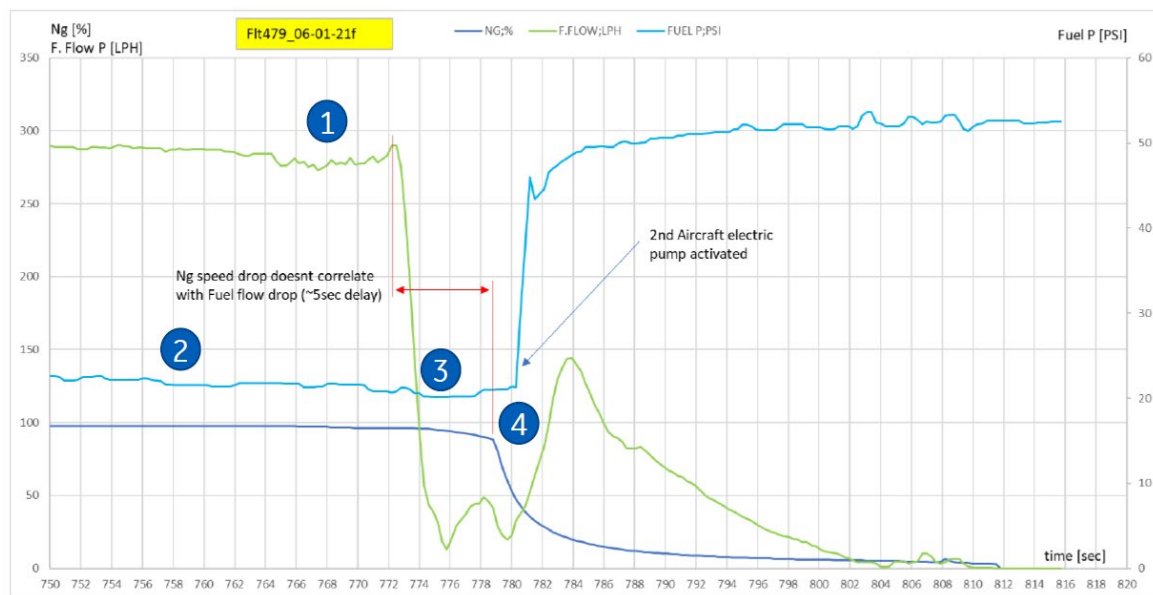
- During the take-off, there was no delay between the fuel flow measurements and the Ng speed on the engine
- There was a fluctuation in the fuel flow (item 1 in Figure 3)
- The fuel pressure was slowly decreasing (item 2 in Figure 3)
- There was a significant fuel flow drop without fuel pressure change and Ng speed slowly decelerated for about 5 seconds (see item 3 in Figure 3)
 - During standard operation when the fuel flow decreases, the fuel pressure increases
 - The data however shows a slow decrease in fuel pressure (item 2 in Figure 3) and no reaction to a significant drop in fuel flow
- The engine decelerated about 5 seconds after the drop in fuel flow
- The engine power dropped below idle, followed by doubling of fuel pressure when the 2nd (emergency) aircraft electric pump was activated (item 4 in Figure 3)

Figure 3: MVP50 analysis

The fuel flow fluctuation and the immediate drop in fuel flow suggested:

- Air or water contamination in the fuel line, or
- Fuel leak upstream of the aircraft fuel flow meter, or
- Aircraft main fuel boost pump malfunction

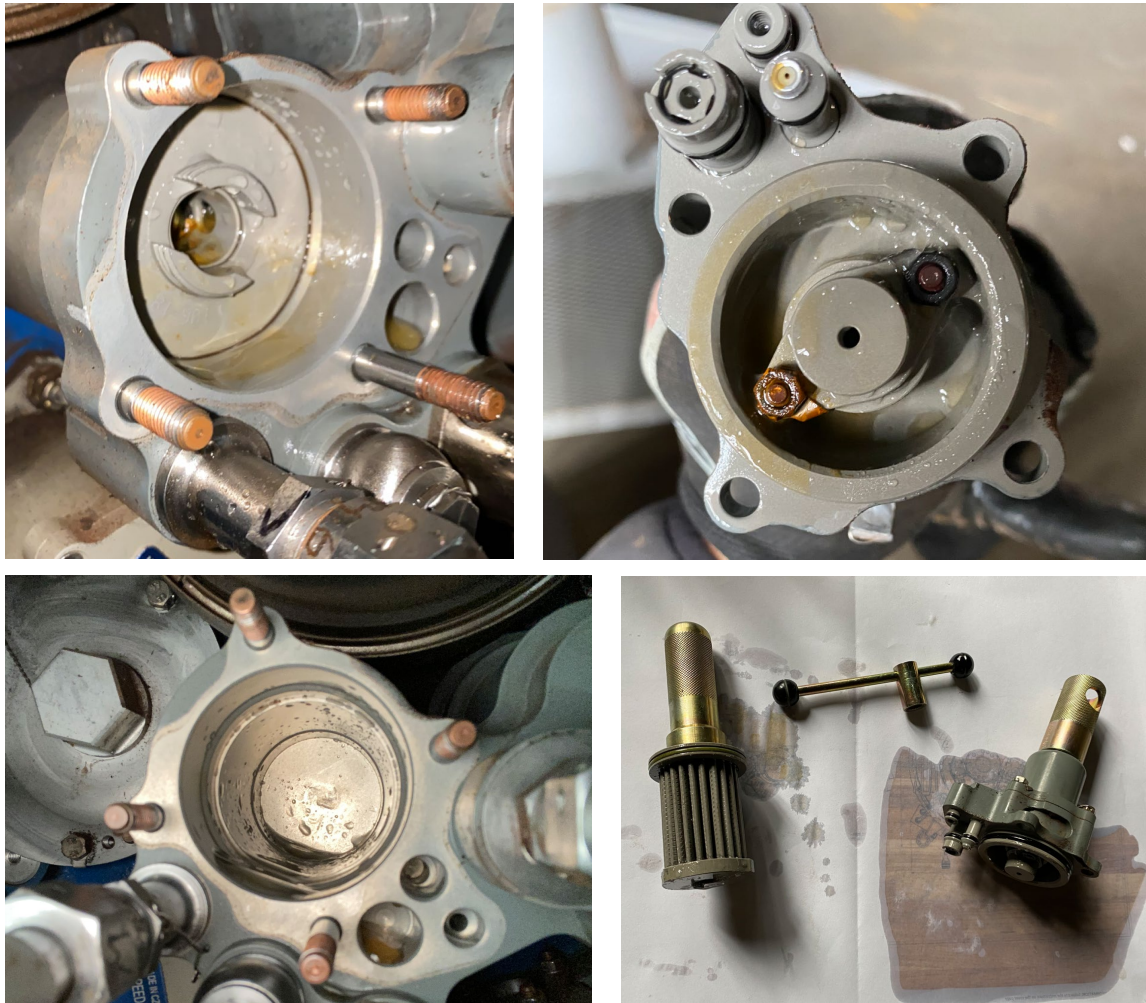
Figure 4: Engine fuel filter (located on accessory gearbox on the engine)

- Both the primary and the emergency electric fuel pumps were found to be operational
- There was no fuel leak located in the aircraft fuel supply system to the engine, having disregarded damage to the Header tank in the aircraft lower fuselage caused by the crash
- Water contamination was found in the fuel system
 - Corrosion was noted on bolts and nuts in the engine fuel filter, indicating water contamination (see Figure 4)
 - Water contamination was confirmed in a fuel sample collected in the engine fuel filter (see Figure 4 and Figure 6 left)
 - Water contamination was confirmed in a fuel sample collected in the aircraft fuel filter drain (see Figure 5 and Figure 6 right)

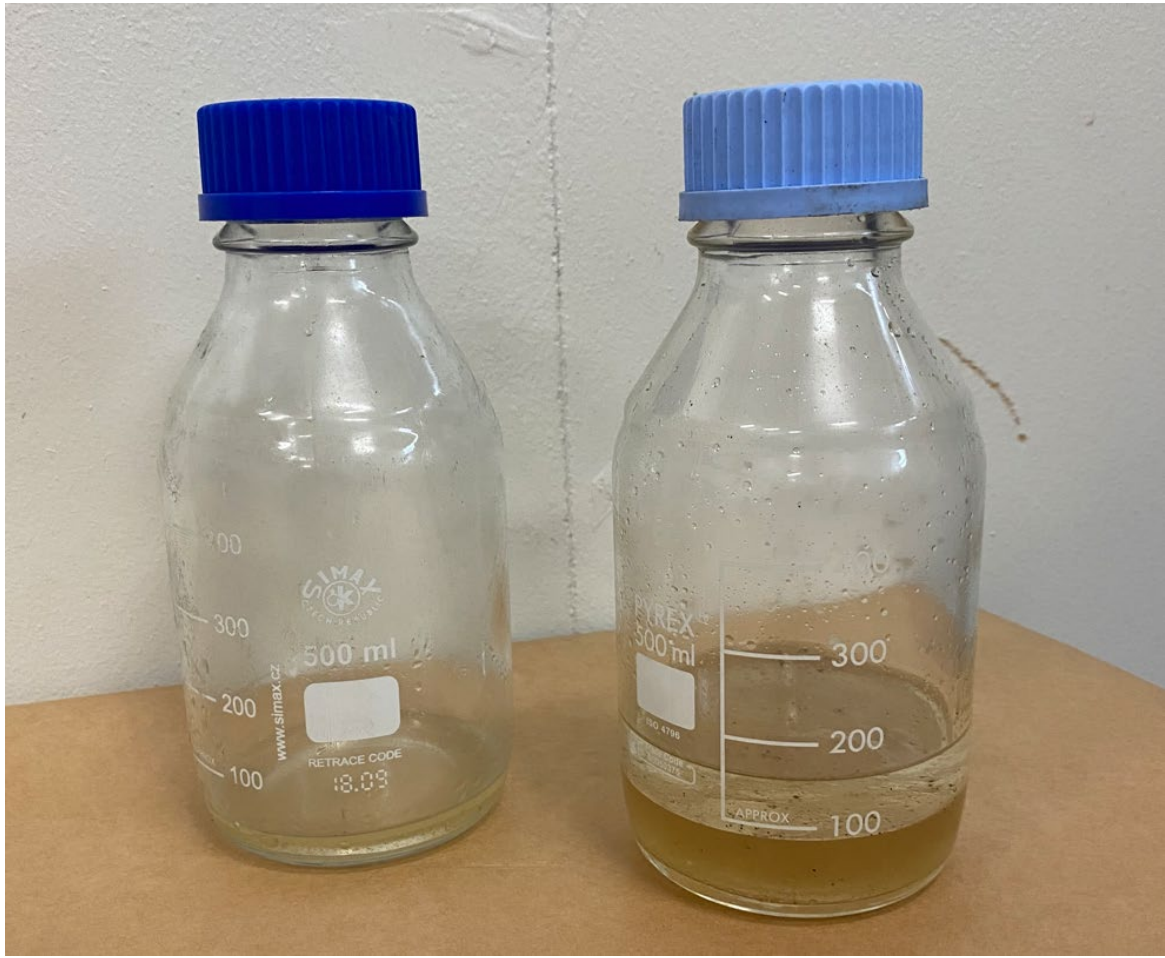
Figure 6: Fuel found contaminated with water

Left: From engine fuel filter / Right: From aircraft fuel filter drain

SIA-Iceland concluded that this allowed for dissolved water to come out of solution with the fuel in the wing tanks and to accumulate at the bottom of the wing tanks.

SIA-Iceland therefore concluded that the loss of engine power was caused by water contamination in the fuel.

SIA-Iceland reminds pilots of the importance of vigilance during fuel sump.
