RANNSÖKNARNEFND FLUGSLYSA

Skýrsla um flugvélinu SE-FUL sem hvarf hér við land.

Upplýsingar um flugvélinu SE-FUL, sem týndist þann 22. desember 1974, á leið sinni frá Narssarssuaq til Reykjavíkur.

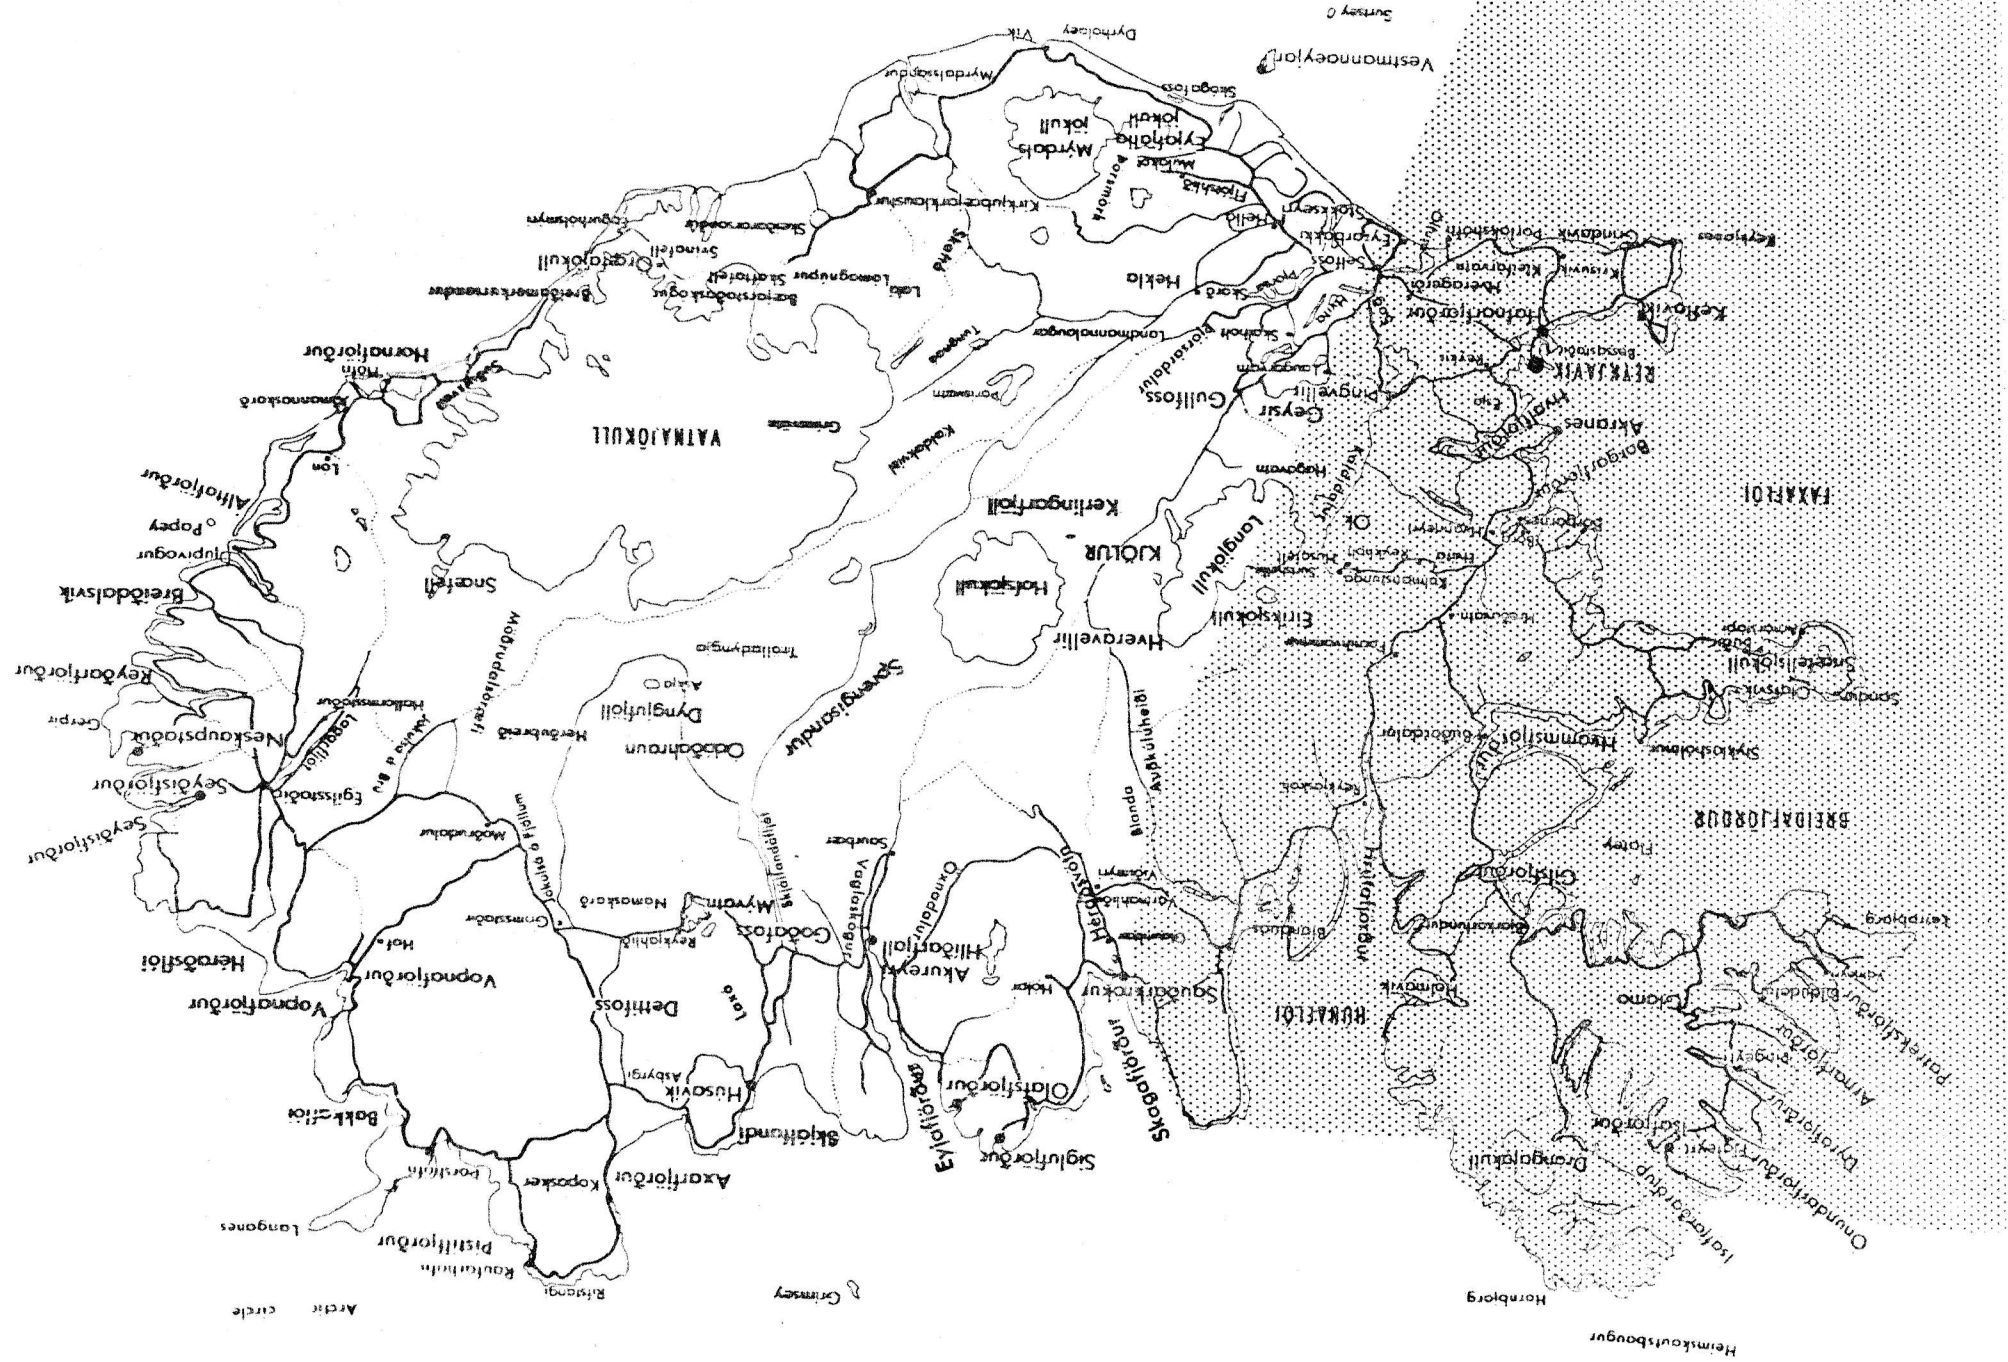
Skyggða svæðið á meðfylgjandi teikningu sýnir svæðið þar sem leitað var.

Rannsóknarnefndin álitur að flugvélin hafi hrakist norður af áætlaðri flugleið og lent þar í slæmum veðurskilyrðum.

Uppdráttur á kortinu sýnir útreiknaðan feril flugvélarinnar, og sýnir hann að flugmaðurinn hefði verið, sem næst á réttri flugleið, miðað við þá stefnu, sem vitað er að hann stýrði, ef vindar hefðu reynst samkvæmt veðurspá, sem hann fékk fyrir brottför.
