### Final report on aircraft serious incident

Case no.: **19-159F044**

Location: **RWY 01 at Keflavik Airport**

Description: **Declared emergency due to low fuel and landed on a closed runway**

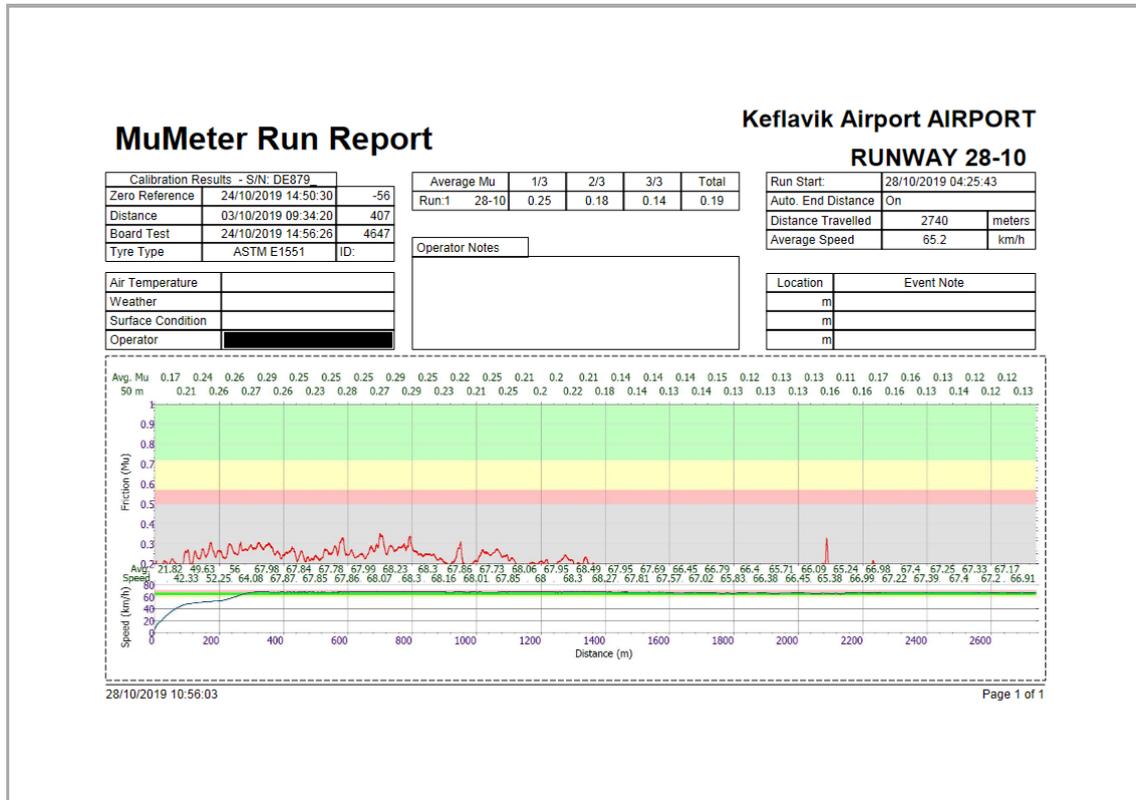
- Runway 10/28 had not been de-iced
- The last measured braking measurement at runway 10/28, performed at 03:54, had shown POOR braking conditions
- The Keflavik Airport Operations had determined that it would be quicker to remove aircraft N812AM from the serious incident site, than deicing RWY 10/28 to such an extent, that sufficient braking action could be gained on that runway
- De-icing RWY 10/28 would divert the Airport's Service manpower and equipment from the task of removing aircraft N812AM from the RWY excursion site, leading to delaying the reopening of RWY 01

Per ICAO Annex 14, 0.25 and below is a POOR braking action.

**Figure 12: The last braking action measurement for RWY 10 prior to flight ICEAIR 680 landing (the time stamp is 31 minutes off as noted earlier)**

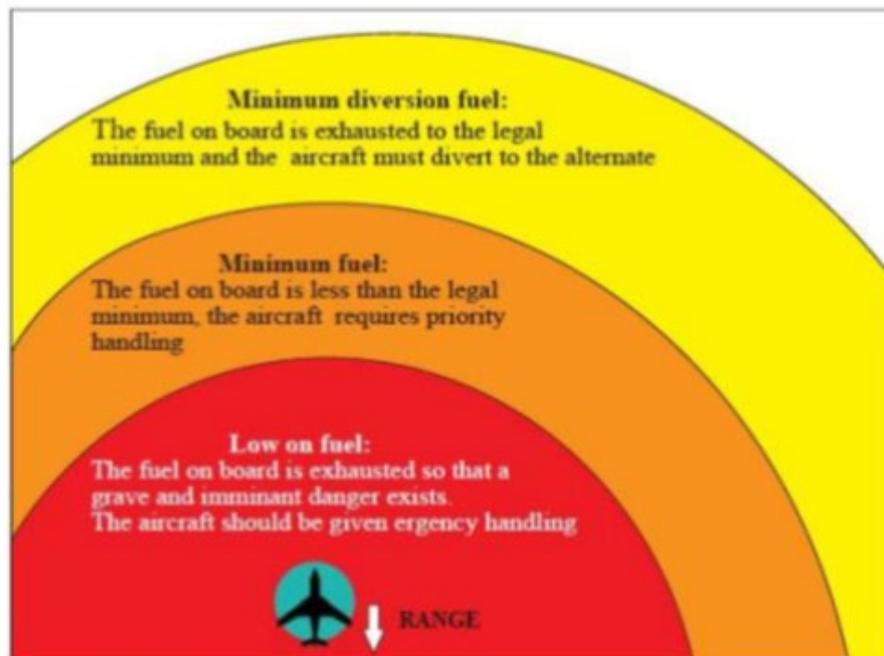
The investigation revealed that the Approach ATCO did not refer to emergency checklist J, for Fuel Problems – Critical Fuel Status, as the workload was high, and he was busy with other tasks.

**Figure 16: Phraseology of fuel status from checklist J Fuel Problems**

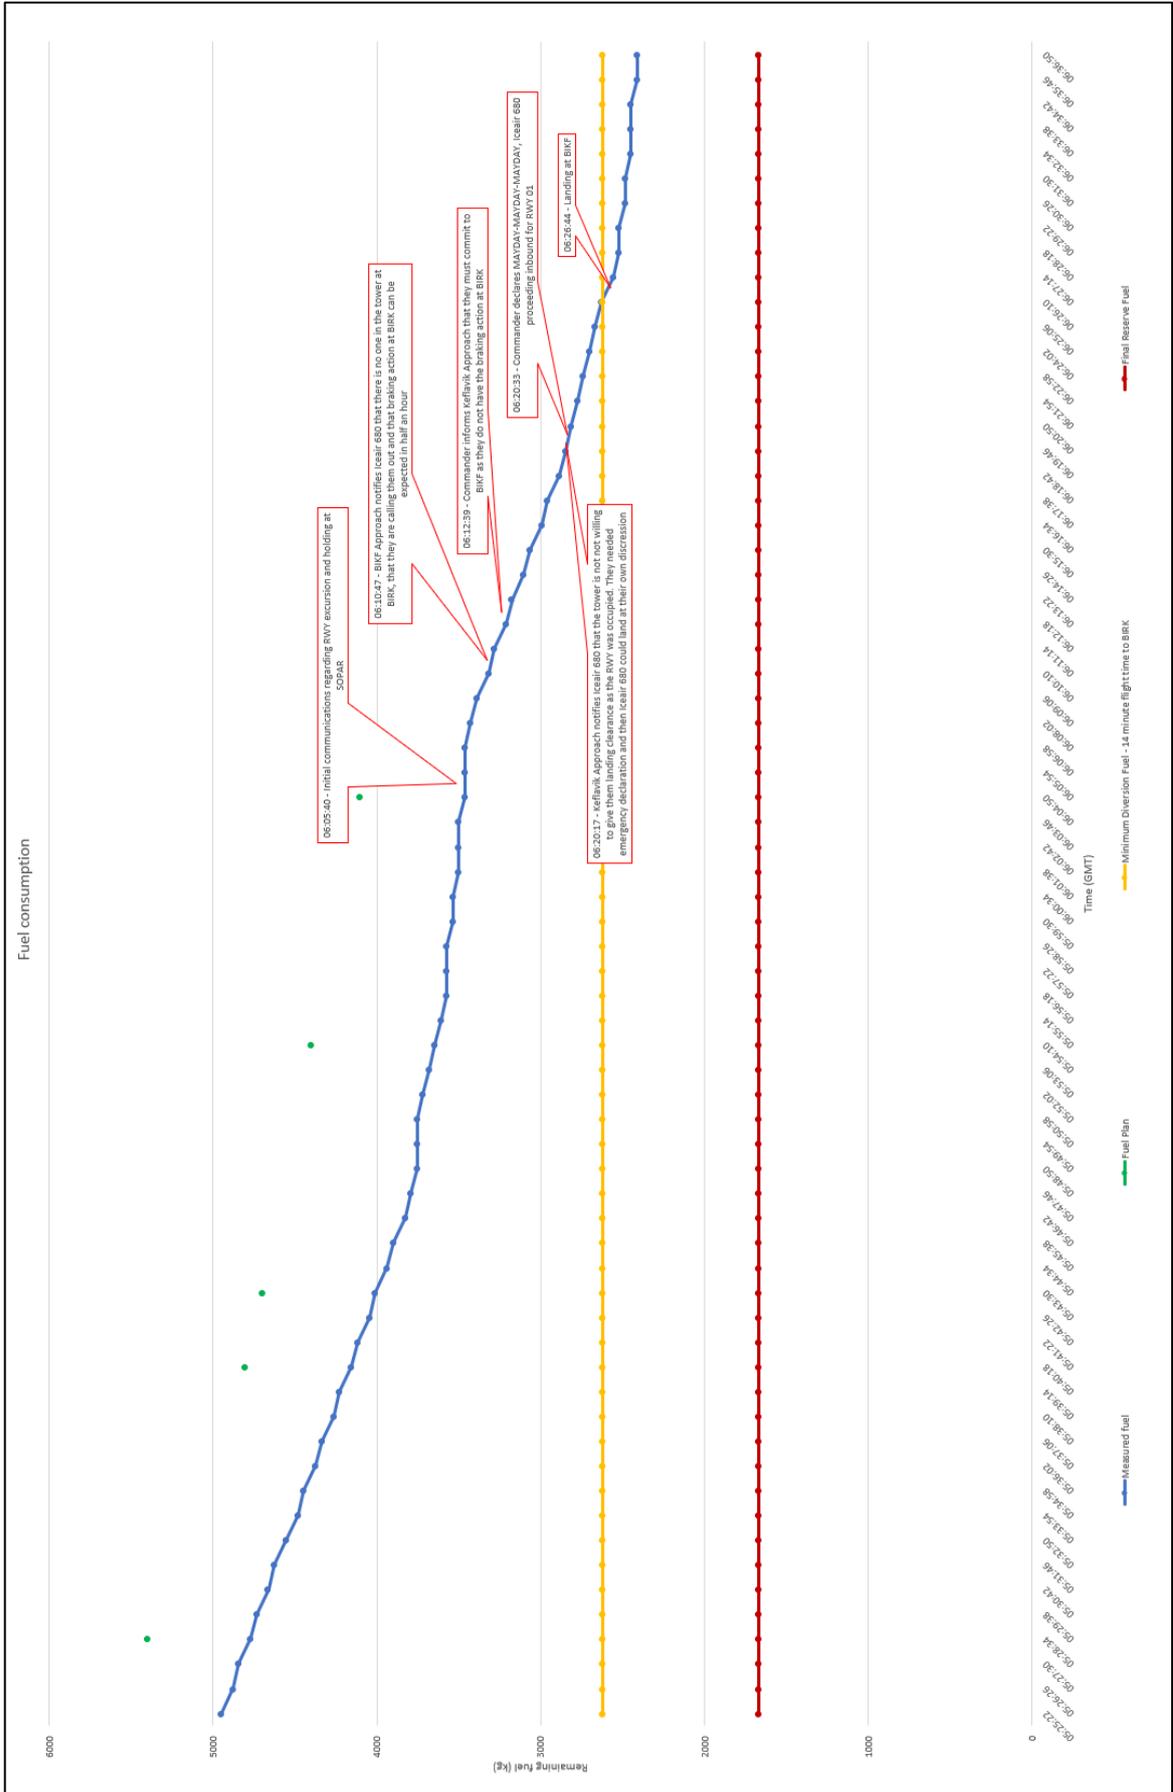
The final reserve fuel for flight ICEAIR 680 was 1666 kg.

SIA-Iceland determined that the decision to commit to land at the closed RWY 01 at Keflavik Airport and declaring minimum fuel at 06:16:02, was most likely the safest option the flight crew could have made at that time, taking into account that they did not know that the braking action of the runways at BIRK had already been measured and that they had been told that they would not receive the braking action numbers until after half an hour.

Figure 18: Fuel consumption during the last hour of flight
