Report on aircraft serious incident

Case no: **M-01913/AIG-14**

Date: **20. October 2013**

Description: **Loss of engine power**

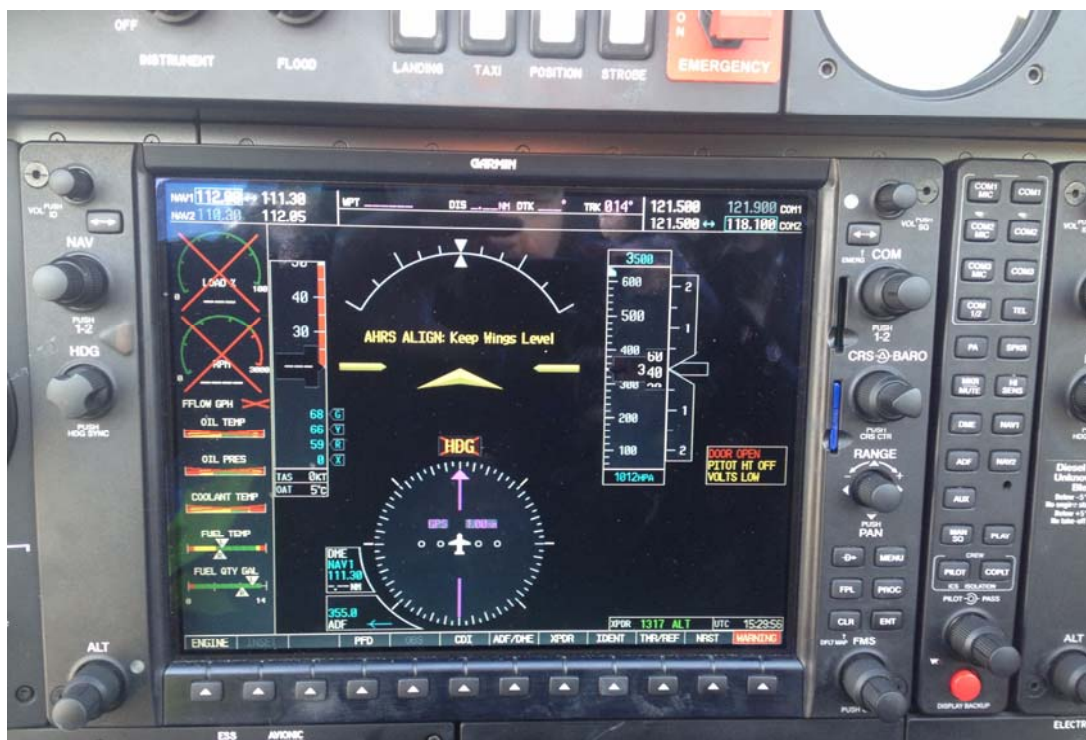
At 11:42, while cruising between Gullfoss and Geysir, in Southern Iceland, at an altitude of 3000-3500 feet⁶, the engine suddenly started running roughly, and did so for about 5 seconds. During this rough engine run, the pilot scanned his instruments and noticed an oil pressure warning light and heard an audio warning. The pilot noticed on the engine instrument section of the flat display panel that the oil pressure had dropped and that the engine power load⁷ was rapidly dropping from its 70% power configuration, down to 0% and the propeller started to windmill. A red X then appeared over engine load and RPM on the engine instruments, confirming loss of engine power. See Figure 1.

Figure 1: Red X over engine load and RPM on the instruments in the top left corner

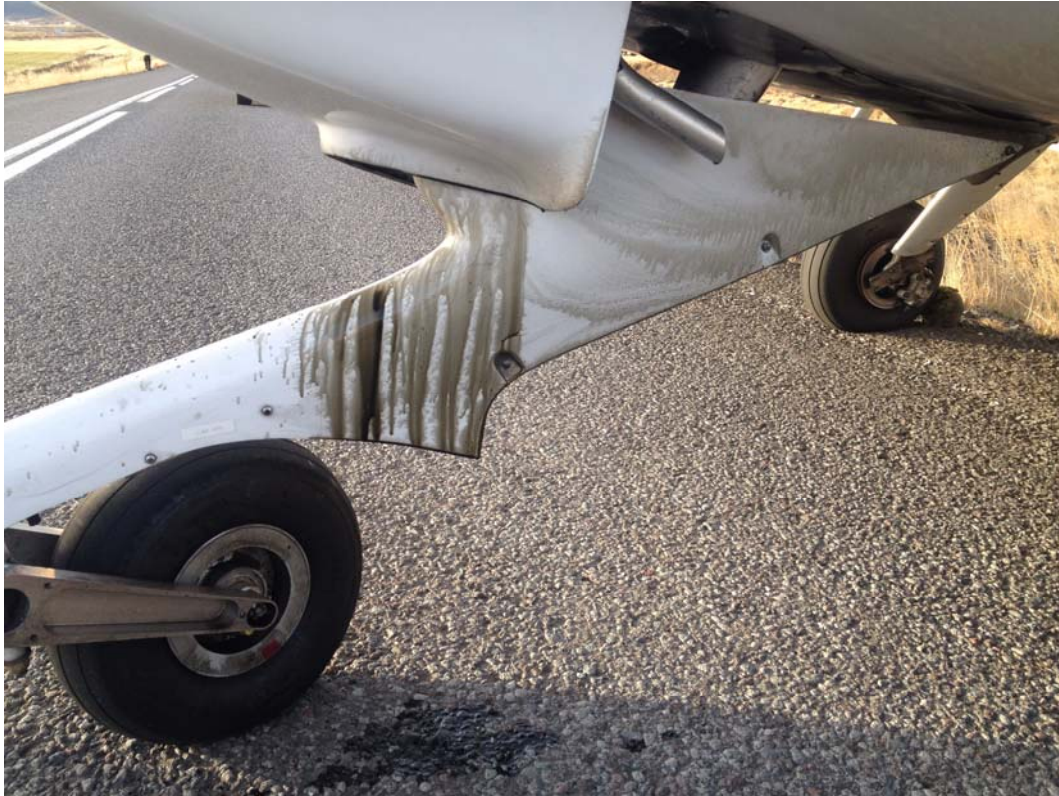
After the landing the pilot and the passenger noticed engine oil on the nose landing gear strut as well as on the road. See Figure 4.

Figure 4: Oil leakage on site

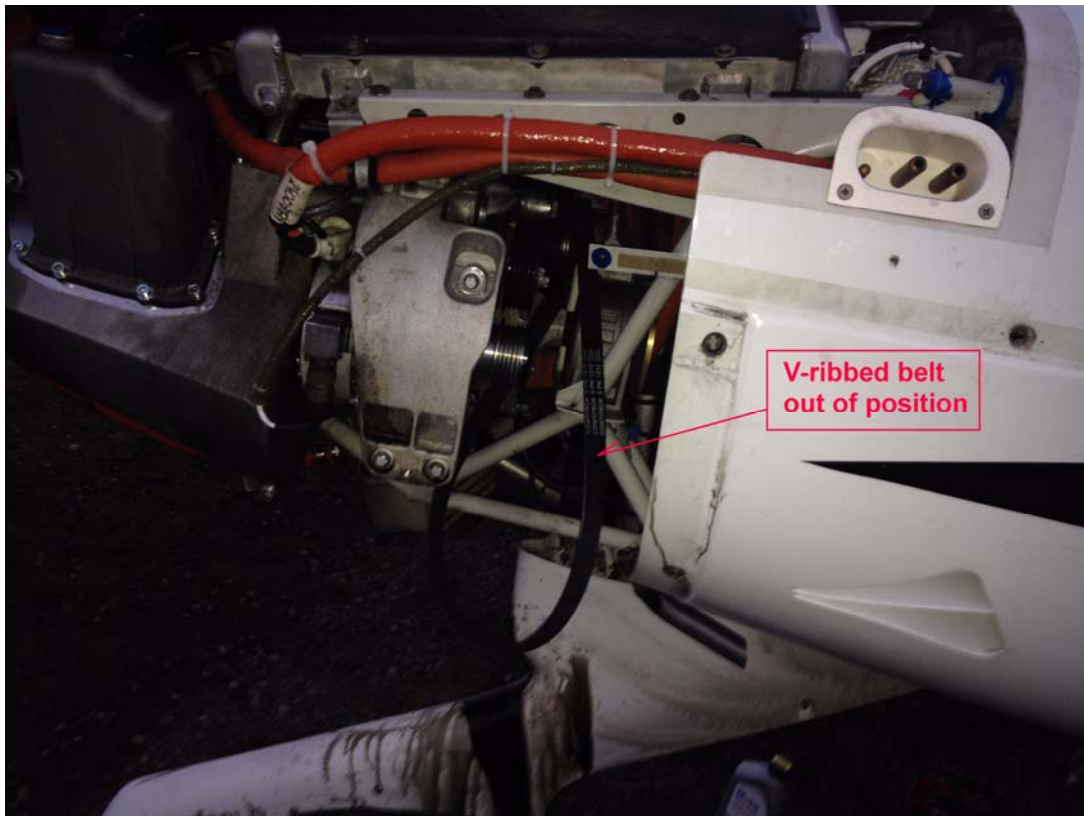
The engine cowlings were removed. Engine oil was found on the lower engine cowling. The V-ribbed belt drive connecting the alternator and other components to the engine's crankshaft was found out of position. See Figure 5.

Figure 5: V-ribbed belt out of position

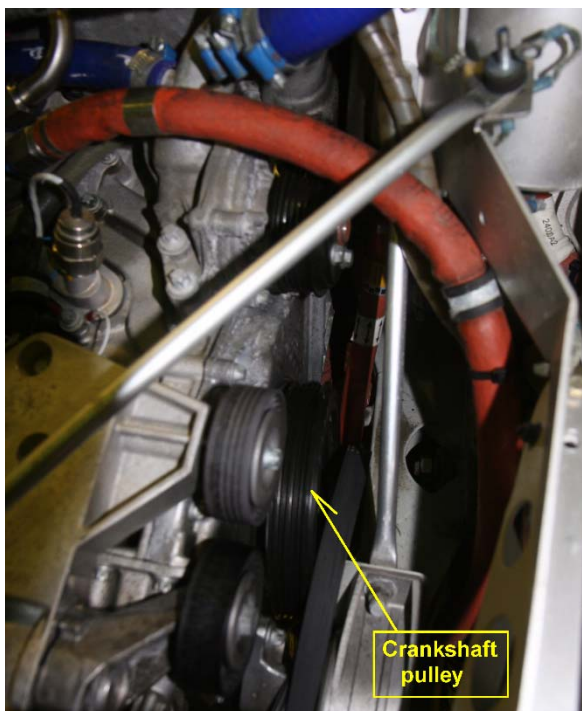
Figure 6: Crankshaft pulley skewed out of position

Further inspection revealed that the V-ribbed belt pulley for the crankshaft was skewed out of position. See Figure 6.

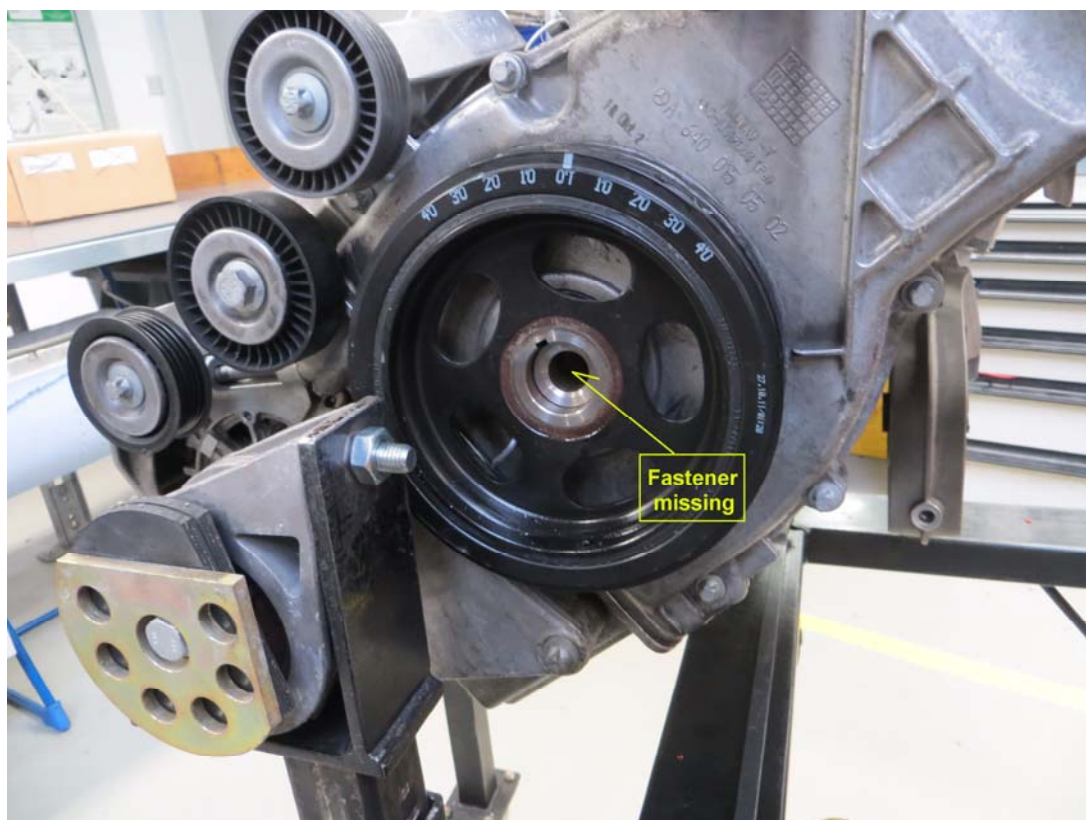
The engine had accumulated over 1244 flight hours since installation. The tear down inspection of the engine revealed extensive damage that was caused by a missing fastener P/N 05-7223-K000501 that attaches the crankshaft's pulley. See Figure 7 for details. This fastener was never found.

Figure 7: Missing the fastener that attaches the belt pulley to the crankshaft

The ITSB was not able to determine why the missing bolt became loose.

- The crankshaft belt pulley fastener became loose

- Issue a service letter to operators, advising of this incident and remind them never to loosen the belt pulley fastener in the crankshaft, due to its critical torque value
- Reconsider the design of the crankshaft belt pulley fastener P/N 05-7223-K000501 in order to prevent loosening of the fastener

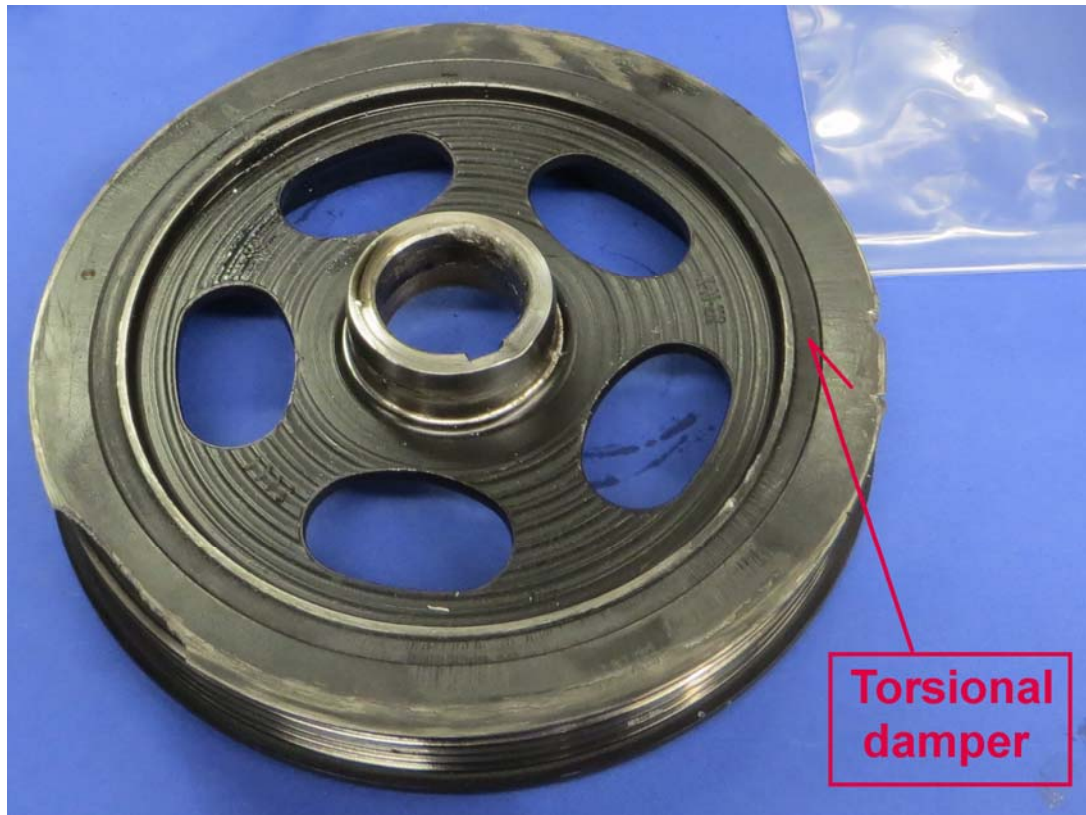
Due to the missing fastener, the belt pulley had moved on the crankshaft and was skewed out of position. This allowed abnormal loading to be put on the crankshaft as it turned. The belt pulley has a torsional damper around its inner area. The purpose of this torsional damper is to act as a dampener for belt pulley vibration. According to the manufacturer, the pulley is also designed to damp the crankshaft vibrations (flexible mode) or to move the modes into non-critical ranges. The crankshaft is usually balanced with the pulley together and therefore the position of the pulley is important and defined by the feather key. The damping only works if there is a tight

connection assured by the bolt. If the bolt gets loose the dampening effect will get lost. Without the absorption of the flexible mode the bending of the crankshaft is higher and causes a higher load to the journals close to the pulley. See Figure 8 for details.

Figure 8: Torsional damper on crankshaft belt pulley

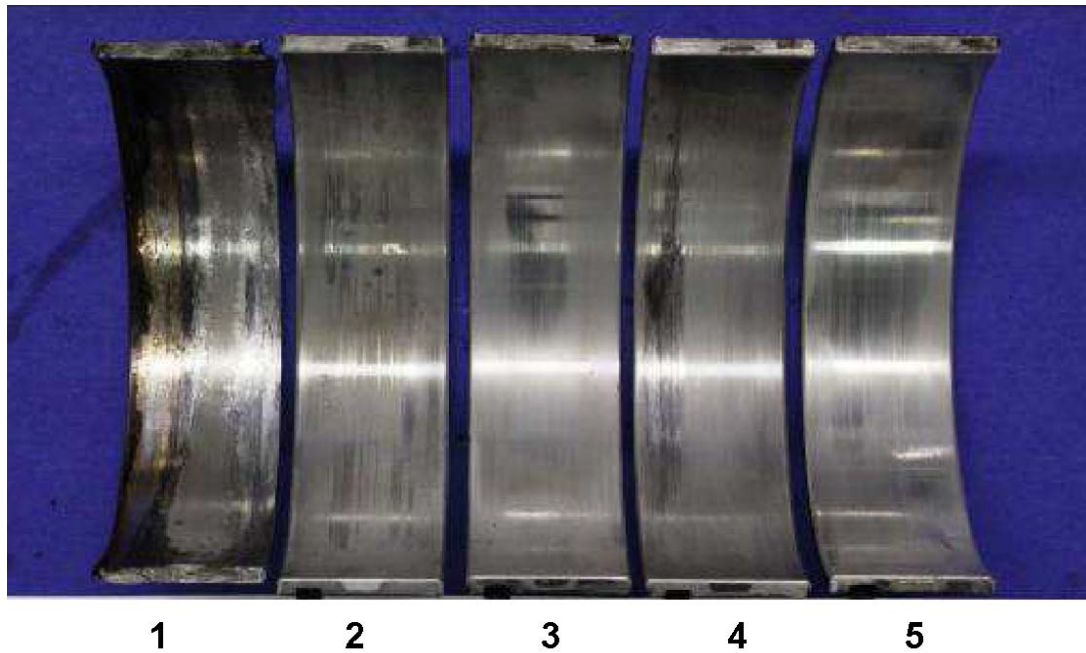
When the crankshaft fastener was no longer in its place and the belt pulley was skewed out of position, this caused significant wear of the bearing halves. Due to the heavy load some of the debris blocked the lubrication bores causing a lack of lubrication with consequently overheating. The oil supply hole in the upper half of the crankshaft bearing closest to the belt pulley was found completely closed by wear damage. This prevented circulation of oil from the oil pump to the crankshaft area of the engine. This process supported the seizure, but the crankshaft fracture is believed to have been the consequence of the lack vibration absorption by the torsional damper. See Figure 9 and Figure 10 for details.

Figure 9: Lower crankshaft bearings (1 is the position closest to the belt pulley)

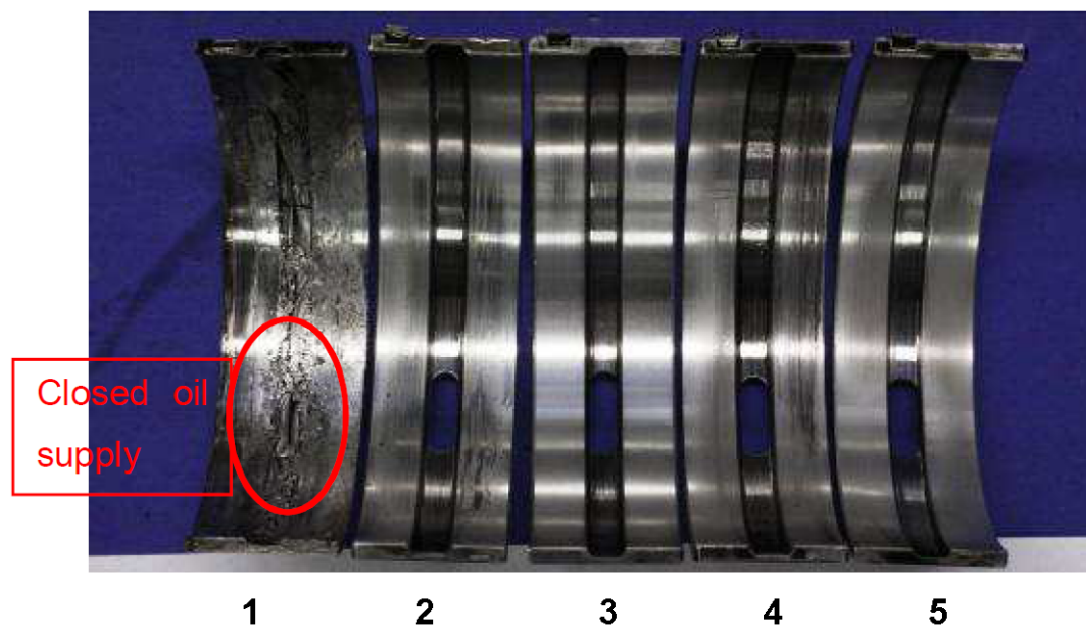
Figure 10: Upper crankshaft bearings (1 is the position closest to the belt pulley)

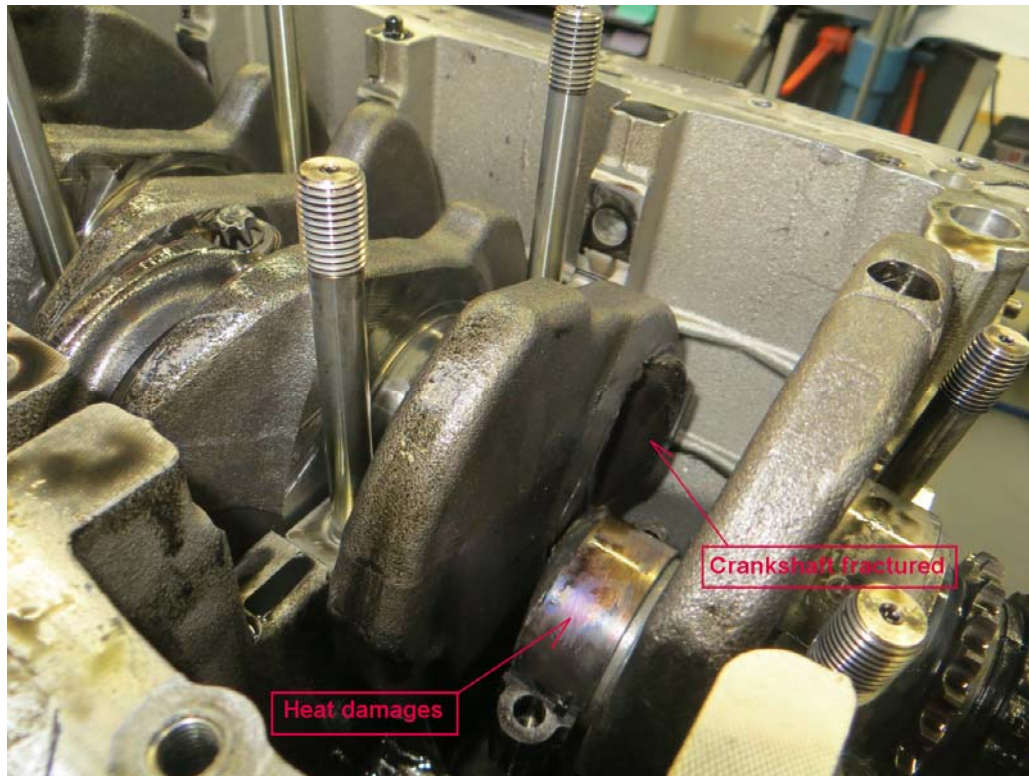
Inspection of the crankshaft area, aft of the closed oil supply hole, revealed elevated temperature indications of the crankshaft, as the crankshaft was found discolored in that area. In the same area the crankshaft was found fractured. See Figure 11 for details.

Figure 11: Crankshaft fractured and heat damages

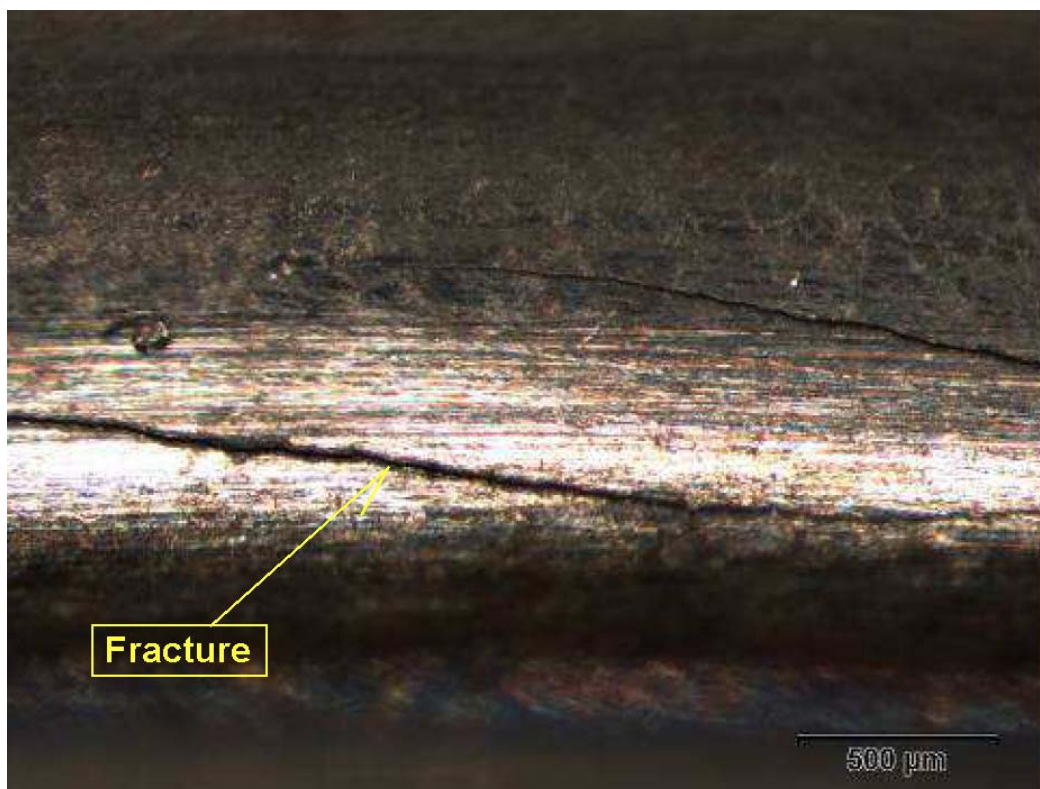
The crankshaft was analyzed around the fracture surface. Scratches were found on the crankshaft at the position of crankshaft bearing 2. See Figure 12.

Figure 12: Scratches on crankshaft surface around fracture located at bearing 2

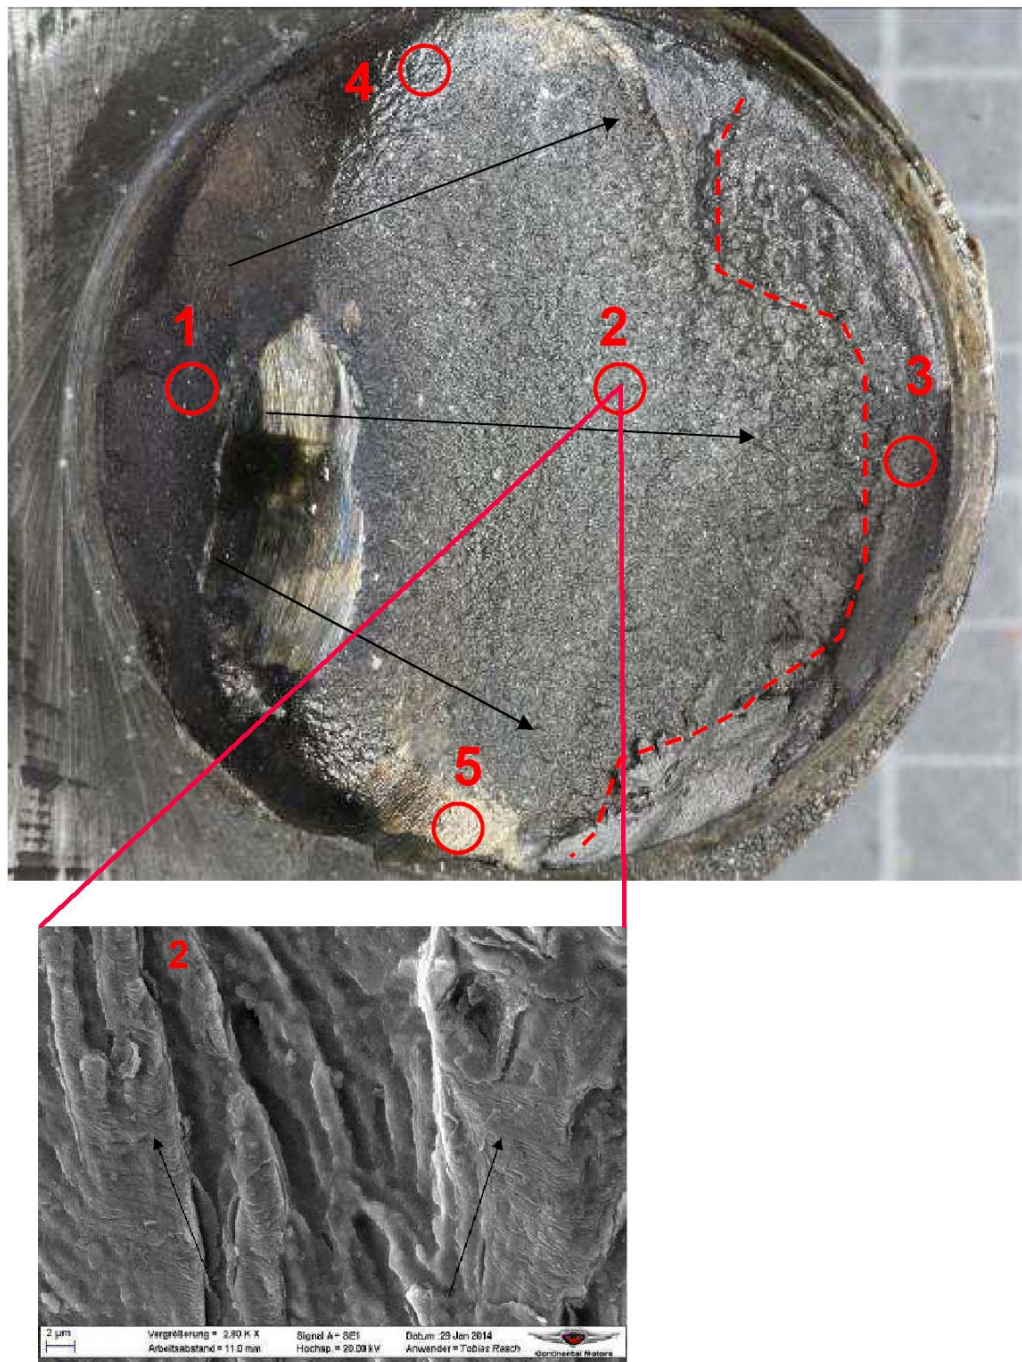
Analysis of the crankshaft fracture revealed crack initiation in the area where scratches were found on the crankshaft surface as well as indications of tempering colors. See circle #1 in Figure 13. The crack then grew through the crankshaft with striations lines (indications of fatigue) being apparent in the middle section. See circle #2 in Figure 13. At the opposite end of the crankshaft's cross section, material analyses showed the fracture surface to change from a fatigue crack to a forced fracture break. At this point the crankshaft could no longer support the loading it was subjected to and it broke. See circle 3 on Figure 13.

Figure 13: Crankshaft fracture at timing chain side

The fracture of the crankshaft then lead to multiple secondary damages, such as fracture of the engine bed plate, crank case housing and the oil pump.

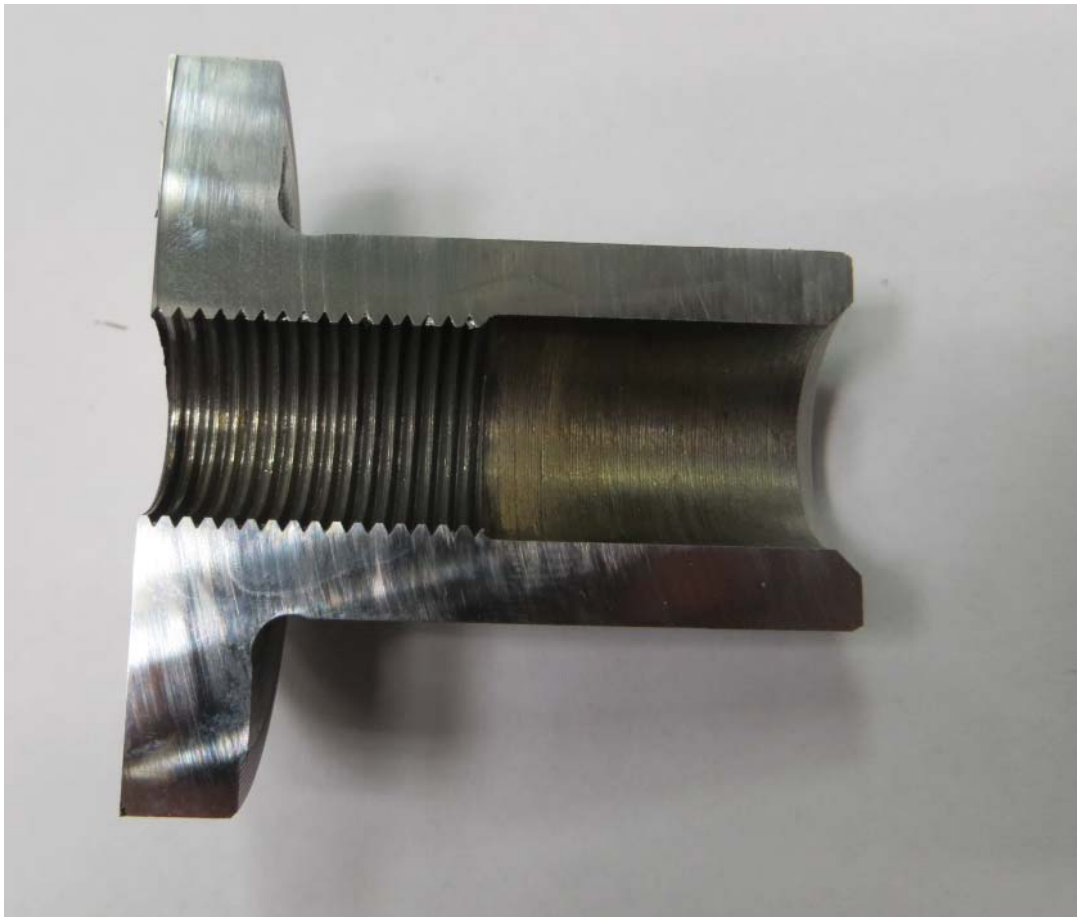
During the engine's teardown inspection the ITSB looked for evidence of fastener P/N 05-7223-K000501 failure, such as a missing fastener head while the shank still in place or damaged threads in the fastener hole. No part of the fastener was found imbedded in the fastener hole. The fastener hole was cut-away to allow the threads to be analyzed for any fastener failure indication. The threads showed no sign of damage. See Figure 15 for details.

Figure 15: No damages found to fastener hole threads

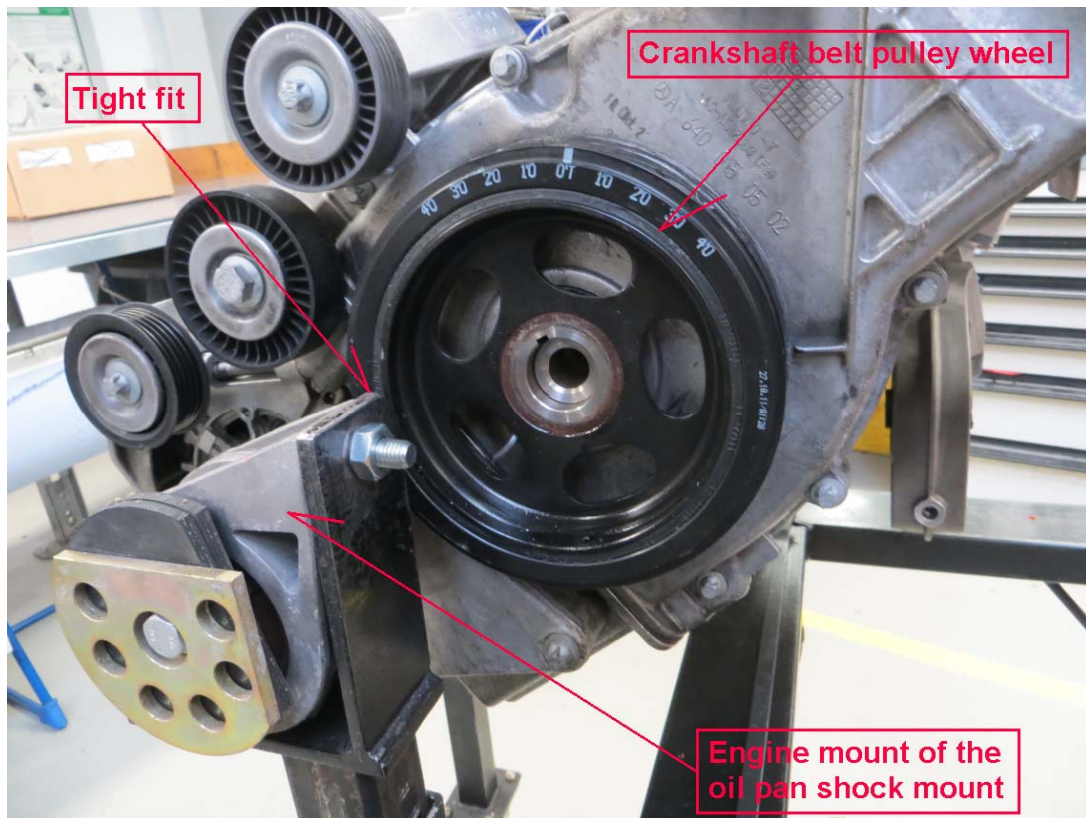
According to RM-02-02, chapter 72-20.01, the replacement instructions for the V-ribbed belt is such that the engine mount of the oil pan shock mount has to be loosened to allow replacement of the V-ribbed belt to be accomplished, due to a very tight fit in this area. See the red boxed CAUTION note on Figure 16 for details and explanations on Figure 17.

Figure 17: Tight fit for V-ribbed belt replacement

After this serious incident the manufacturer changed RM-02-02 chapter 72-20.01 and added a caution that crankshaft belt pulley fastener P/N 05-7223-K000501 shall only be turned counterclockwise.
