Investigation Report

Type of Occurrence:	Incident
Date:	18 July 2012
Location:	En route
Aircraft:	Airplane
Manufacturer / Model:	Boeing / 757-223
Injuries to Persons:	None
Damage:	None
Other Damage:	None
Information Source:	Investigation by BFU
State File Number:	BFU TX008-12

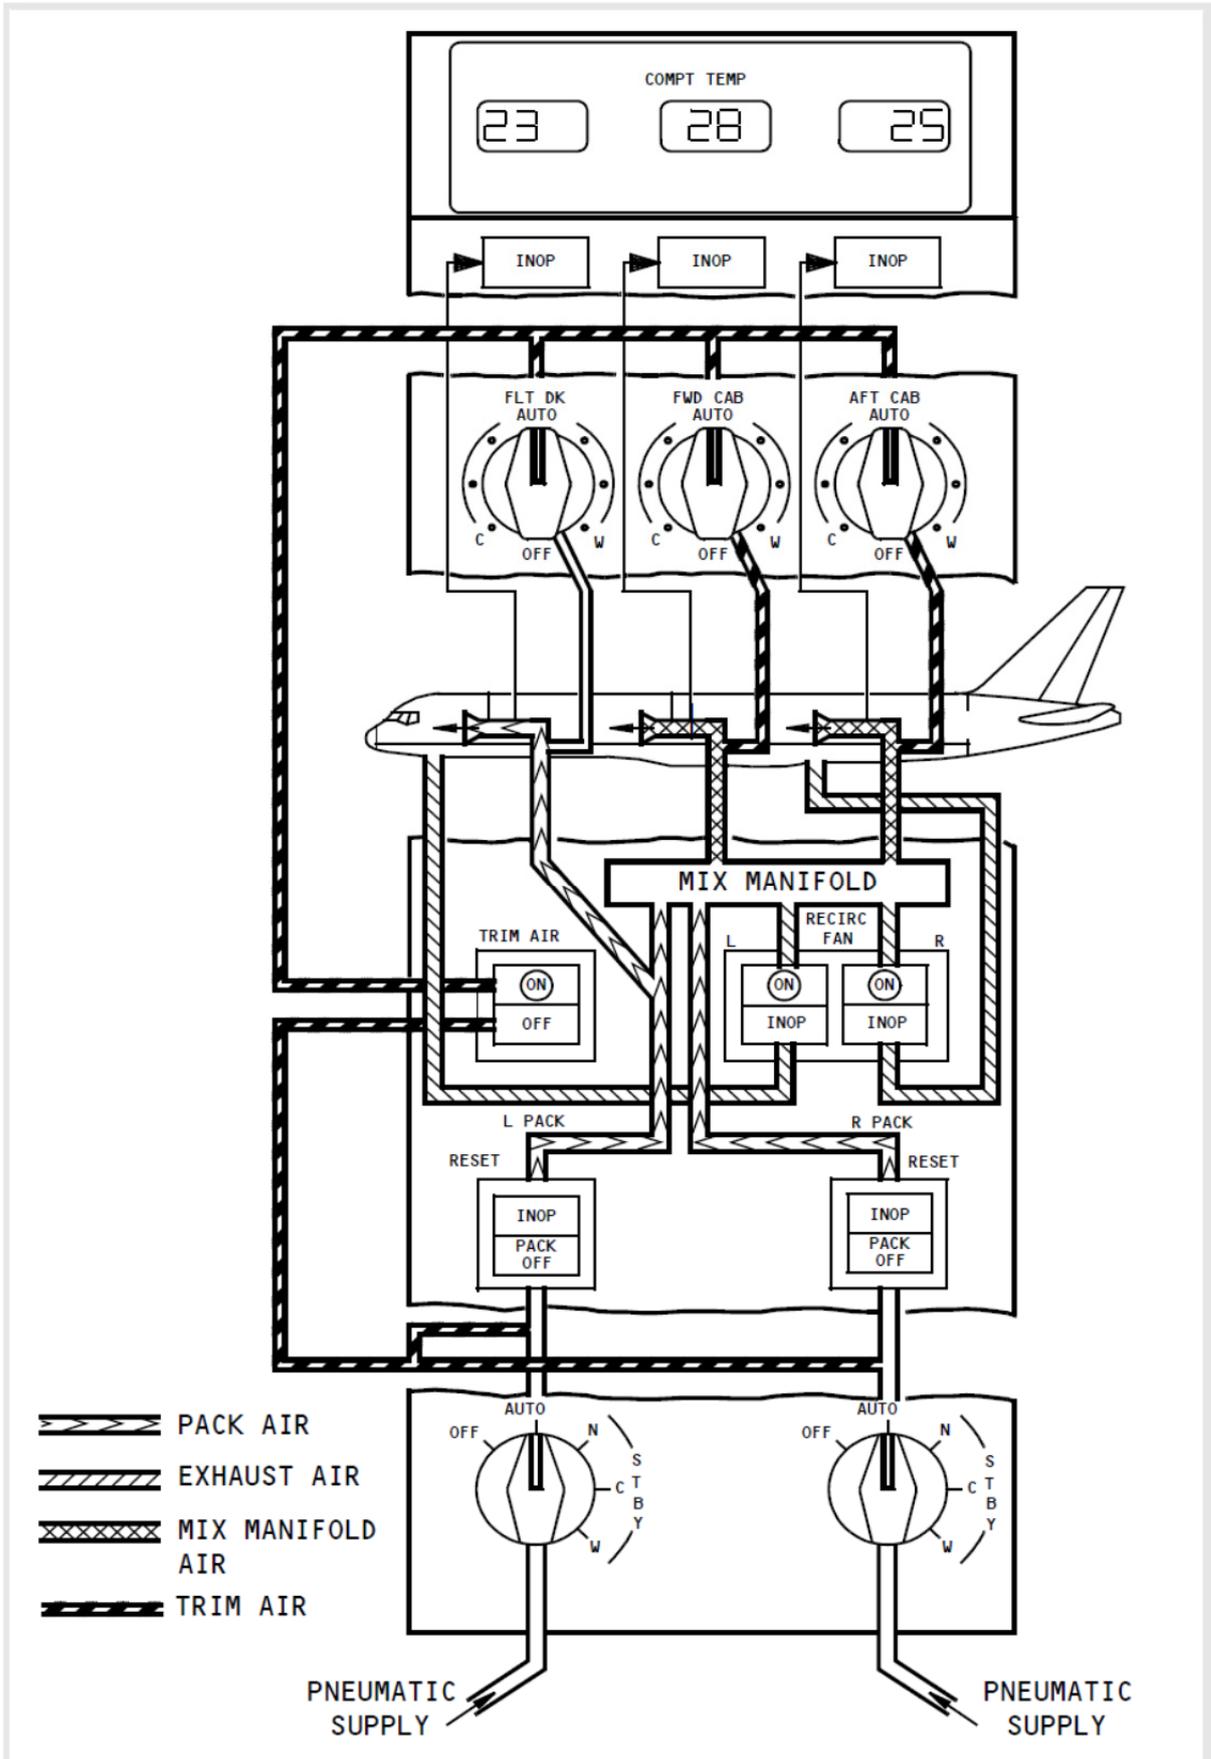
Schematic diagram of the air conditioning system - 7 -

The test Pack High Flow Inhibit was conducted for both packs. The test result for the left pack was negative. The right pack could not be put into High Flow.

The aircraft manufacturer Boeing said to the operator one day after the incident that in the past similar problems had occurred in airplanes of the same type which were attributed to restricted airflow in the cabin in particular in the aft part of the cabin. In those cases the restricted airflow had been caused by foreign objects in the air conditioning system.
