SKÝRSLA UM ALVARLEGT FLUGATVIK

Neyðarútgangur opnaðist á flugi

M-00509/AIG-03

Piper PA-44-180 (Seminole)

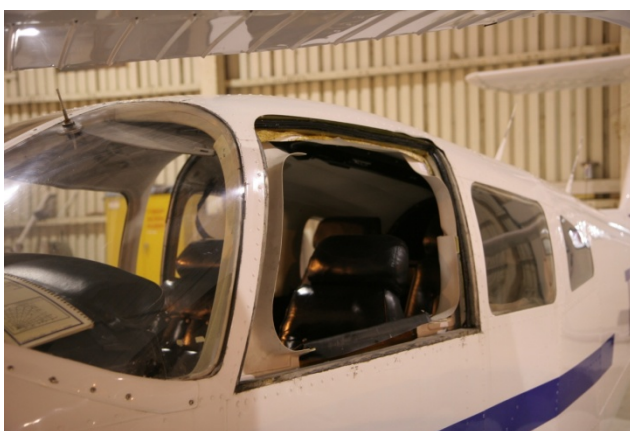
Flug TF-FTN var fyrsta flug eftir ársskoðun flugvélarinnar og átti að vera stutt áfangamat nemanda. Í ársskoðuninni hafði hleri á neyðarútgang á vinstri hlið flugvélarinnar verið fjarlægður og settur í að nýju. Í lok flugsins, á milli Keflavíkur og Voga, í 1500 fetum og á 120 hnúta hraða, losnaði hlerinn úr falsi sínu og féll til jarðar. Talsverður hávaði fylgdi atburðinum en að sögn flugkennarans virtist flugvélin að öðru leyti óskemmd og flughæfnin óskert. Flugkennarinn kallaði PAN-PAN til öryggis og lenti síðan á Reykjavíkflugvelli. Atvikið hafði ekki áhrif á samskipti flugmannana og flugumferðarstjóra.

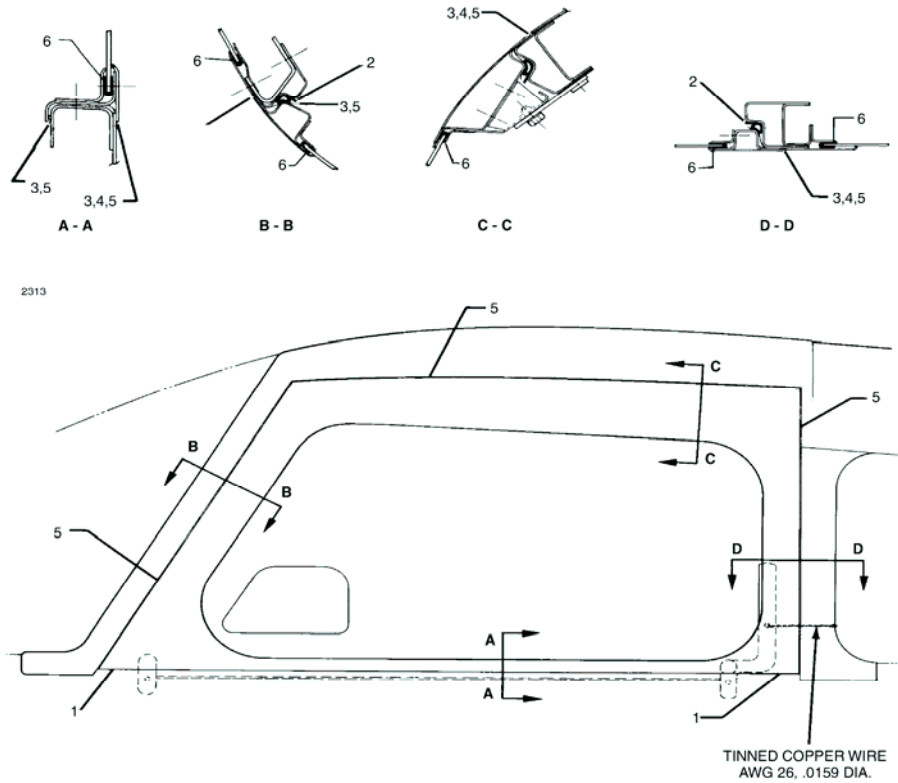
Figure 52-3. Emergency Exit Installation

1. Slá (Door Latch Rod Assembly) sem tengir saman fremri og aftari læsingu á neyðarútgangnum kann að hafa brotnað, þar sem hún er soðin við lásana, og því losnað upp á lásunum.
2. Festingar (ró og splitti) sem að tengja saman slánna og lása (Door Latch Arm Assembly) kunna að hafa gefið sig.

The Icelandic Accident Investigation Board recommends that Piper update their PA-44-180/180T Airplane Maintenance Manual section 52-21-01, page 52-06 EMERGENCY EXIT as a result of this incident. The board recommends that additional inspections be added to the instructions:

1. Before installing the emergency exit:
 - a. Inspect the Emergency Door Latch Rod Assembly welds for cracks.
 - b. Inspect the forward and aft Emergency Door Latch Arm Assembly (nut, pin, cotter pin) for wear.
2. After installing the emergency exit ensure there is no gap between the Emergency Door Latch Arm and the frame-mounted striker plate.
