REPORT ON SERIOUS INCIDENT

Smoke in cabin due to audio jack overheat

M-06008/AIG-19

**TF-FIV
Boeing 757-200
Icelandair
Over Ireland
September 18, 2008**

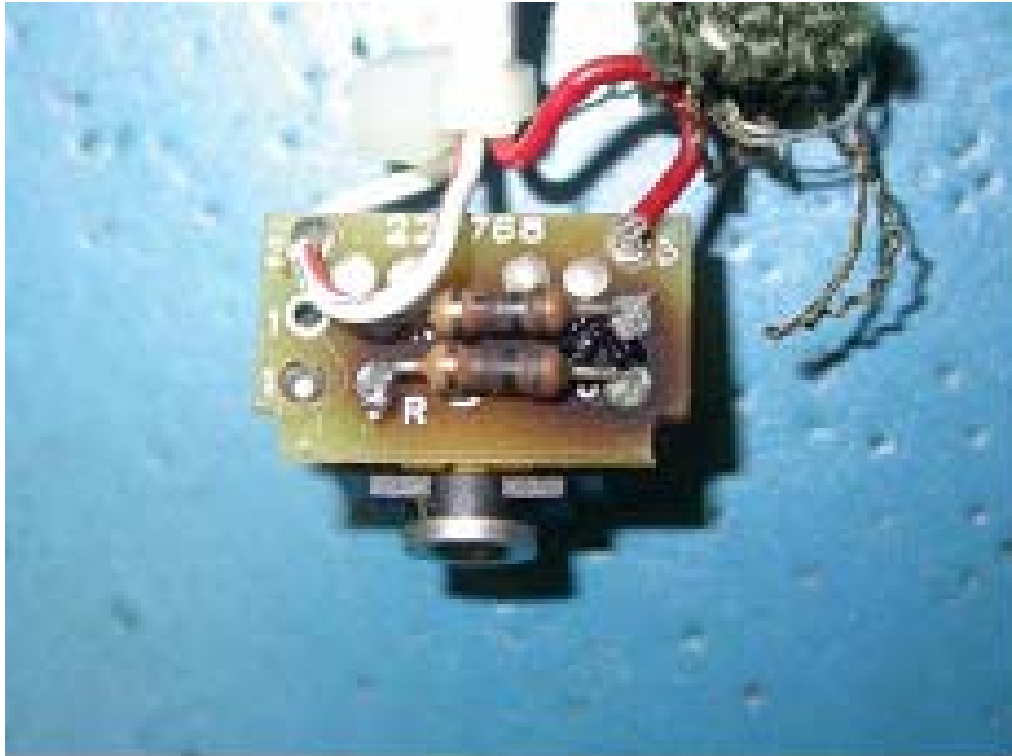
The incident was notified to the Icelandic Aircraft Accident Investigation Board (IAAIB), which initiated an investigation into the cause of the incident. The system components were examined and tested at the manufacturer's facilities in the United States under supervision of a representative from the National Transportation Safety Board (NTSB). No root cause was established during the examination. It was however established that a voltage source of less than 32VDC caused the audio jack to overheat. See Figure 1.

Figure 1: Audio jack in the September 18th, 2008, incident

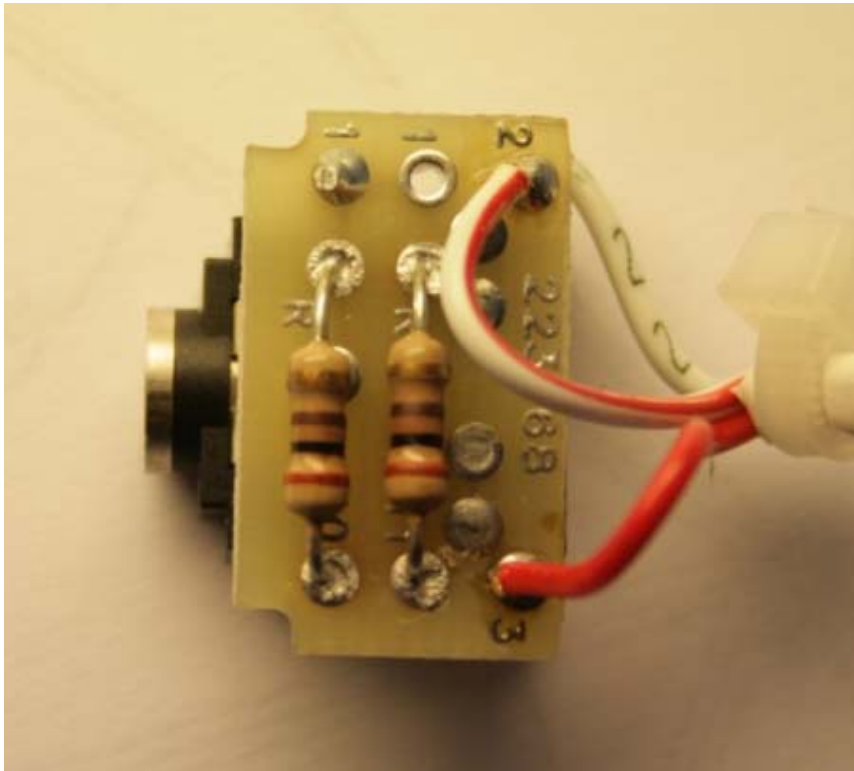
A passenger in seat 5F reported a smell of something burning and that the armrest of his seat was getting hot. When the audio jack was touched it was burning hot. The doors were opened again and a technician unplugged seat 5F from the IFE system.

After a second push-back a passenger in seat 5D called and reported the same problem. The aircraft was brought back to the gate where technicians unplugged the electricity to both seats. After that the armrest cooled down and the aircraft departed Keflavik. See Figure 2.

Figure 2: Audio jack in the June 15th, 2009, incident

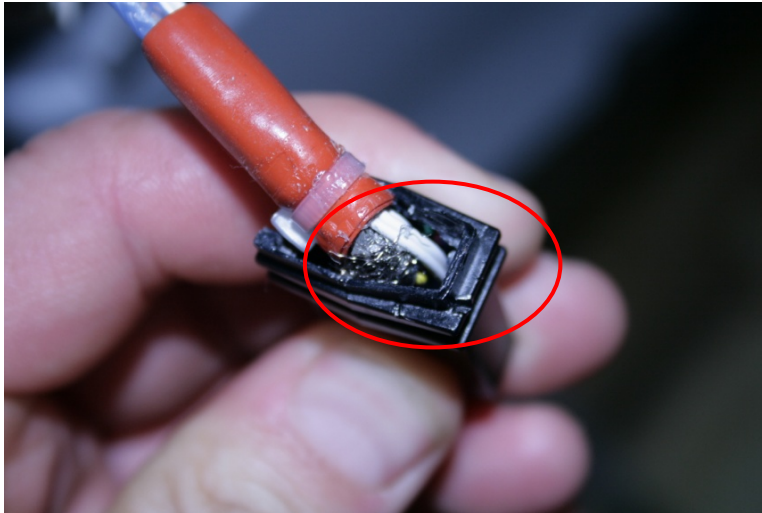
2. Inspection of a serviceable cable assembly on a different seat revealed that the wire screen was not protected and could easily disconnect from the plug shield. See Figure 3.

Figure 3: Serviceable P2 plug showing unprotected Ethernet screening

A solution suggested by the IFE System manufacturer in order to reduce likelihood of recurrence was to replace current USB couples for new ones (re-design) which will, if loose cable plug situation arises, ensure that grounding will always occur and therefore prevent higher than normal voltage entering to the audio jack and prevent overheating.

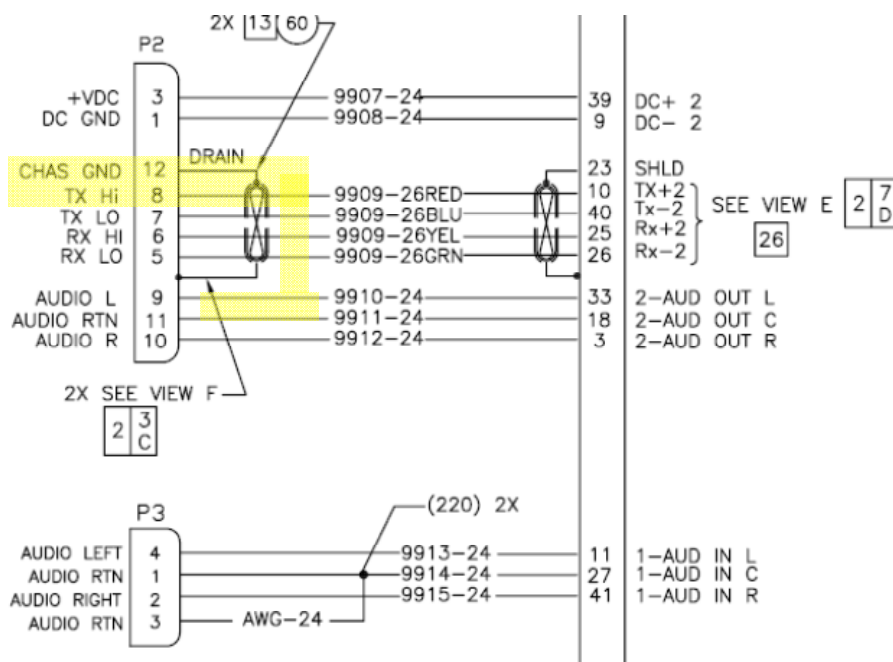
1. Ethernet wire screen (CHAS GND, pin 12 on Thales drawing 179169, sheet 3) was not connected to the plug shield and pin #12 (ground) was also disconnected from the plug.

The Ethernet wire screen (ground) and pin 12 in the P2 plugs in cable assembly p/n 179169-117 were found disconnected from the plug and plug shield. See cut-out from drawing 179169 in Figure 4 below. Disconnected wires highlighted in yellow.

Figure 4: Wire diagram showing disconnected ground wires in Ethernet cable

The design holder of the installation (EAD Aerospace), in cooperation with the seat manufacturer (Aviointeriors), released SB 17/10. This SB was based on recommendation by the IFE System manufacturer (Thales). At the time the SB was released, a total of 10 Icelandair airplanes were affected.

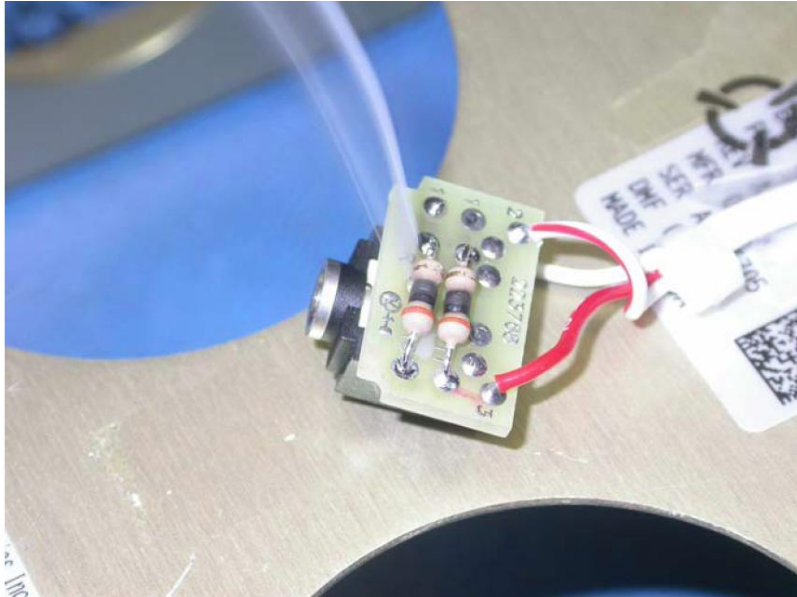
This fault can cause a ~32VDC load to feed through the SVDU and through the audio jack return lines, causing the resistors in the audio jack to overheat and burn as shown on Figure 5 (32 volts directly applied).

Figure 5: Simulated failure using direct 32 VDC current
