PRELIMINARY REPORT ON AIRCRAFT ACCIDENT

M-01508/AIG-04

**TF-ARS
BOEING 747-300
Zia Airport Dhaka Bangladesh**

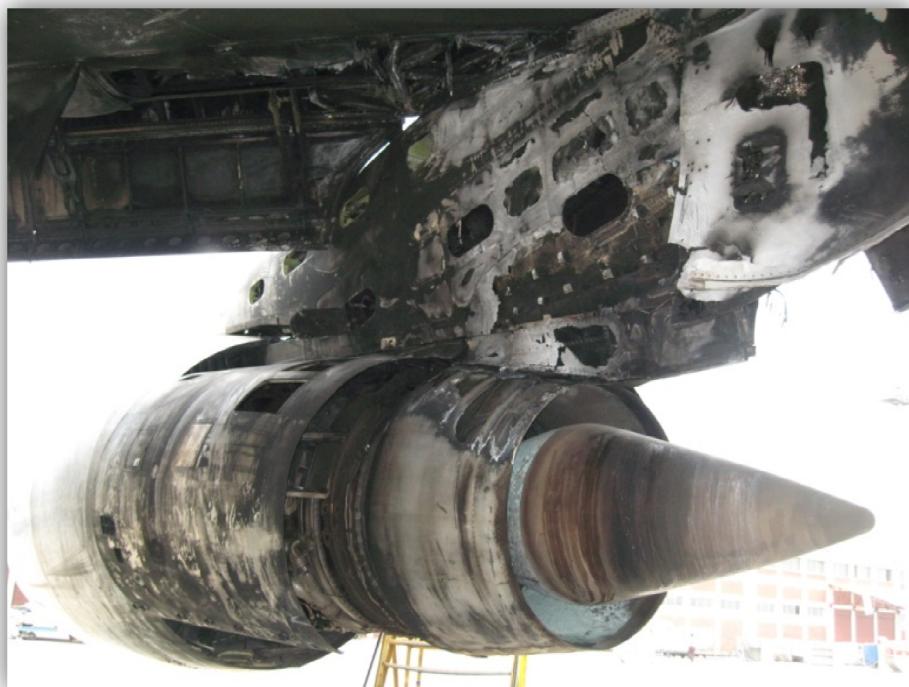
Damage: Aircraft damaged beyond economic repair.

Incident description: Fire at front spar of engine no. 3 after landing.

Figure 1: Fire damage to right hand wing, engine and spar no. 3

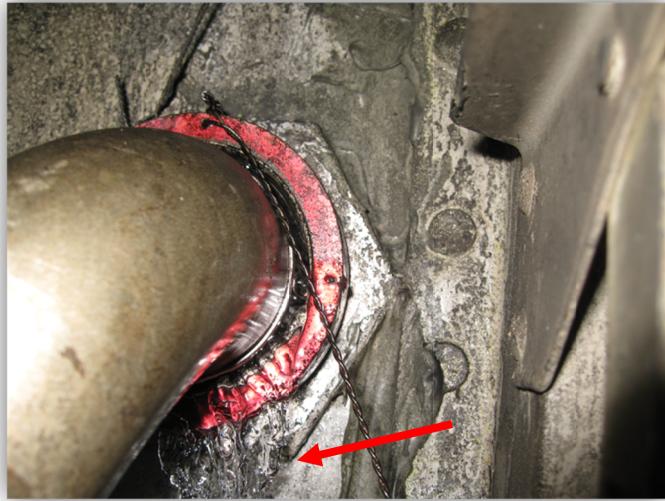
During on-site investigation, a fuel leak was discovered on one of the main fuel line couplings. The leak was found where the fuel line enters the front spar for engine no. 3 (see attachment A). By wiggle the fuel line a little by hand, a fuel leak was observed (See figure 2). The coupling was safety wired but after cutting the safety wire the coupling-nut was found to be loose.

Figure 2: Fuel leak through coupling

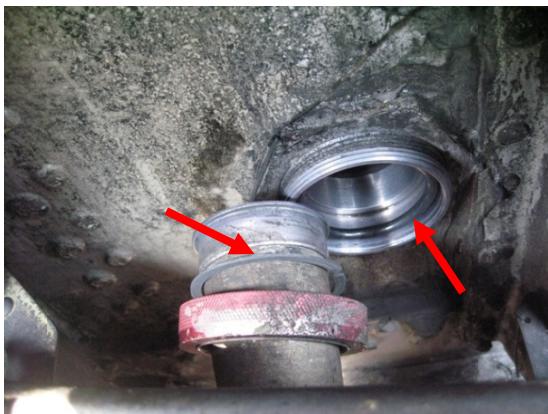
After opening the coupling it was discovered that one out of two retaining rings was missing (See figure 3) and the O-ring was in wrong position (not on the fuel line). Therefore it is considered that the O-ring was not working to seal as it should.

Figure 3: Coupling where fuel leak was detected showing only one retainer ring and position of the O-ring

The maintenance data shows that the fuel coupling was opened and the O-rings replaced during C Check on 27 August 2007.

Following the accident a Fleet Team Digest (FTD) was prepared by Boeing and sent out where Boeing recommends that operators review list of SB's and SL's to ensure proper maintenance actions to prevent any further strut fire events.

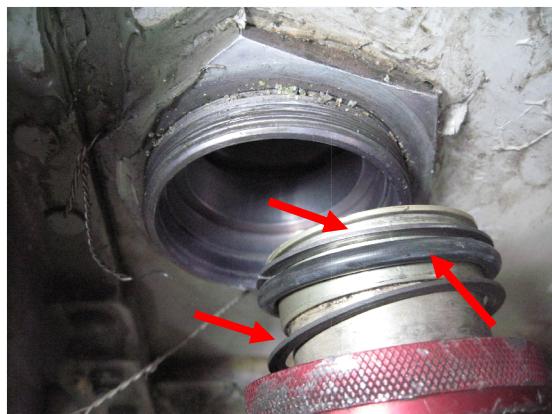
Figure 4, shows a comparable coupling in the front spar for engine no. 2. On figure 4 you can see that O-ring is on the fuel line between two retaining rings.

Figure 4: Comparable coupling for engine no. 2 showing two retaining rings and position of the O-ring
