TRANSPORTATION SAFETY BUREAU

FINAL REPORT

2007-307-4 Serious incident

Boeing-747-236SF TF-ATX

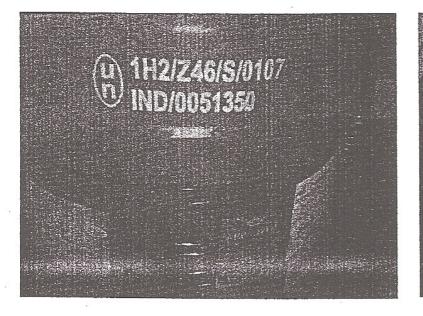
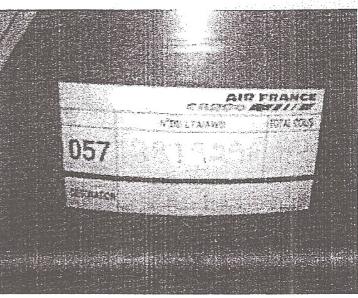
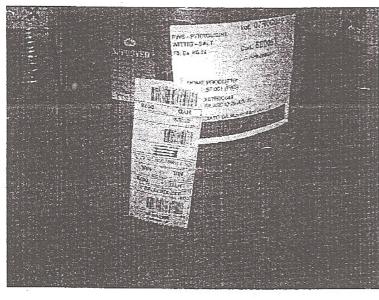
- There were several packages where the UN sign, the UN number, the PSN number, or the sender's data were covered or otherwise not clearly visible.
- The ULD identification tags contained the three-letter cargo IMP code, in contradiction with the IATA DGR which requires the usage of Class/Division Numbers.
- There were simultaneously Air Malaysia and Air France package ID labels on the packages which is not allowed.
- The form for listing the non-radioactive dangerous goods was a 2006 edition, and the answers given to questions No. 37 and No. 51 were incorrect.
- The medical check in the captain's pilot licence expired on 2 June 2007.
