REPORT ON SERIOUS INCIDENT

[Republication of AAIB UK Report EW/C2006/06/07 published
in March 2007 Bulletin](#)

**TF-CSB
Dornier 328-100
11 June 2006**

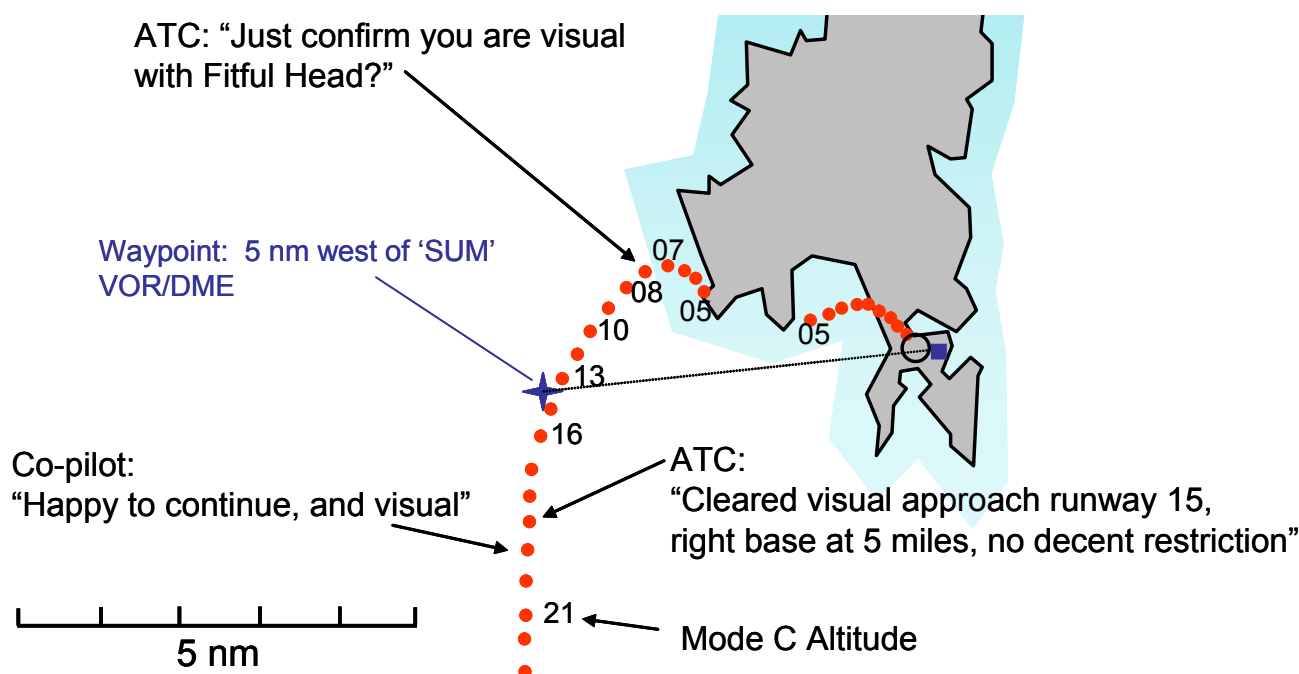
Figure 2 shows the aircraft's radar track and significant R/T exchanges. When the co-pilot contacted the Sumburgh Approach controller he was told that the aircraft would be radar vectored for the Localiser/DME procedure for Runway 09. The co-pilot acknowledged this, but requested a visual approach to Runway 15, if it was possible. The commander then transmitted "...WE'VE SET UP OUR NAV BOX TO PUT US ON A

As it approached the FMS waypoint, the aircraft commenced a gentle turn to the right. It passed about 0.2 nm to the east of the waypoint, whilst descending at about 1,500 ft/min through a Mode C altitude of 1,300 ft. The aircraft continued in a very gentle right turn towards the high ground of Fitful Head. The average descent rate reduced as the aircraft descended below 1,000 ft, to about 1,000 ft/min. When the aircraft was about 0.6 nm from the coastline as shown on the radar display, and at a Mode C altitude of 700 ft, the Approach controller asked "... JUST CONFIRM YOU ARE VISUAL WITH FITFUL HEAD?" The co-pilot replied with the single word "AFFIRM" and the subsequent radar returns showed the aircraft's turn rate to the right increased significantly until the aircraft had turned to track approximately

Radar plot and significant R/T exchanges

parallel to the coastline. The indicated altitude remained at 700 ft initially, then reduced to 500 ft. At that point radar contact was lost, as the aircraft became masked by the high ground.

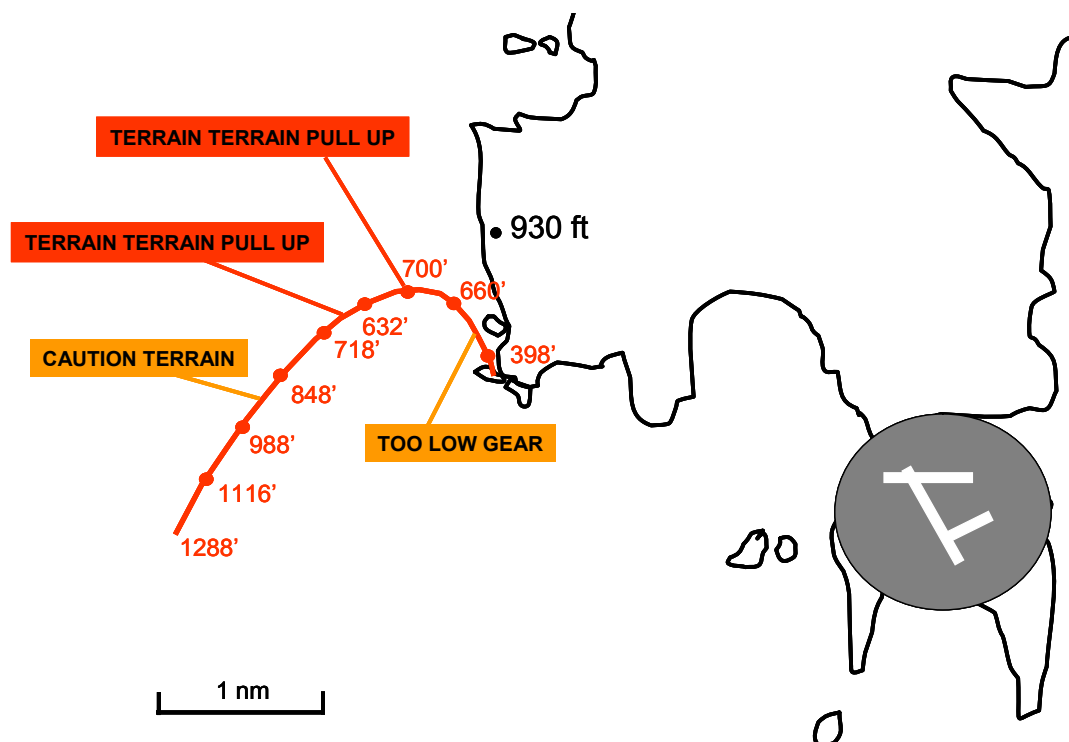
Figure 3
EGPWS record

The position of warnings and cautions generated by the EGPWS are depicted at Figure 3; values in red are radio altitudes. Figure 4 shows the aircraft’s vertical profile for the same period. Flight data for each significant event, commencing with the start of the recorded data, is given in Table 1. Two recorded parameters were common to each event, these were: landing gear up and landing flaps not selected.

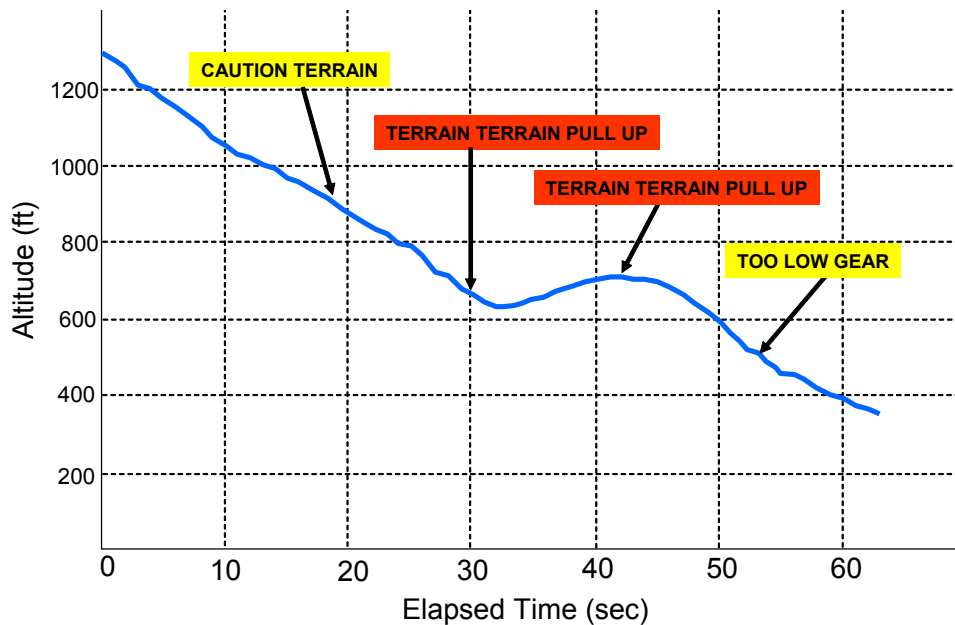
Figure 4

Aircraft vertical profile
