**INCIDENT**

<b>Aircraft Type and Registration:</b>	Dornier 328-100, TF-CSB	
<b>No &amp; Type of Engines:</b>	2 Pratt and Whitney PW 119B turboprop engines	
<b>Year of Manufacture:</b>	1997	
<b>Date &amp; Time (UTC):</b>	11 June 2006 at 1256 hrs	
<b>Location:</b>	Near Sumburgh Airport, Shetland	
<b>Type of Flight:</b>	Public Transport (Passenger)	
<b>Persons on Board:</b>	Crew - 3	Passengers - 17
<b>Injuries:</b>	Crew - None	Passengers - None
<b>Nature of Damage:</b>	None	
<b>Commander's Licence:</b>	Airline Transport Pilot's Licence	
<b>Commander's Age:</b>	61 years	
<b>Commander's Flying Experience:</b>	18,000+ hours (of which approximately 280 were on type) Last 90 days - 120 hours Last 28 days - 36 hours	
<b>Information Source:</b>	AAIB Field Investigation

**Synopsis**

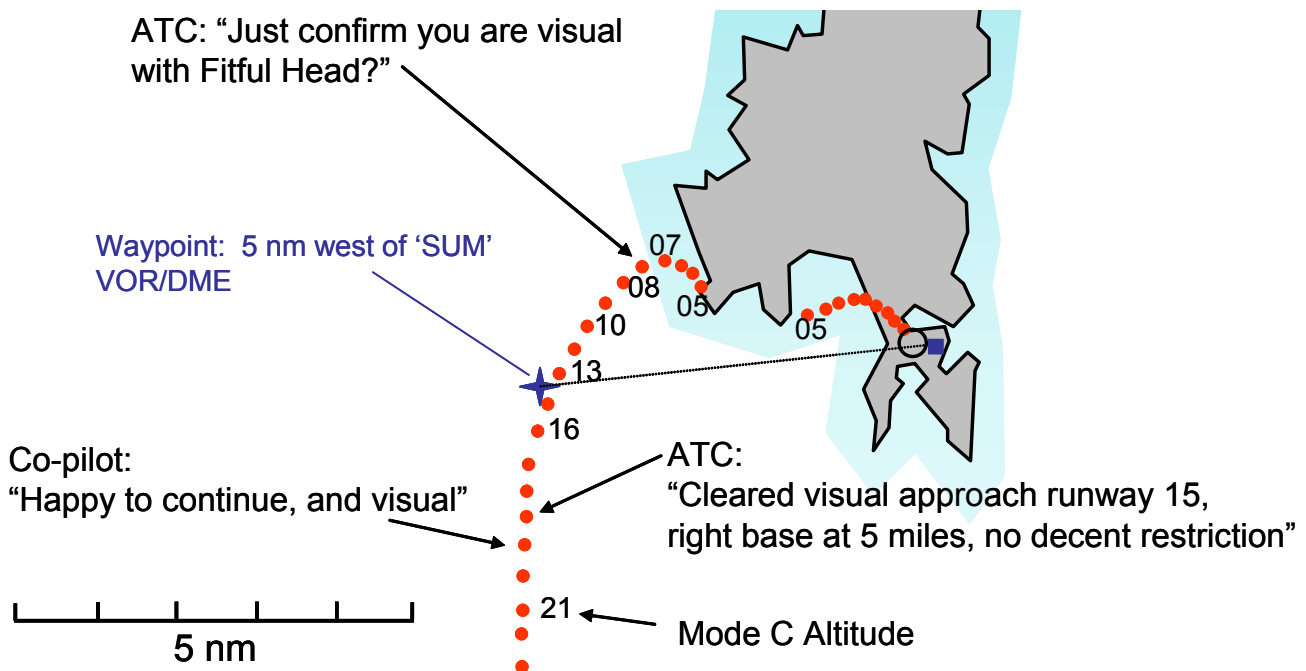
Figure 2 shows the aircraft's radar track and significant R/T exchanges. When the co-pilot contacted the Sumburgh Approach controller he was told that the aircraft would be radar vectored for the Localiser/DME procedure for Runway 09. The co-pilot acknowledged this, but requested a visual approach to Runway 15, if it was possible. The commander then transmitted "...WE'VE SET UP OUR NAV BOX TO PUT US ON A

DESCENT RESTRICTION". As the controller began this transmission the SSR Mode C altitude indicated that the aircraft began descending below 2,100 ft, with an initial descent rate of between 1,500 ft/min and 2,000 ft/min.

As it approached the FMS waypoint, the aircraft commenced a gentle turn to the right. It passed about 0.2 nm to the east of the waypoint, whilst descending at about 1,500 ft/min through a Mode C altitude of 1,300 ft. The aircraft continued in a very gentle right turn towards the high ground of Fitful Head. The average descent rate reduced as the aircraft descended below 1,000 ft, to about 1,000 ft/min. When the aircraft was about 0.6 nm from the coastline as shown on the radar display, and at a Mode C altitude of 700 ft, the Approach controller asked "... JUST CONFIRM YOU ARE VISUAL WITH FITFUL HEAD?" The co-pilot replied with the single word "AFFIRM" and the subsequent radar returns showed the aircraft's turn rate to the right increased significantly until the aircraft had turned to track approximately

Radar plot and significant R/T exchanges

parallel to the coastline. The indicated altitude remained at 700 ft initially, then reduced to 500 ft. At that point radar contact was lost, as the aircraft became masked by the high ground.

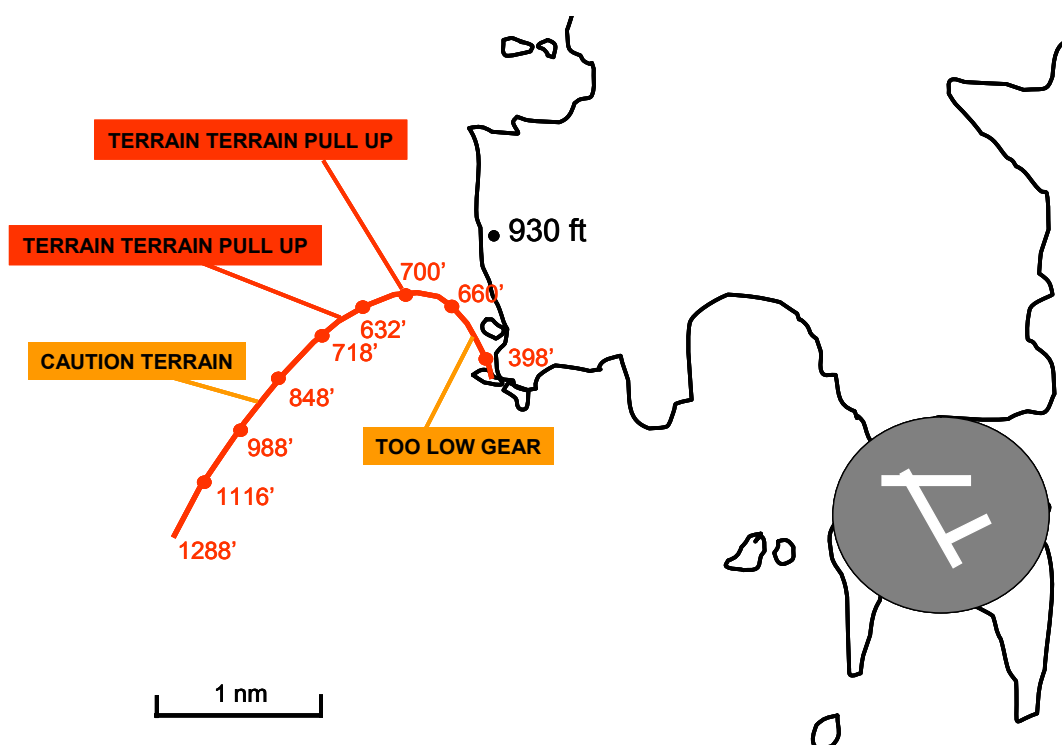
**Figure 3**  
EGPWS record

The position of warnings and cautions generated by the EGPWS are depicted at Figure 3; values in red are radio altitudes. Figure 4 shows the aircraft’s vertical profile for the same period. Flight data for each significant event, commencing with the start of the recorded data, is given in Table 1. Two recorded parameters were common to each event, these were: landing gear up and landing flaps not selected.

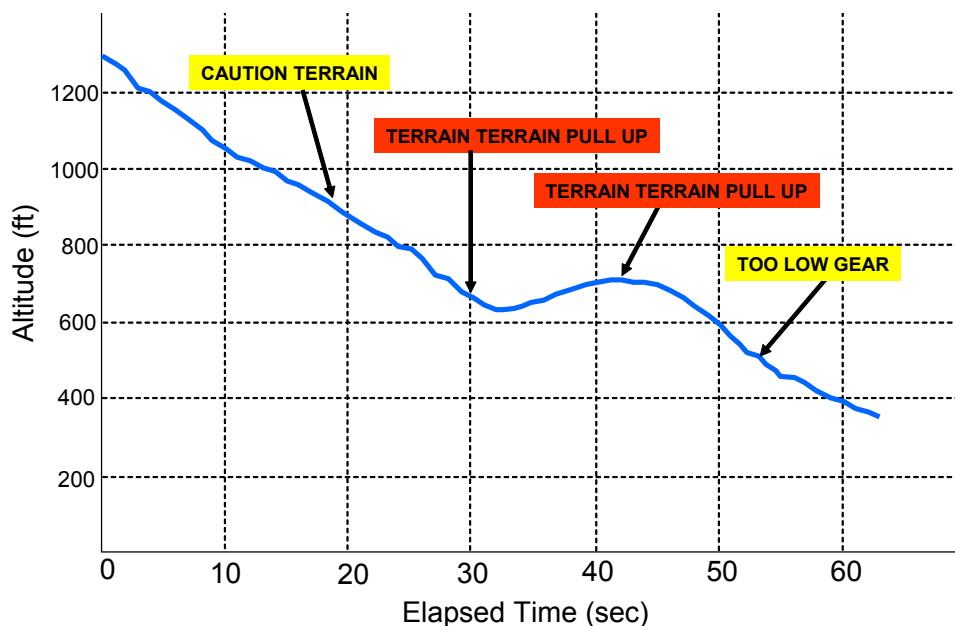
**Figure 4**

Aircraft vertical profile
