ACCIDENT

Aircraft Type and Registration:	Boeing 757-200, TF-ARE	
No. and Types of Engines	2 Rolls Royce RB211-534E4-37 turbofan engines	
Year of Manufacture	2005	
Date & Time (UTC):	11 June 2005 at 2030 hrs	
Location:	Manchester International Airport	
Type of Flight:	Public Transport (Passenger)	
Persons on Board:	Crew - 8	Passengers - None
Injuries:	Crew - 1	Passengers - None
Nature of Damage:	None	
Commander's Licence:	Airline Transport Pilot's Licence	
Commander's age:	N/A	
Commander's Flying Experience:	Last 90 days - N/A Last 28 days - N/A	
Information Source:	Aircraft Accident Report Form, Airline internal investigation and AAIB inquiries

Synopsis

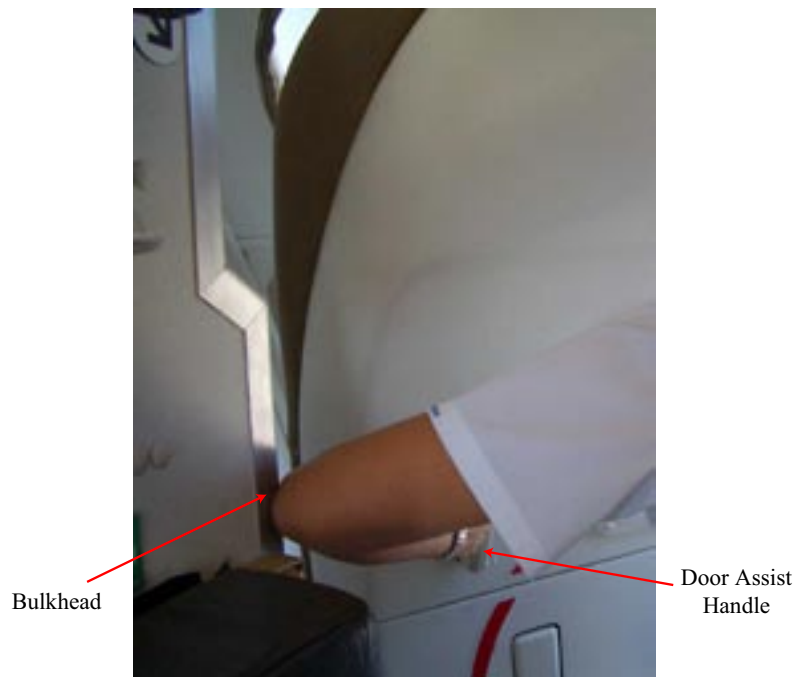
her left hand to bend around the door assist handle and her wrist to fracture. Figure 1 shows a reconstruction of how a person's arm may become trapped. It was only once the door had moved into the fully closed position that the attendant was able to free her arm. Paramedics treated her at the aircraft before she was taken to hospital by the Duty Station Officer.

Reconstruction of a cabin crew member's arm trapped between bulkhead and door assist handle
