Technical Report A-011/2004

Accident to aircraft Boeing
B747-300, registration
TF-ATJ, operated by Iberia
LAE, during flight over the
Atlantic Ocean tropics on
26 February 2004

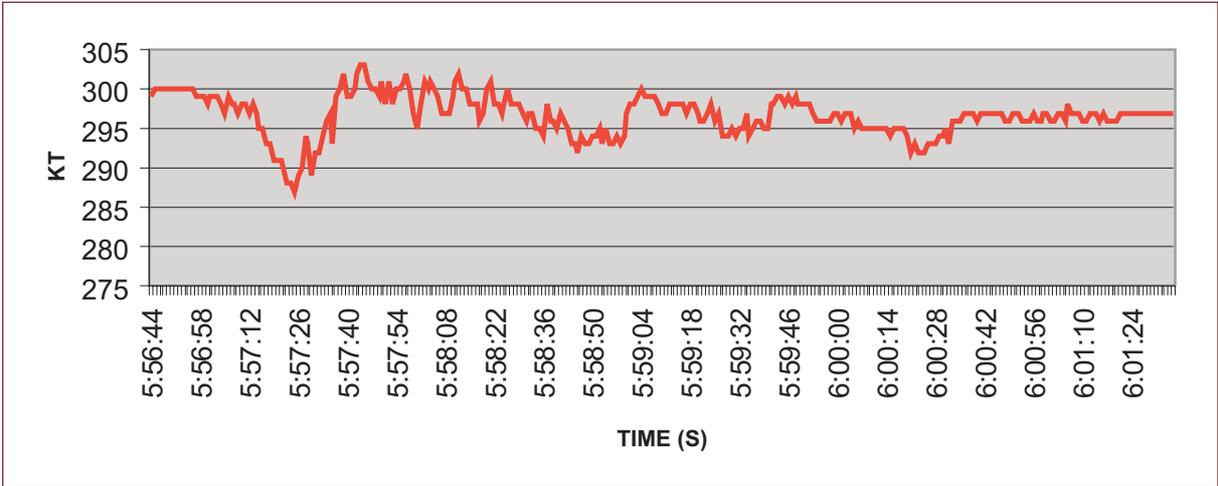
Figure 1.11.1. Aircraft's indicated airspeed

Flying according to procedures and recommendations of the Basic Operations Manual, the aircraft speed was maintained within a margin of ± 13 kt. The pitch angle only suffered $\pm 1^\circ$ variations and lateral roll of $\pm 5^\circ$.

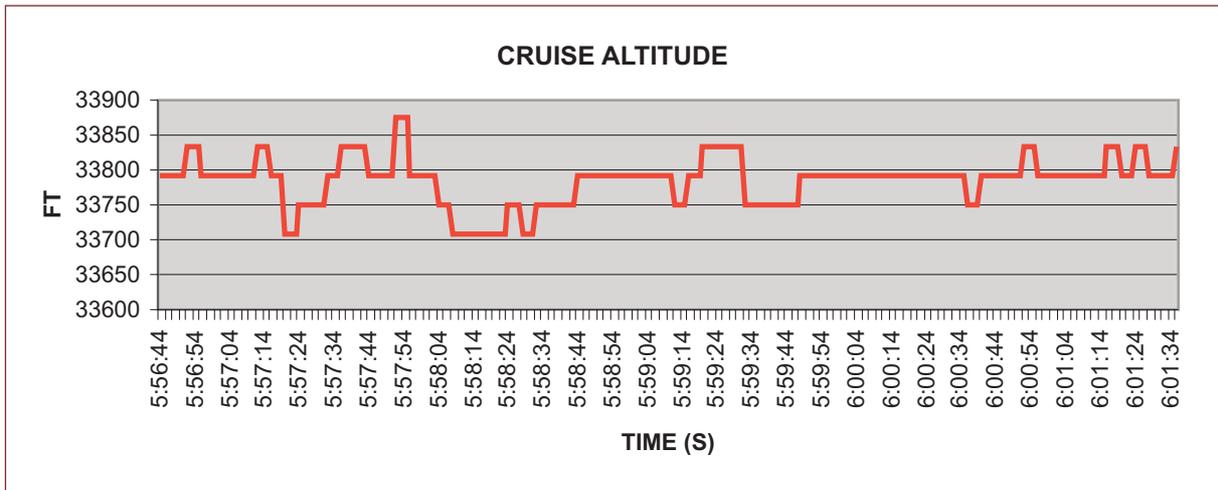
Figure 1.11.3. Flight level

The aircraft moved between flight levels separated by 165 ft (50 m). The up and down periods were no longer than 10 seconds, according to the oscillations represented on graph 1.11.3.

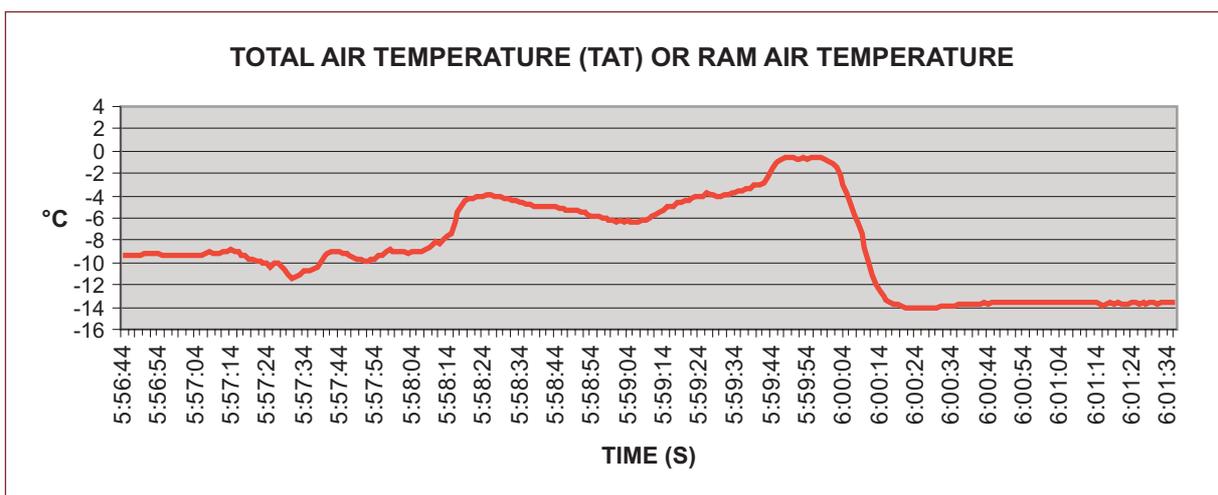
Figure 1.11.5. Total air temperature (Appendix A1 shows that TAT tends to recover values prior to the penetration of the turbulence as the aircraft flies away)

It is observed that TAT regained previous normal values for the area, once the aircraft moved away from the turbulence.

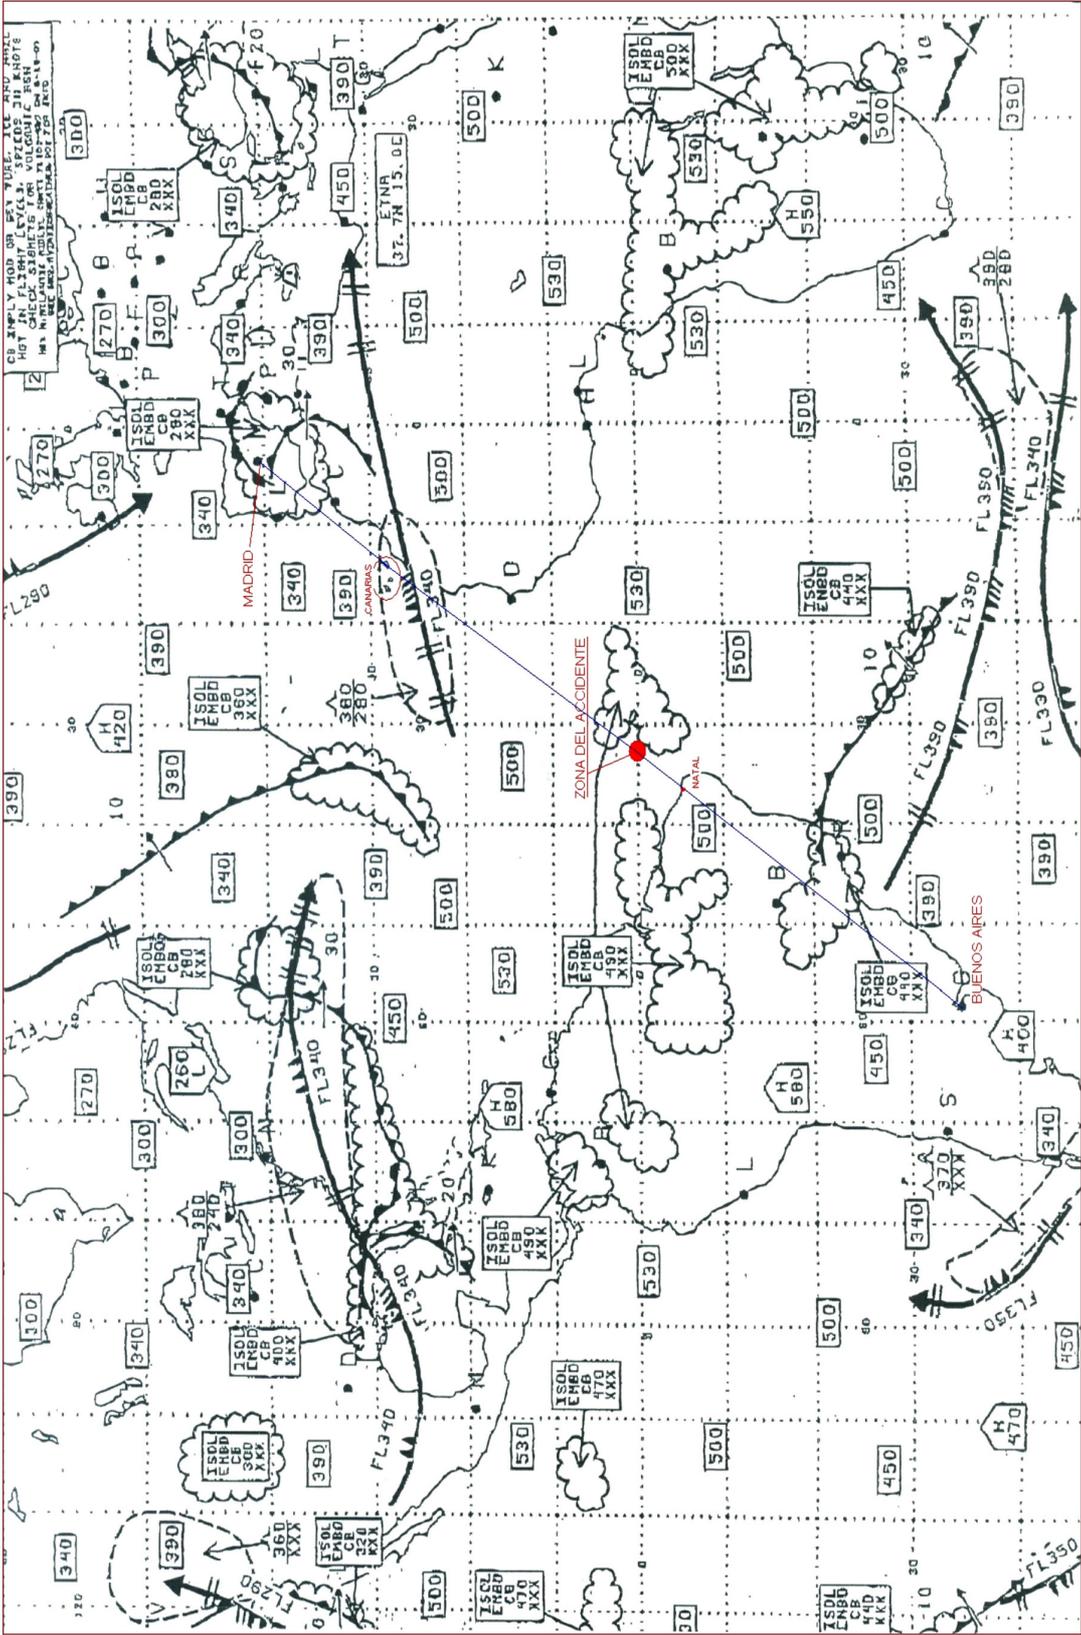
Appendix A2. SIGMET weather map for flight dispatch

The significant weather chart that was given to the flight crew (see Appendix A2) summarizes the information they had for the planning of the flight.

In the tropical regions, between latitudes 10° S and 5° N, there were two limited areas with significant weather warnings, one over the continent and the other over the Atlantic Ocean, separated by 350 NM. The scheduled route went between these two areas. Thermo convective activity with CB-type clouds were forecast for those areas, which implied moderate to severe turbulence conditions. CB would be isolated and embedded or hidden amongst other layers of vertical development clouds up to 49,000 ft. The height of the Tropopause at those latitudes was 50,000 ft.

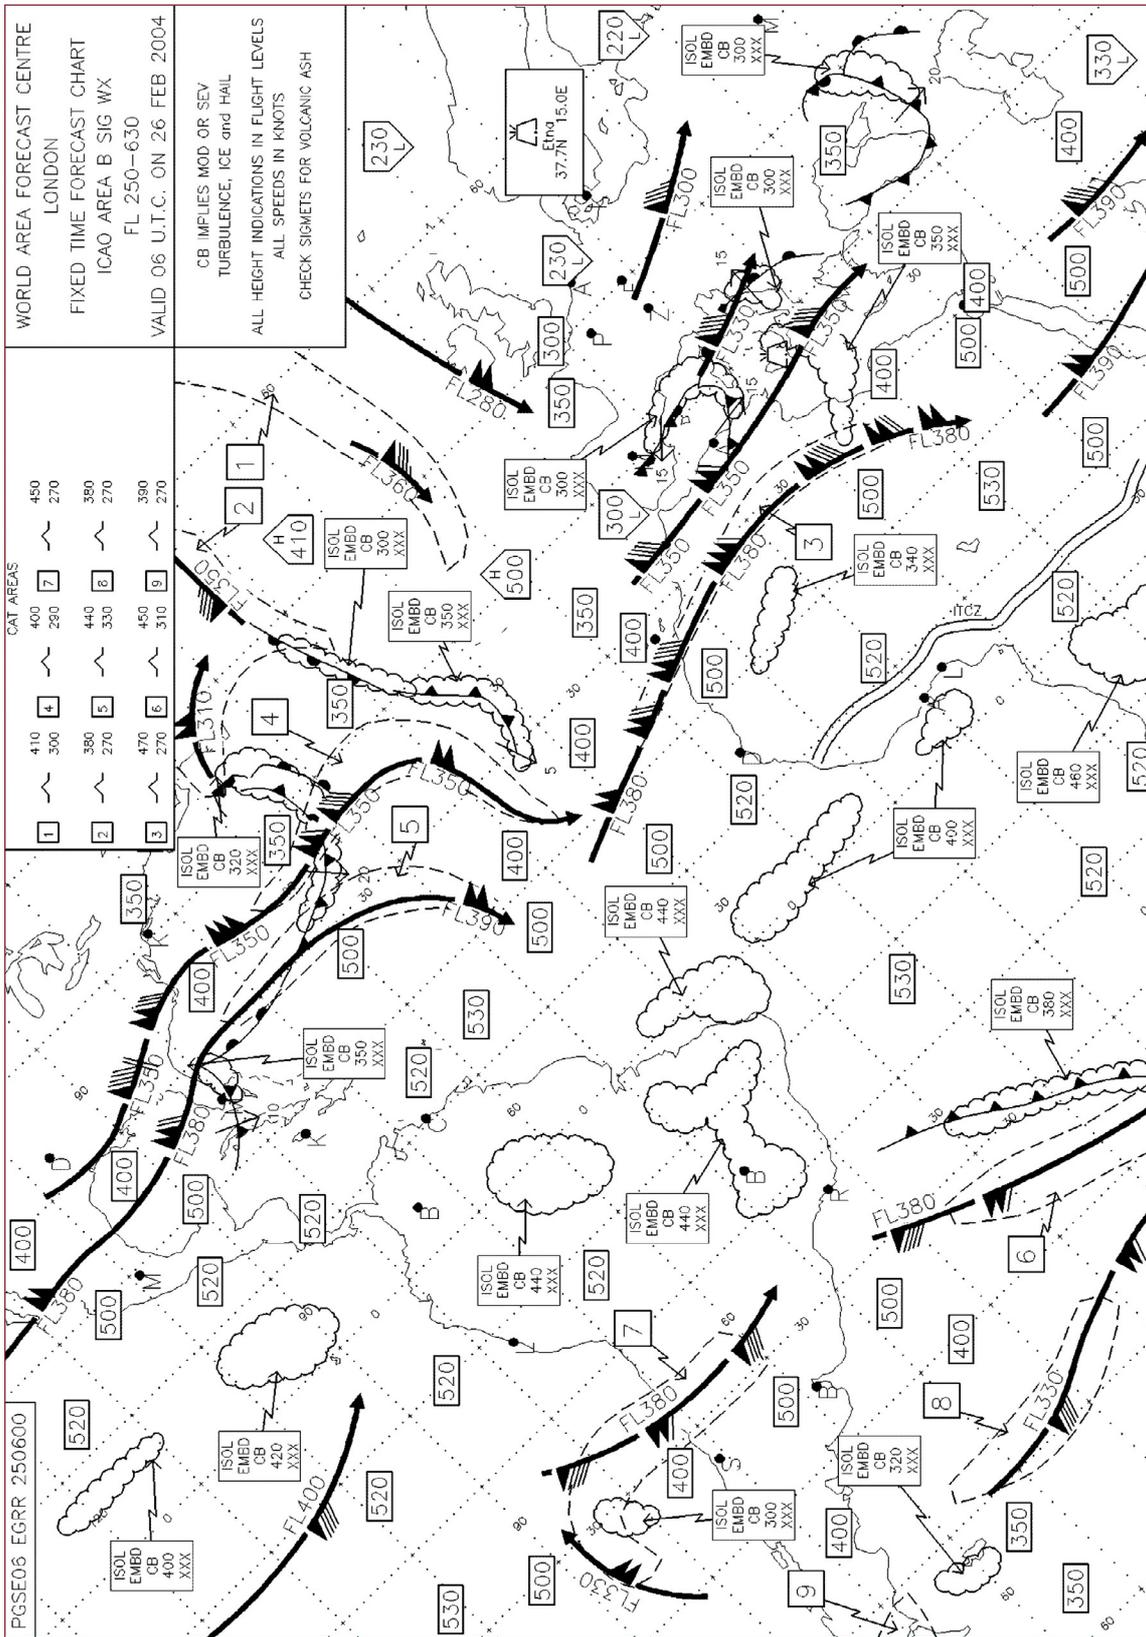
Appendix A4. Forecast SIGMET weather map 06:00

The significant weather forecast (see Appendix A4) for 06:00 UTC for the same day and location showed no indication of these cumulonimbuses, but did forecast them

in nearby areas to the East up to flight level 440, and to the West up to flight level 400.

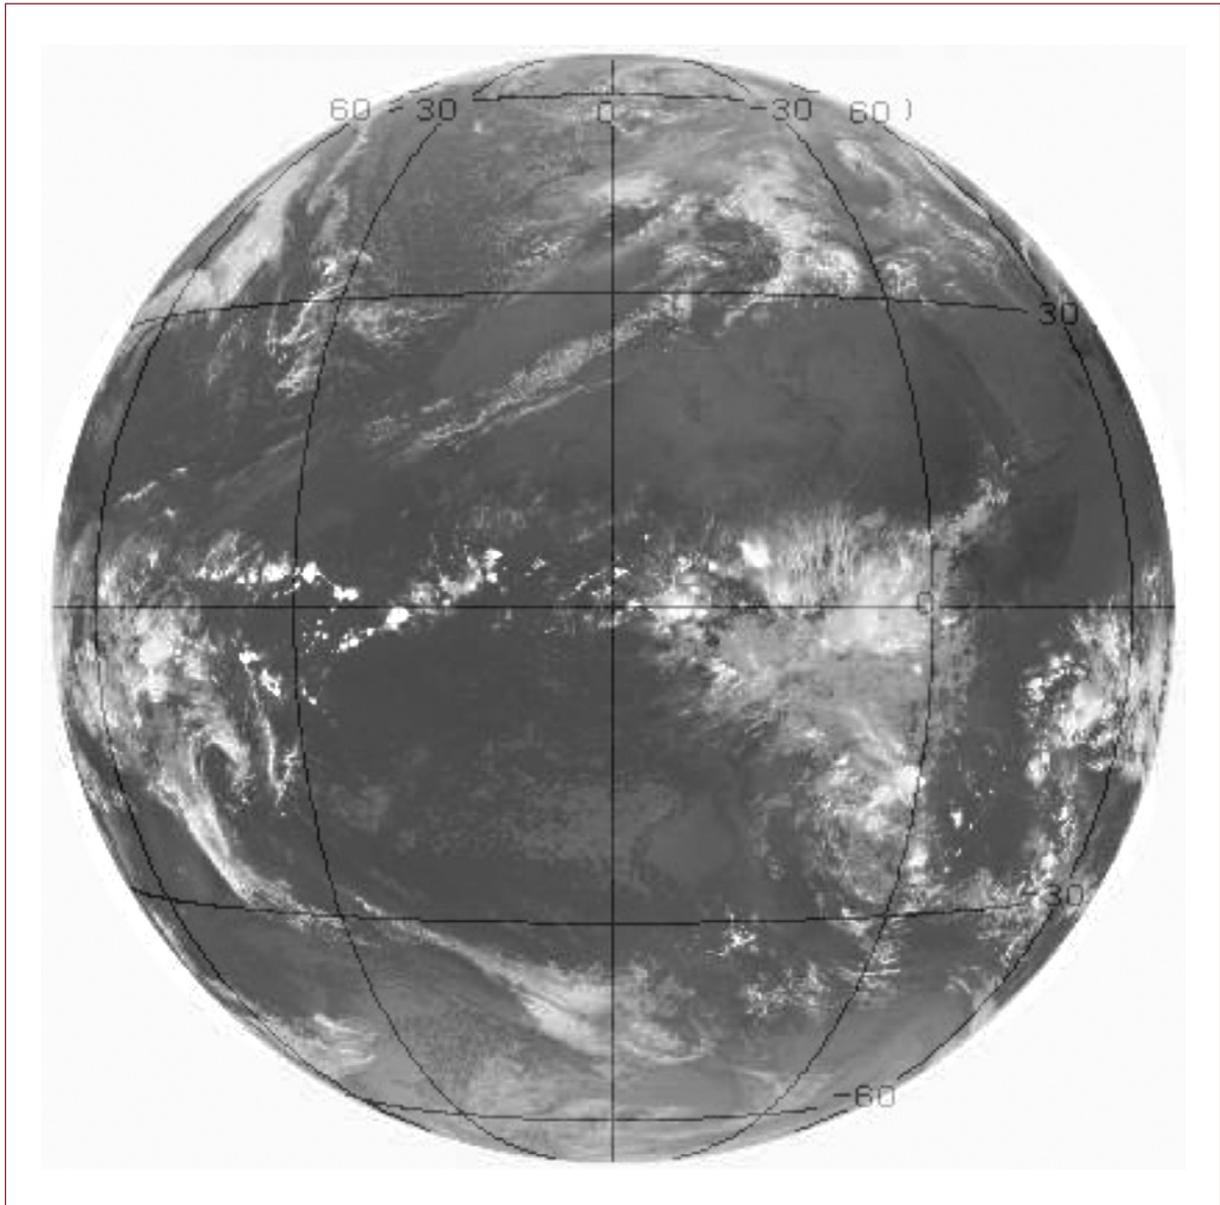
Appendix A5. *Satellite image: visible*

Although at low resolution, water vapor and infrared satellite pictures (see Appendices A5 and A6) for the location, day and time of the accident, showed that slightly more than a geographic degree of distance North of the place where the accident occurred (just over 60 NM), and extending in a Northeasterly direction, there was a strip of organized cumulonimbus clouds, with higher tops the further they were from that point.
