# REPORT ON SERIOUS INCIDENT

**M-07404/AIG-35**

**TF-SYN**

**Fokker F-27-200**

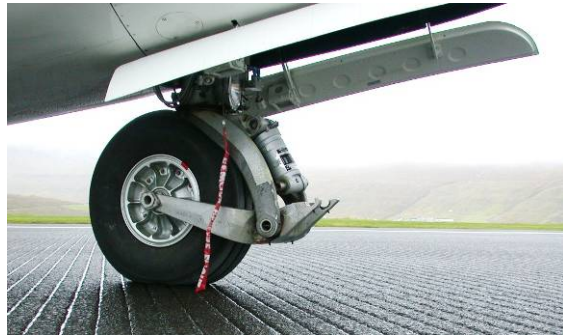
**Figure 1: Nose landing gear**

TF-SYN landed at 09:35 local time on runway 13 at Vaagar Airport. During the landing run the crew felt a bump and when the aircraft was taxied from the runway the nose of the aircraft tilted downwards and the aircraft came to a stop. Inspection revealed that the nose landing gear had collapsed, as can be seen in Figure 1. The collapse was due to a fracture in the nose wheel lever sub-assembly, as can be seen in Figure 2.

Field inspection by Icelandic Coast Guard technicians revealed that the wheel lever sub-assembly had fractured at the attachment points for the shock absorber. The fracture allowed the wheel lever sub-assembly to overrotate so that it clamped the nose wheel between the pivot bracket sub-assembly and the ground (see Figure 1 and illustration in Appendix A).

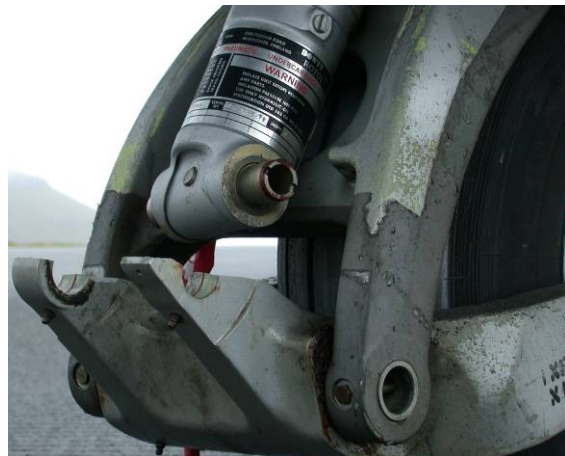
**Figure 2: Wheel lever sub-assembly**

- The Coast Guard technical management performed the landing gear exchange and released the aircraft back into service.
- The Loaner Nose Landing Gear wheel lever sub-assembly failed due to overstress and weakening of the metal due to corrosion.

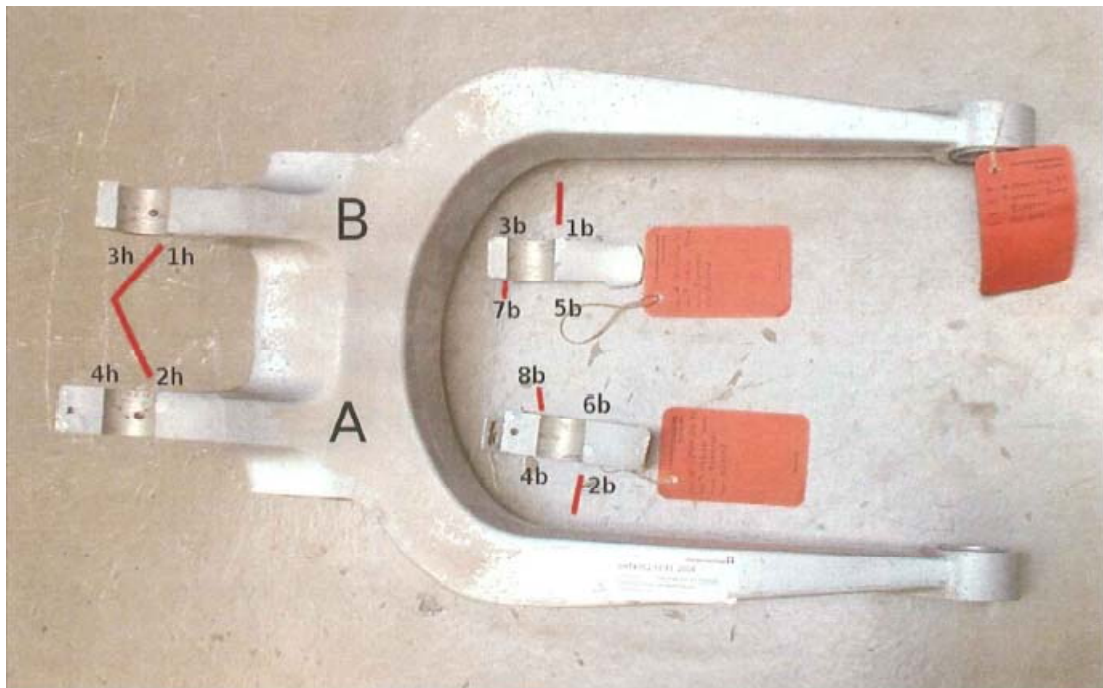
**Figure 3: Overview of fractured surfaces**

The AAIB sent The Loaner Nose Landing Gear wheel lever sub-assembly to IceTec (Technological Institute of Iceland) for an independent metallurgical analysis. The fractured pieces (made of aluminum) were visually inspected and photographed using a stereoscope. The fractured surfaces were also inspected using an electron microscope. Figure 3 below is an overview of the fractured surfaces on the wheel lever sub-assembly. Position 1h matches with position 1b and so on.

The analysis determined that the fracture was a brittle fracture on both surfaces. Figure 4 shows where corrosion has formed in cracks (crevice corrosion) close to the fracture surfaces with pitting close to the surface. Figure 5 shows a side view of the same area. Chemical analysis of the fracture surfaces found traces of chlorine. Chlorine is a highly corrosive agent in aluminum.

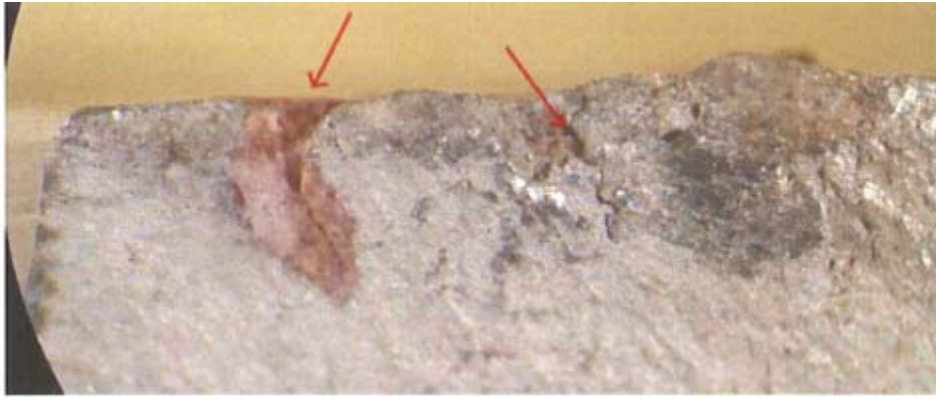
**Figure 4:** Starting point of fracture can be seen in figure 3 marked as 1b. The left arrow points to a crack where corrosion has collected (the area has been dyed slightly red). The right arrow points to a crack.

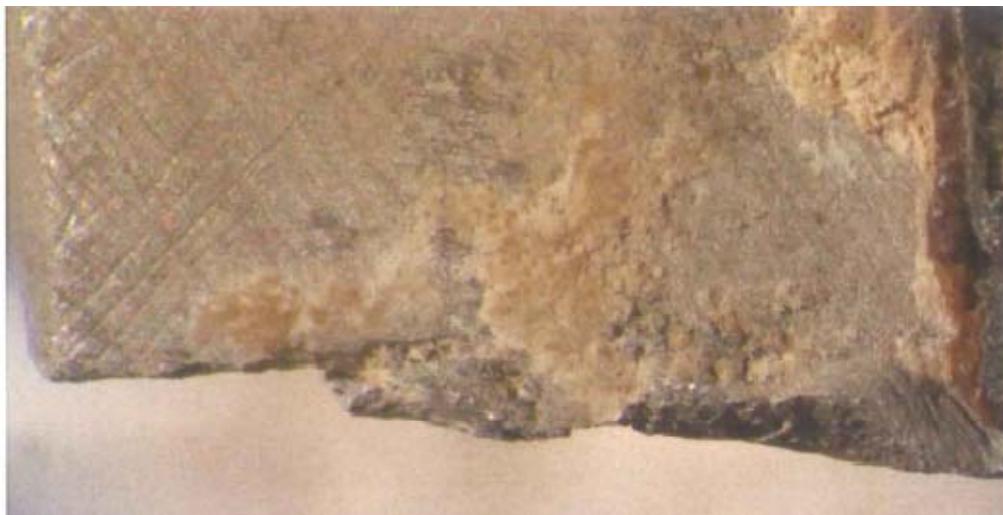
**Figure 5:** Position 1b seen from the side. Corrosion pits are visible on the surface.

Close to area 1b a deformation can be seen. As this deformation is not visible on area 1h it can be assumed that it occurred after the incident. Such deformation is visible in other areas as well. The engineer performing the metallurgical analysis was of the opinion that the most likely reason for the fracture was a combination of overstress and weakening of the material due to corrosion.
