AIRCRAFT INCIDENT REPORT

**Report by the France Airprox Board into the incident between aircraft
TF-ATU and HB-IJL at FI-380 near Paris, France on 1 August 2003**

M-04503/AIG-28

Inquiry final report

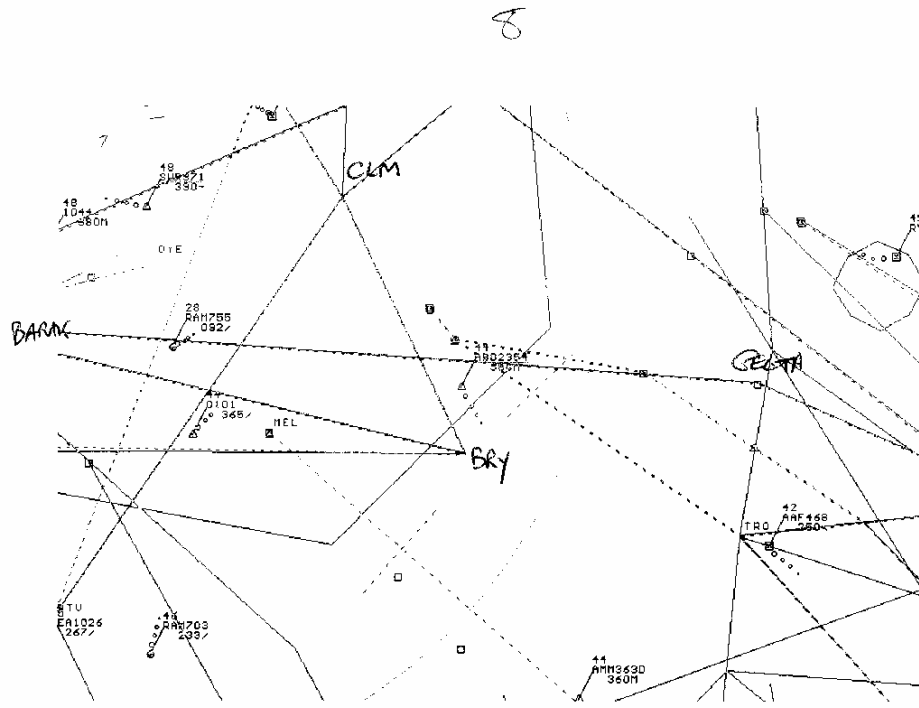
Appendix 2

SWR3711.STR
SWR371: 48N56'15 - 02E05'53 01/08/2003 20H32M38 Couches: ...PQUI5
