AIRCRAFT INCIDENT REPORT

**Report by the Danish Accident Investigation Board
into the incident to Cessna 404, TF-JVG
App. 30 nm west of Kulusuk Airport (BGKK) at FL 130**

M-05602/AIG-20

**TF-JVG
Cessna 404
Greenland, west of Kulusuk Airport
01 August 2002**

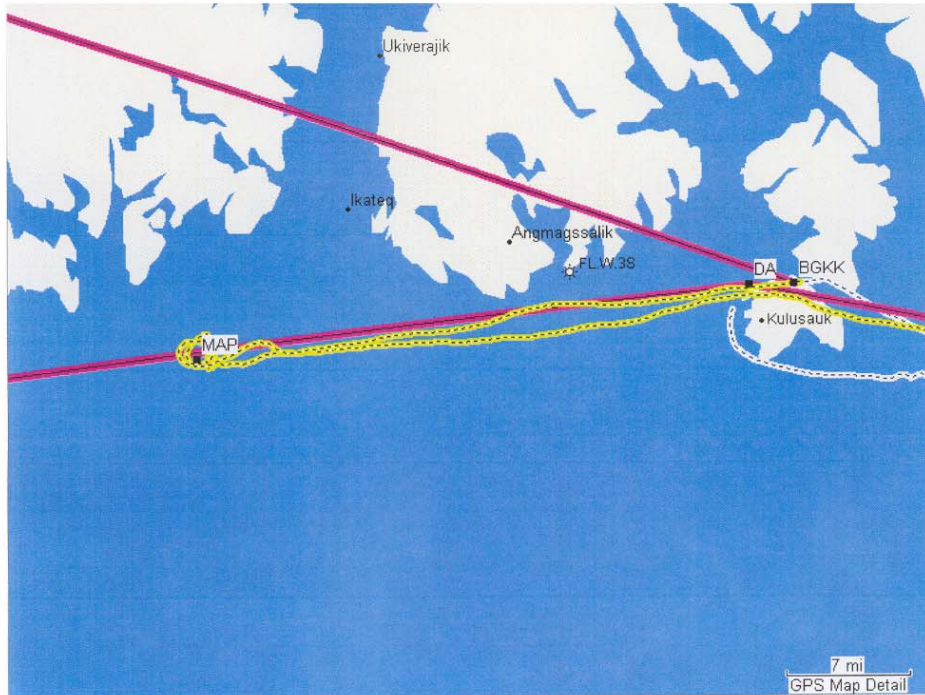
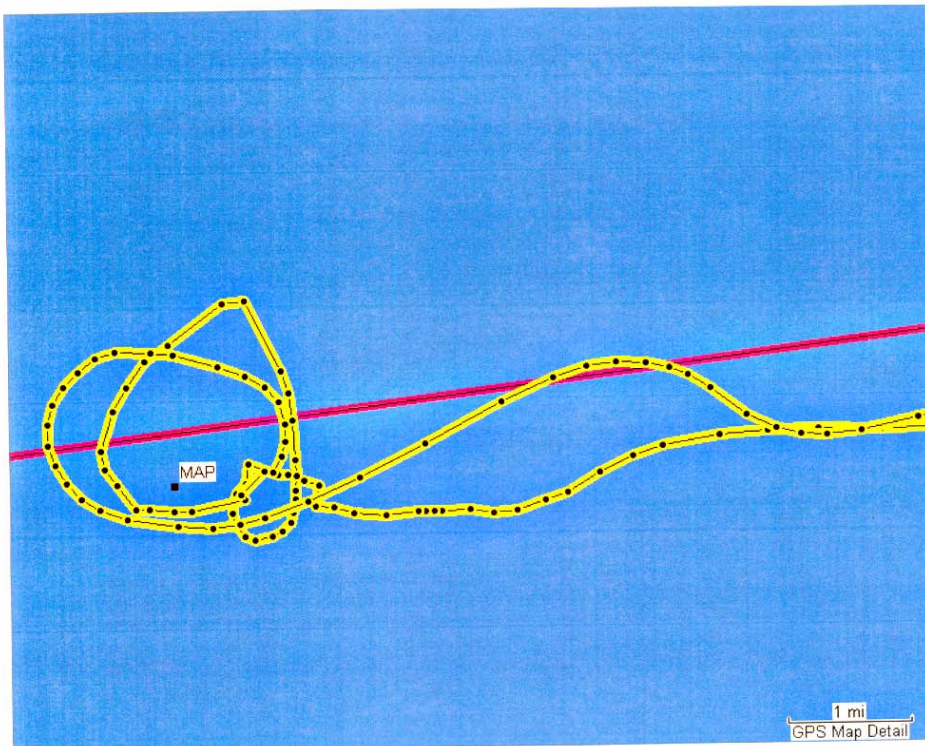
Enclosure 1

1.8.2.2 The Icelandic AAIB assisted the Danish AAIB in downloading data from the GPS. See enclosure 1.
