Report on aircraft accident

Case no: **M-01313/AIG-09**

Date: **21. July 2013**

Description: **Runway excursion during flight testing**

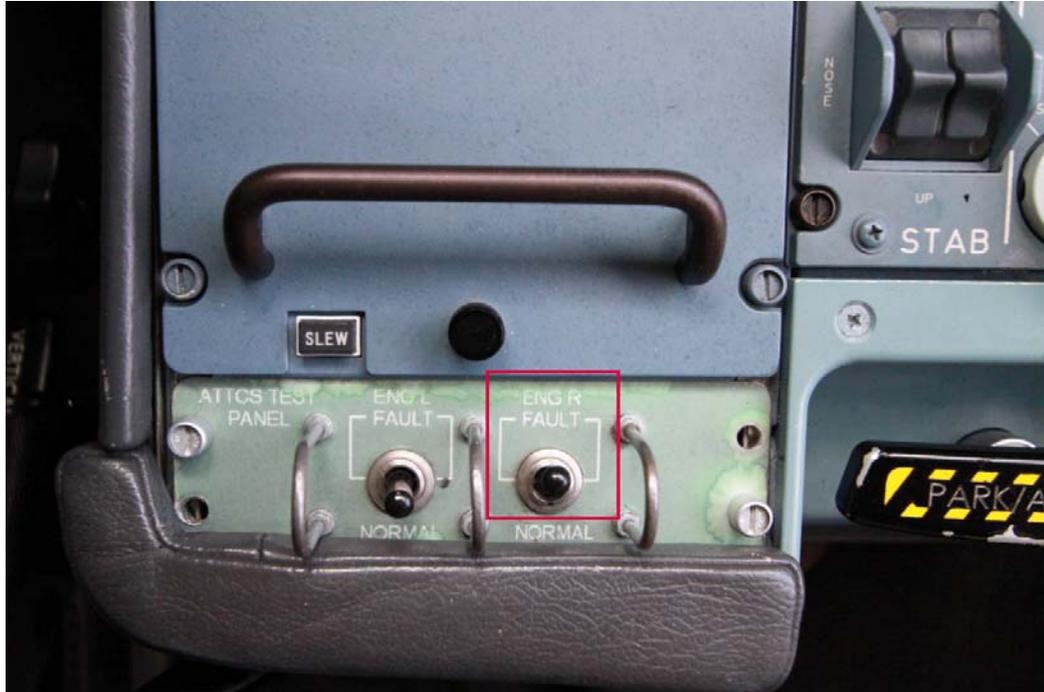
certification expert sitting in the jump seat in the cockpit selected right engine failure on the ATTCS⁶ Test Panel located on the pedestal before approach. See Figure 2.

Figure 2: Right engine fault selected on the ATTCS test panel

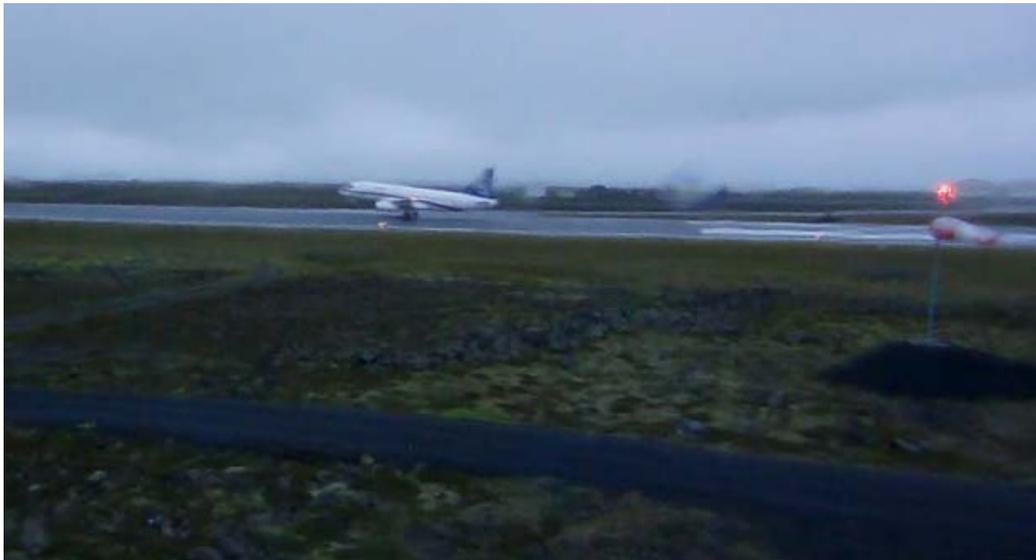
Almost simultaneously, at 05:23:28.70, the main landing gear touched the RW and as a result of left main LG shock strut compression a/c avionics complex received WOW signal (weight on wheels). See Figure 3.

Figure 3: Touchdown with the landing gear down

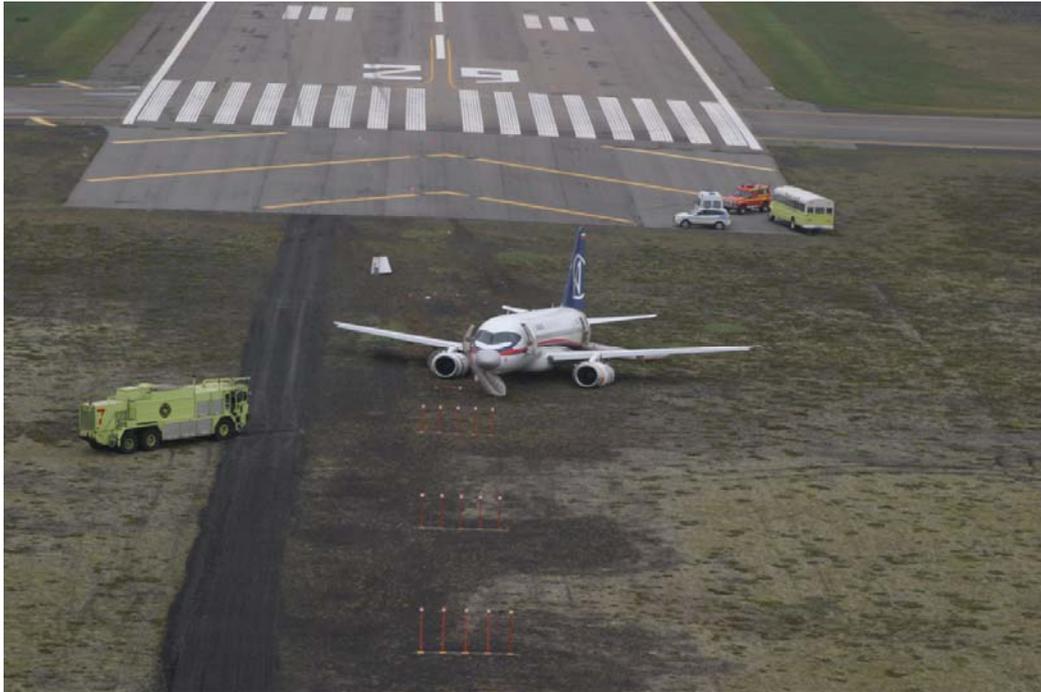
The airplane skidded off the end of RWY 11 and came to rest at 05:24:25 after having passed 163 meters beyond the threshold of RWY 29. See Figure 5.

Figure 5: The airplane came to rest beyond the threshold of RWY 29

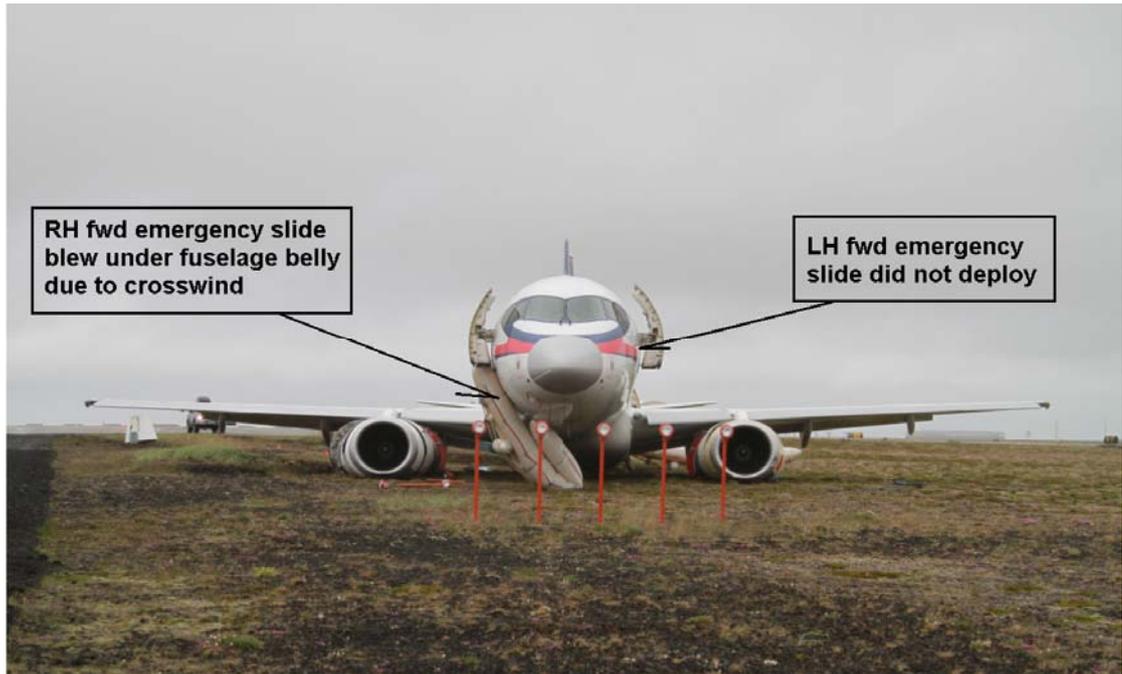
Figure 6: Forward RH emergency escape slide unusable

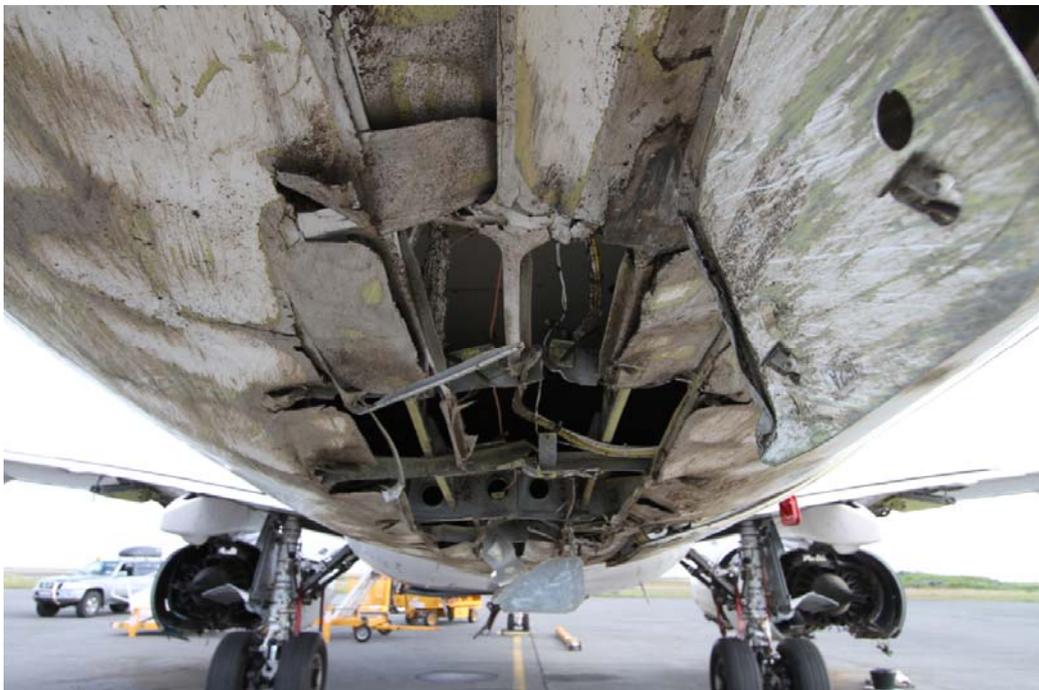
The airplane's aft lower fuselage section was extensively damaged. Other damage, included both engines and cowlings. See Figure 8.

Figure 8: Damage to the aircraft

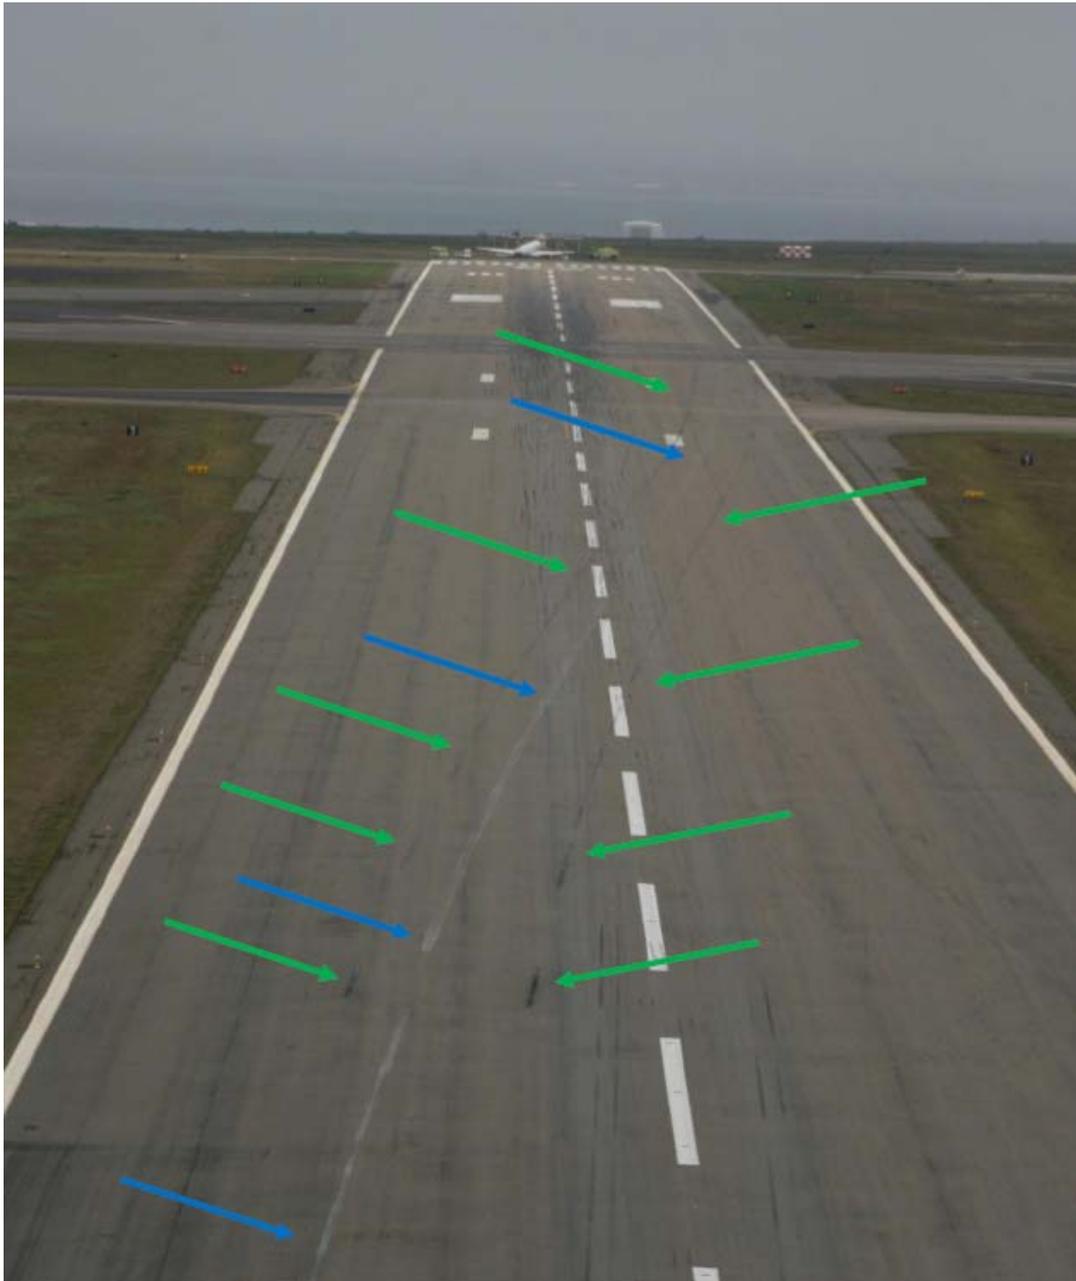
Figure 11: Airplane skid marks on RWY 11 (blue = fuselage / green = engines)

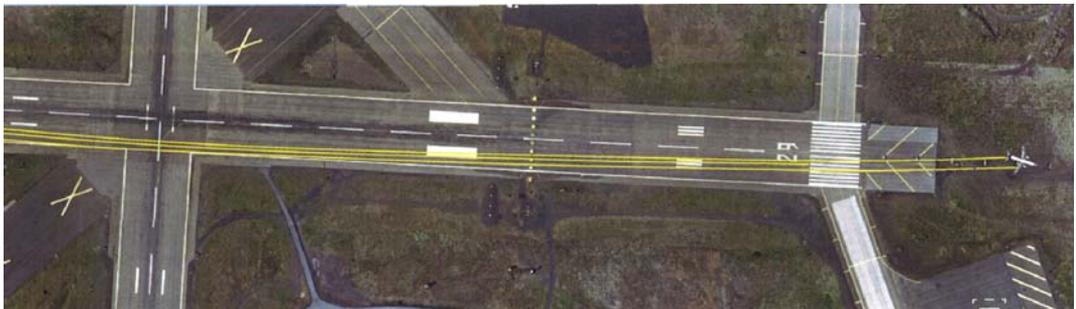
Figure 12: Airplane at RWY 11 right edge when crossing RWY 20

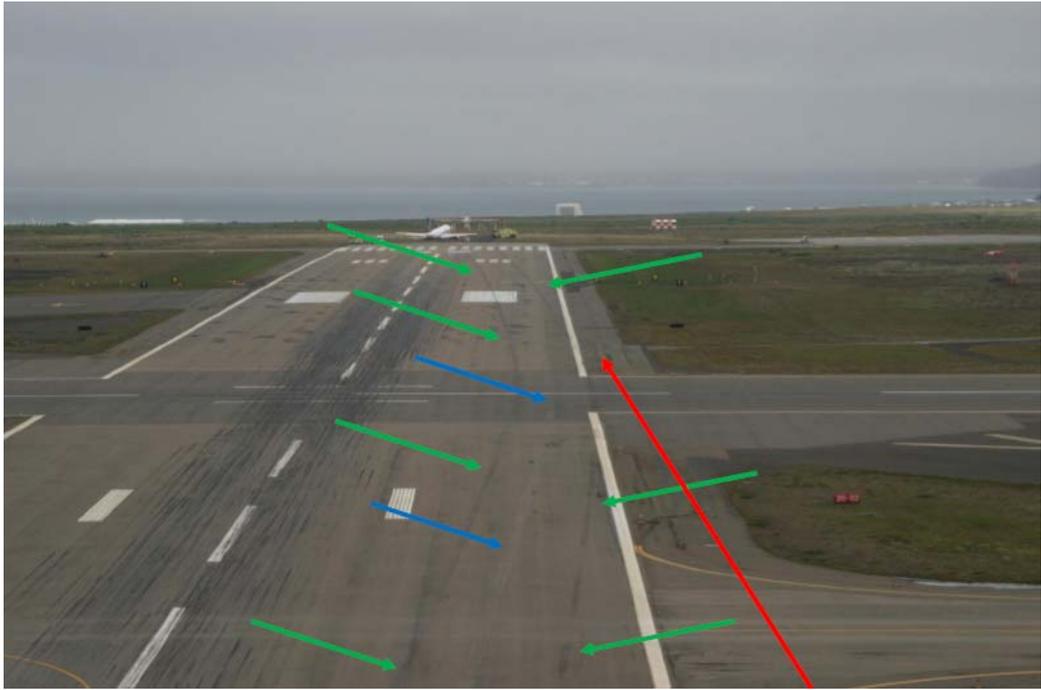
Figure 13: Airplane skid marks on RWY 11
(blue = fuselage / green = engines / red = broken RWY light)

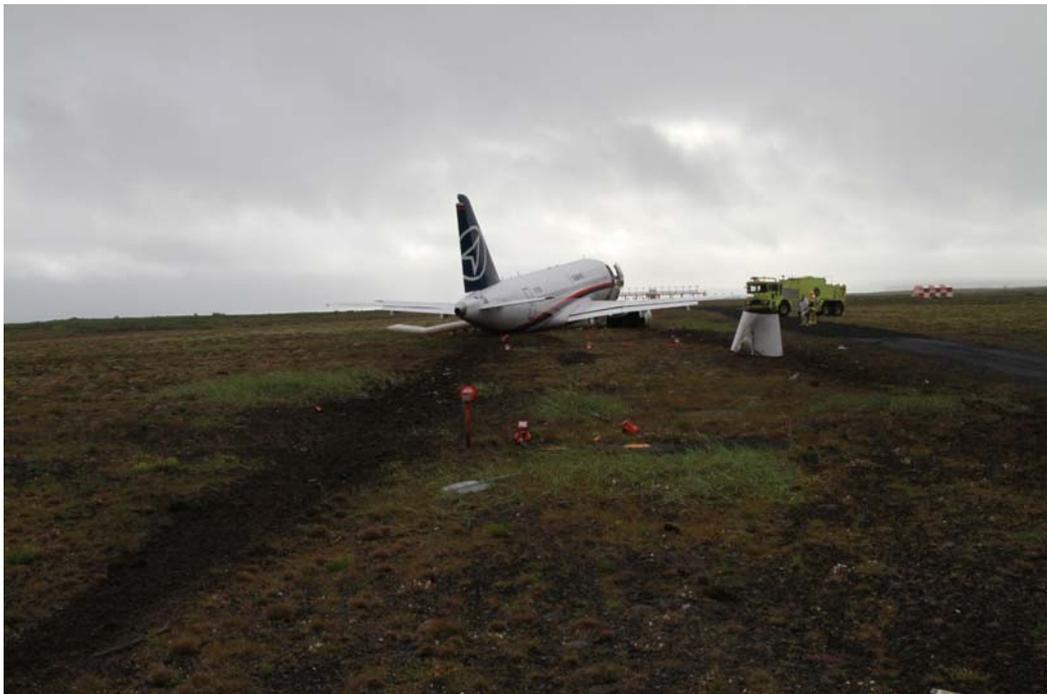
Figure 14: Airplane skidded off the end of RWY 11

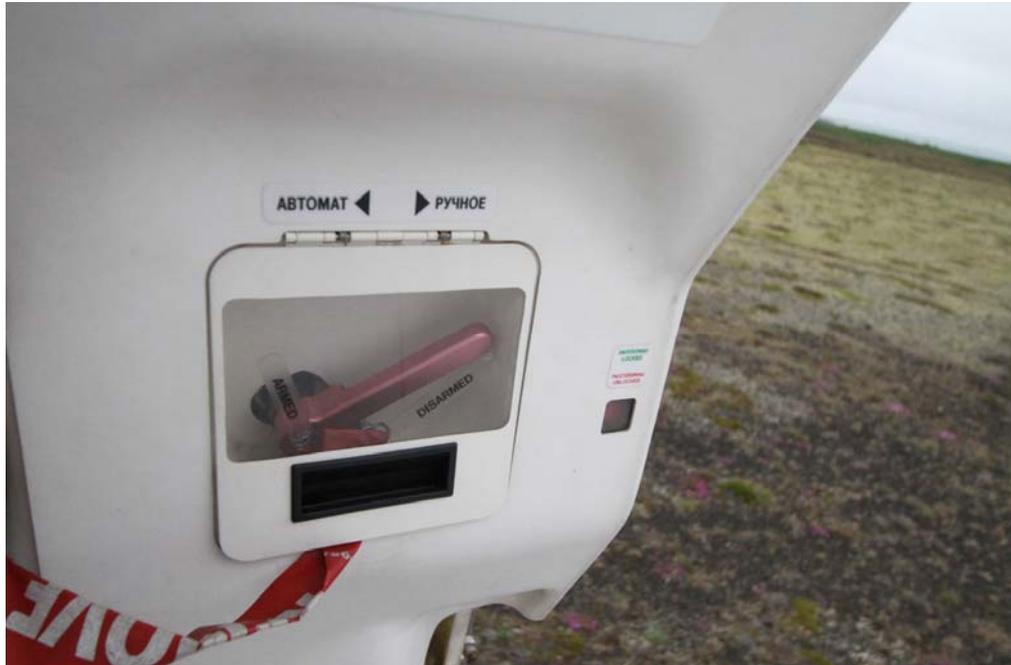
Figure 15: Forward left cabin door slide was not armed

- 1) Ensure sufficient resources for flight dispatch operation, independent of the flight crew, during flight tests
- 2) Review the flight test program and take the necessary steps to ensure that arming of door slides is performed prior to flight
- 3) Clarify the AFM procedures to require both TQLs to be operated in cases where a failed engine has not been identified and secured

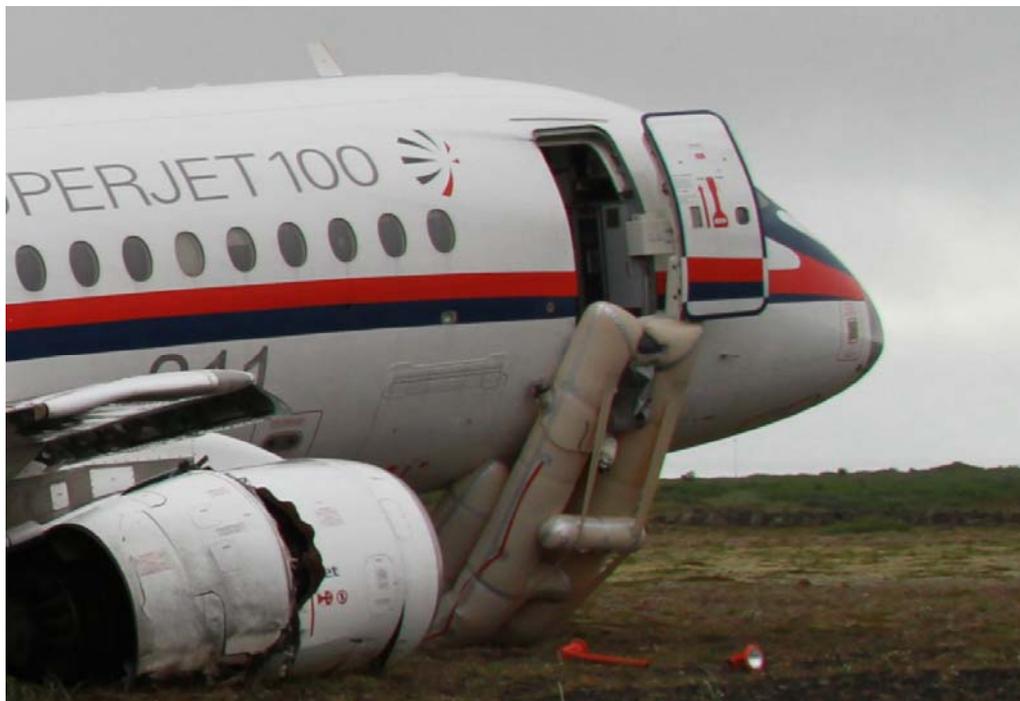
Figure 16: Forward right cabin door slide unusable

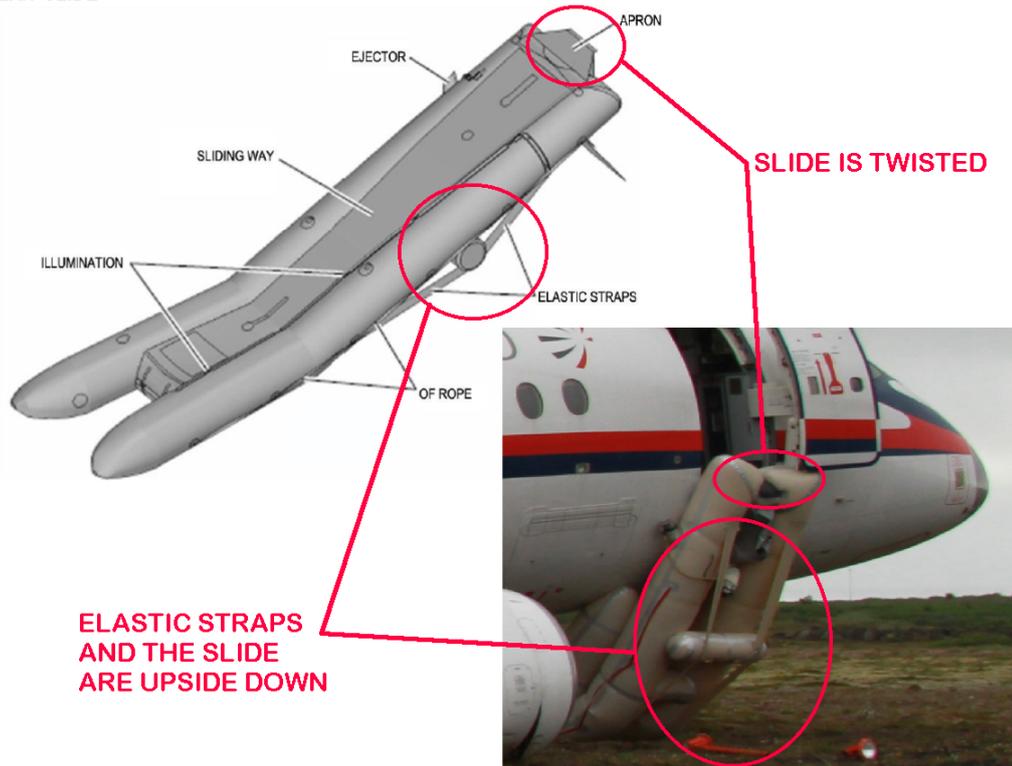
Figure 19 Right forward door slide twisted upside down and under fuselage belly
