Interim Report on aircraft accident

Case no: **20-014F001**

Location: **RWY 10 at Keflavik Airport**

Description: **Right Main Landing Gear collapsed during landing**

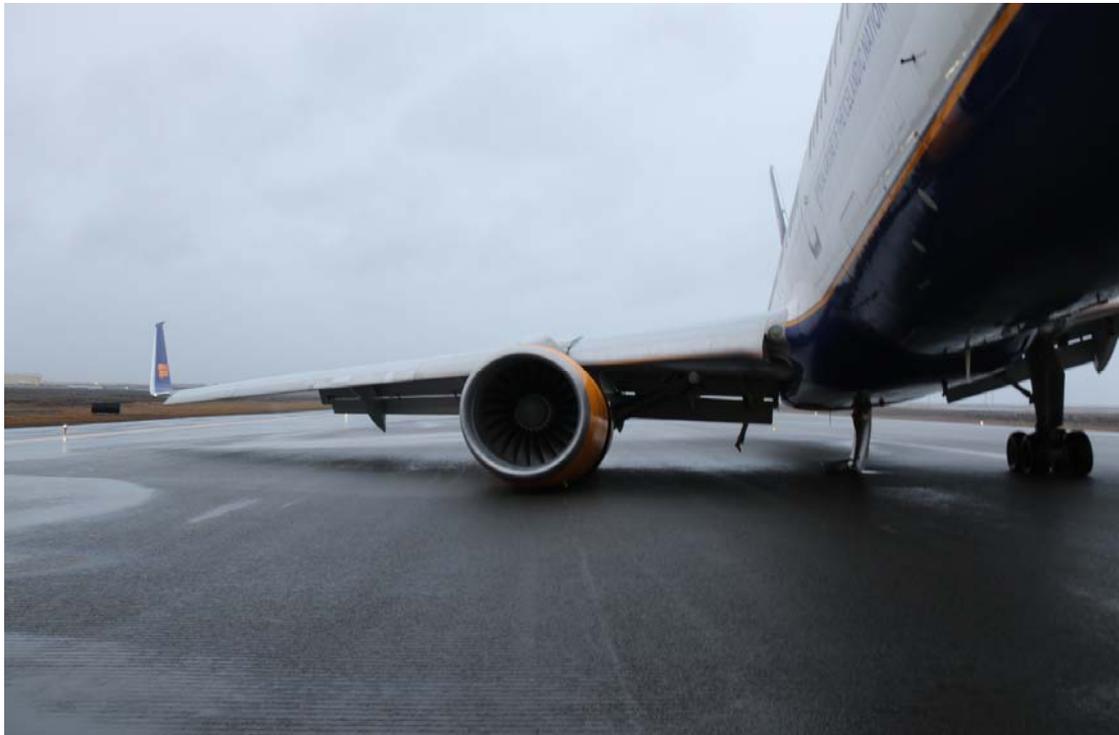
Figure 1: Airplane TF-FIA resting on its Right Engine at the accident site

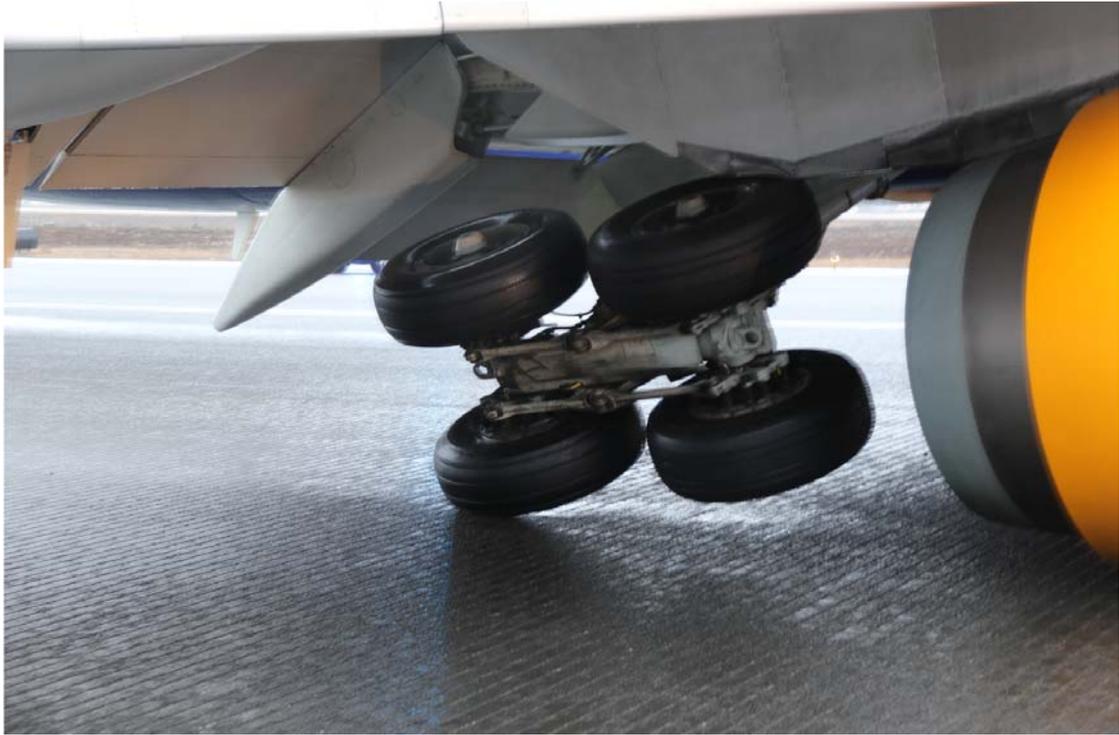
Figure 2: Right Main Landing Gear collapsed behind the Right Engine

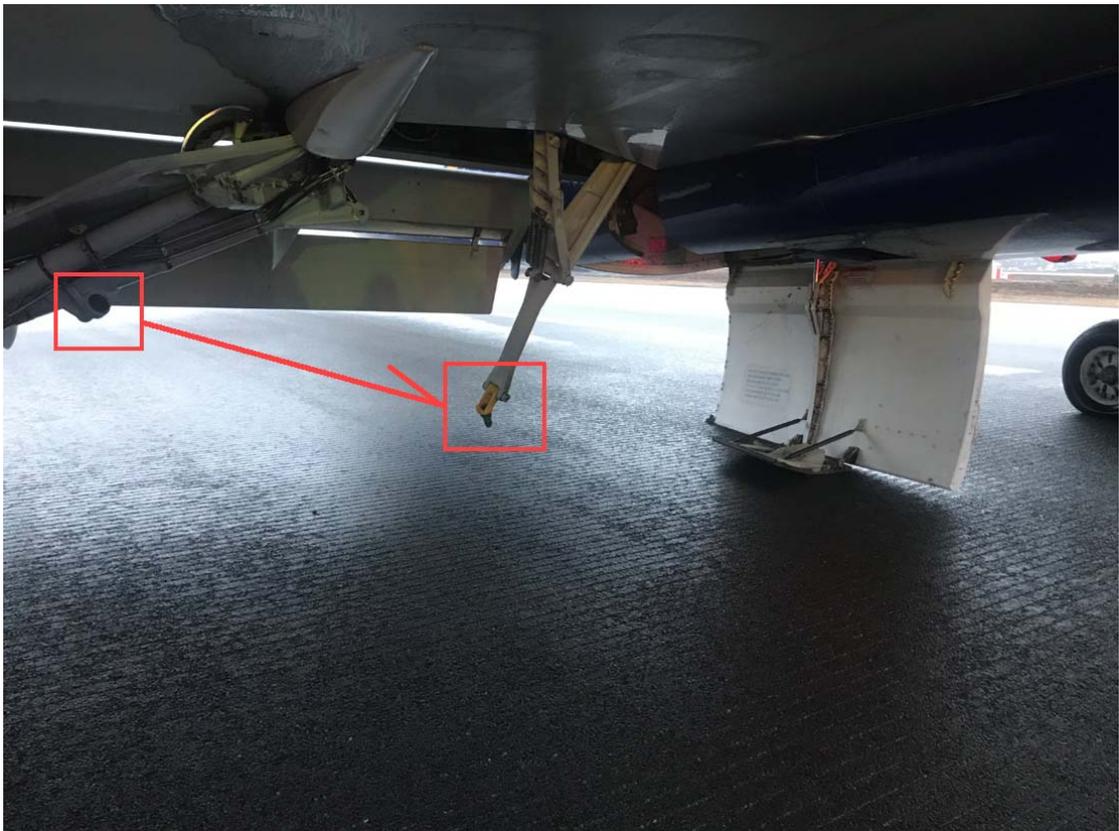
Figure 3: Right Main Landing Gear - Side Strut Swivel disconnected from the Shock Strut

During the ITSB³ on-site investigation it became clear that the NUT used to fasten the SWIVEL in the lug position on the MAIN LANDING GEAR SHOCK STRUT was missing along with its mating WASHER-SPLINED.

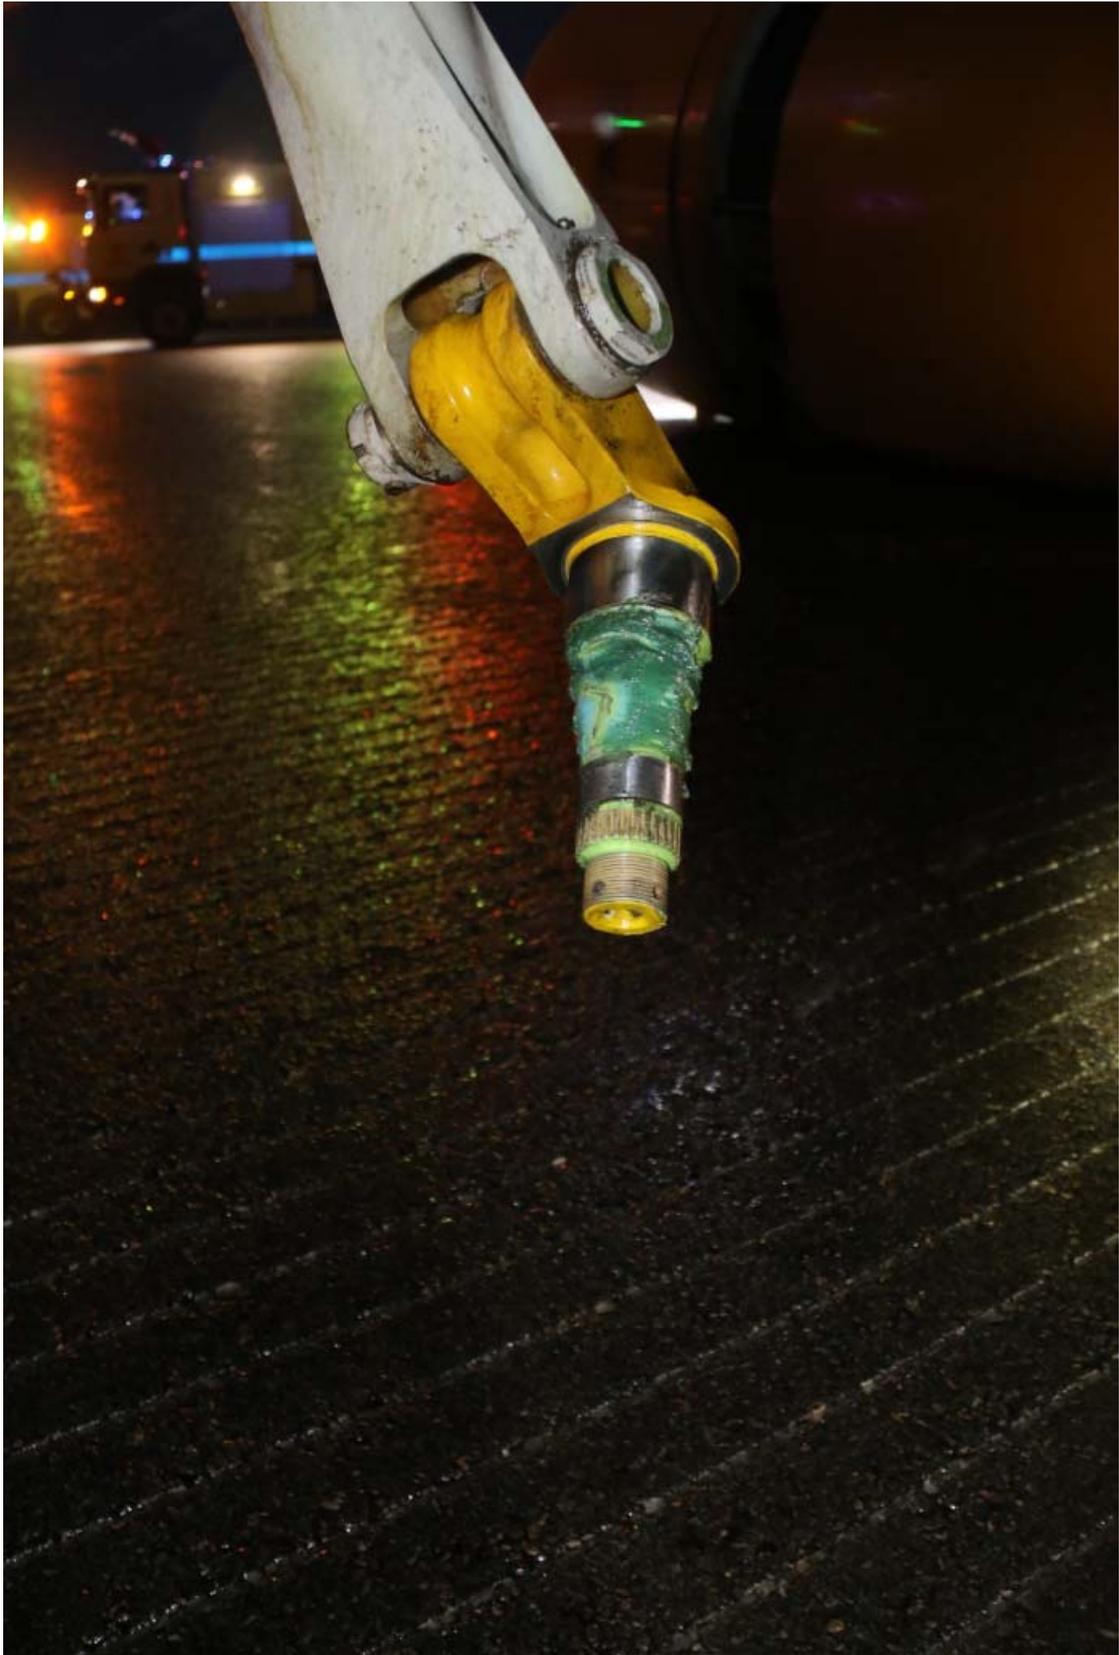
Figure 4: Side Strut Swivel – Missing the Nut and the splined Washer

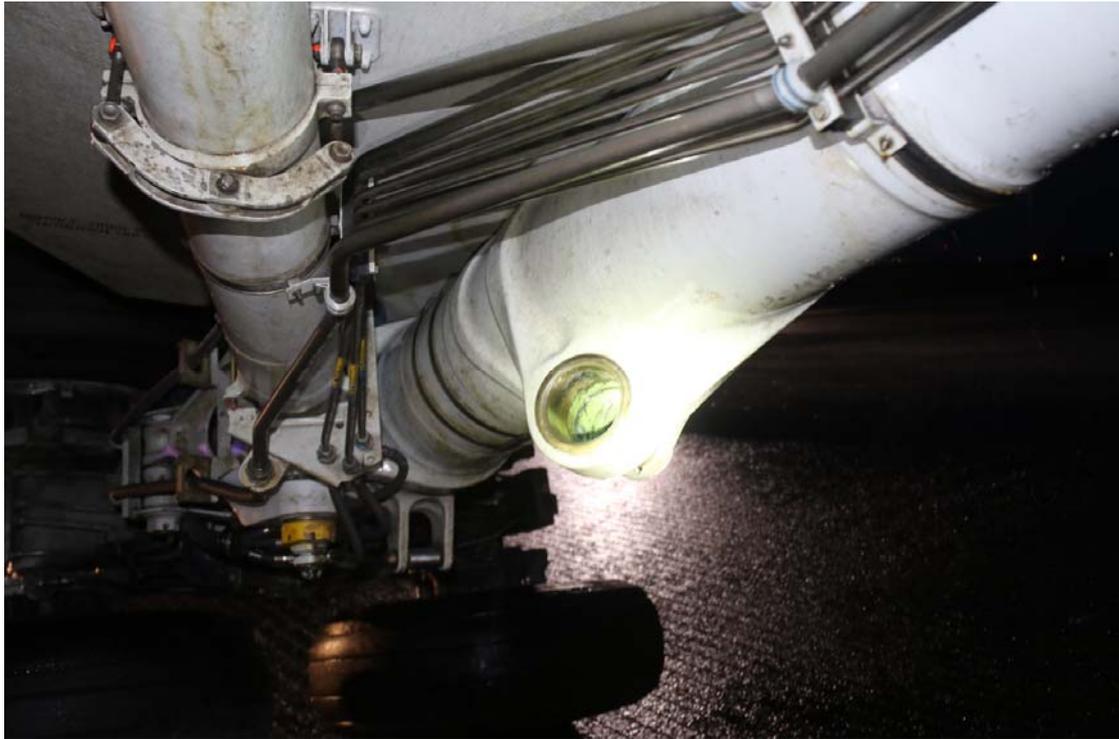
Figure 5: Right Main Landing Gear – Shock Strut lug for Swivel connection found unbroken, but bushing migration observed

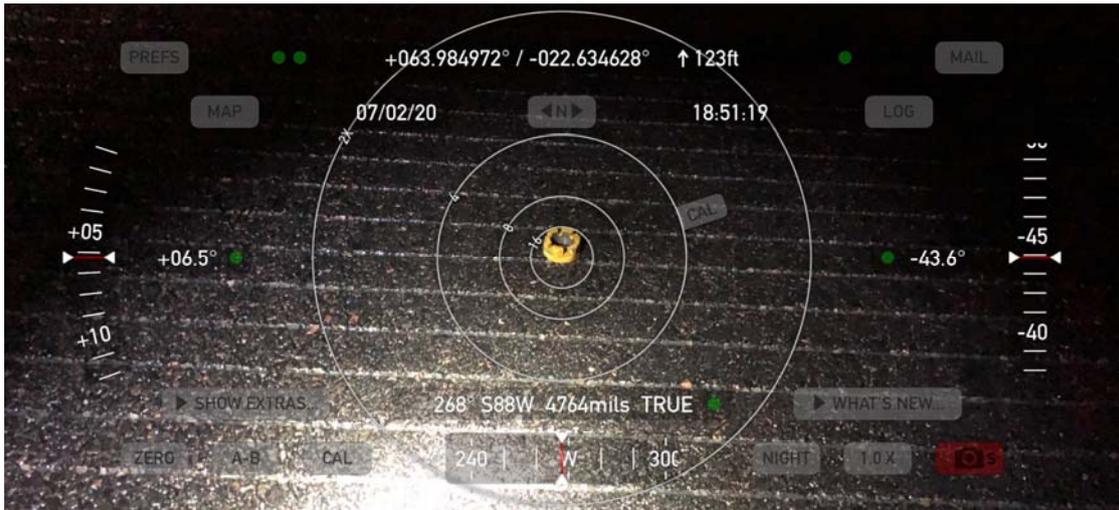
Search of the missing parts revealed the NUT (P/N 161N2515-1 or equivalent) and WASHER-SPLINED (P/N 161N2514-1) in other locations of the runway, close to the touchdown point of the aircraft during landing.

Figure 6: The missing Nut located on RWY 10, close to the touchdown position

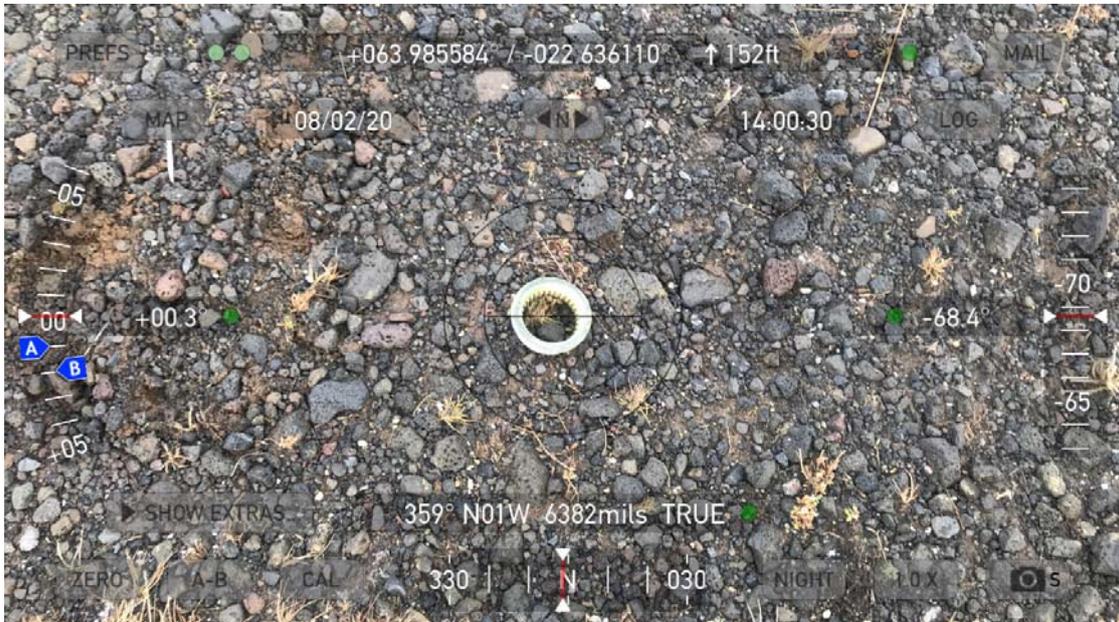
Figure 7: The missing Washer located just outside RWY 10, close to touchdown

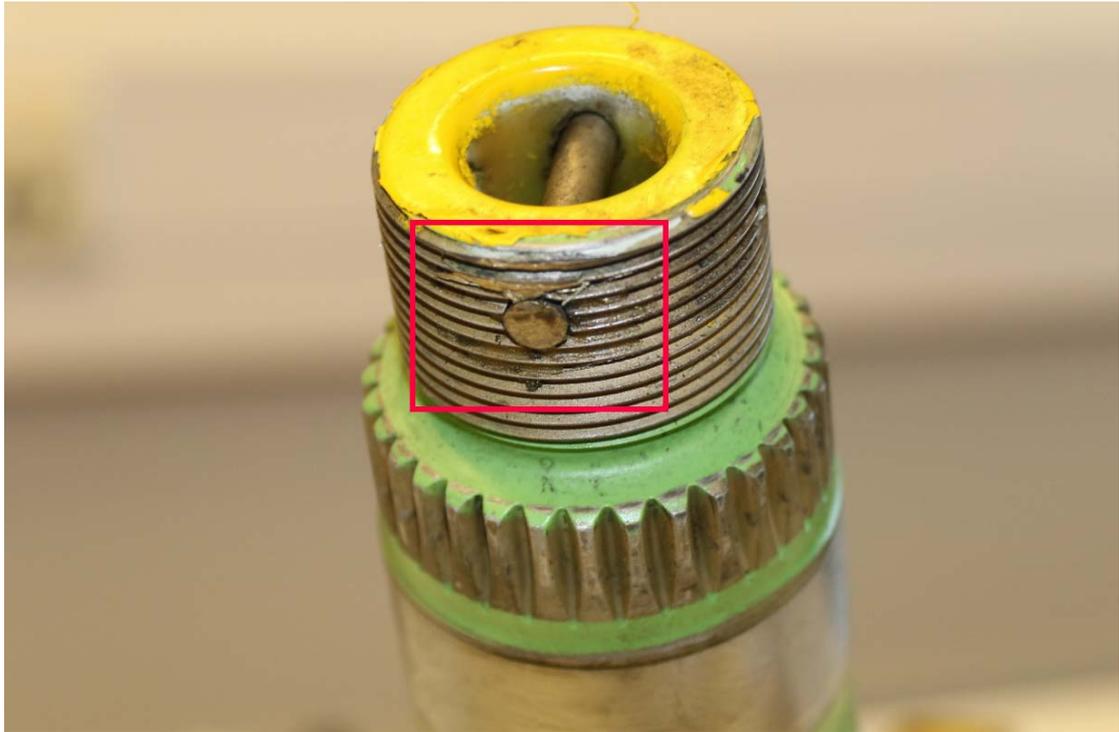
Visual inspection of the SWIVEL revealed only minor damage in one location of the threads.

Figure 8: Swivel threads damage

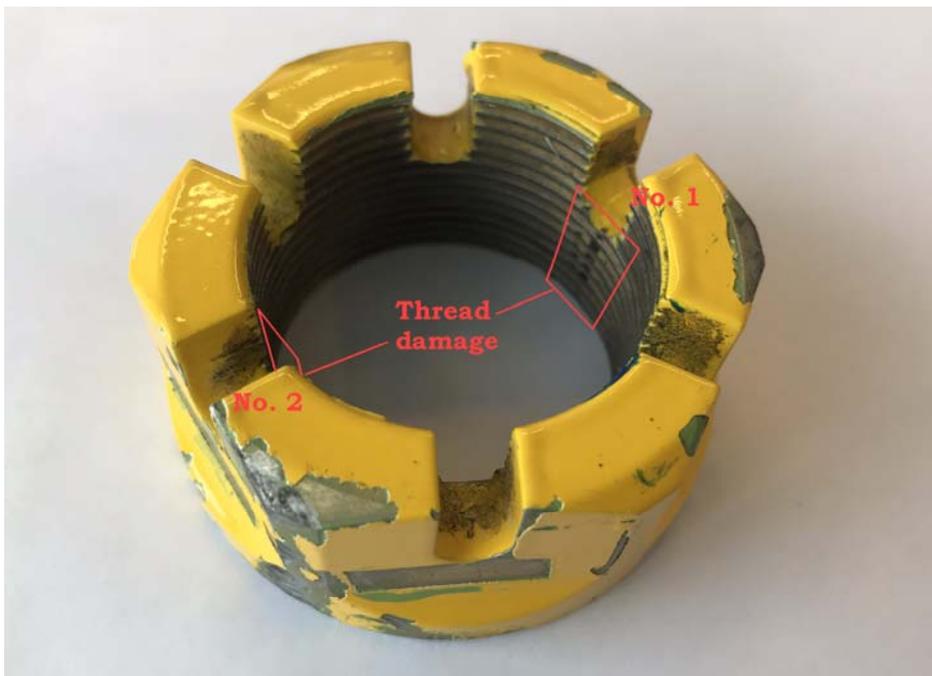
Visual inspection of the NUT revealed only two minor damaged areas on the nut threads, 180° apart and across the threads, most likely caused by the sheared off head and threaded end section of the shank as the NUT came off the SWIVEL.

Figure 9: Thread damage located 180° apart on the NUT

This suggests that the NUT came off the SWIVEL without the NUT turning. This also suggest that the thread sizes of the SWIVEL and the NUT did not match.

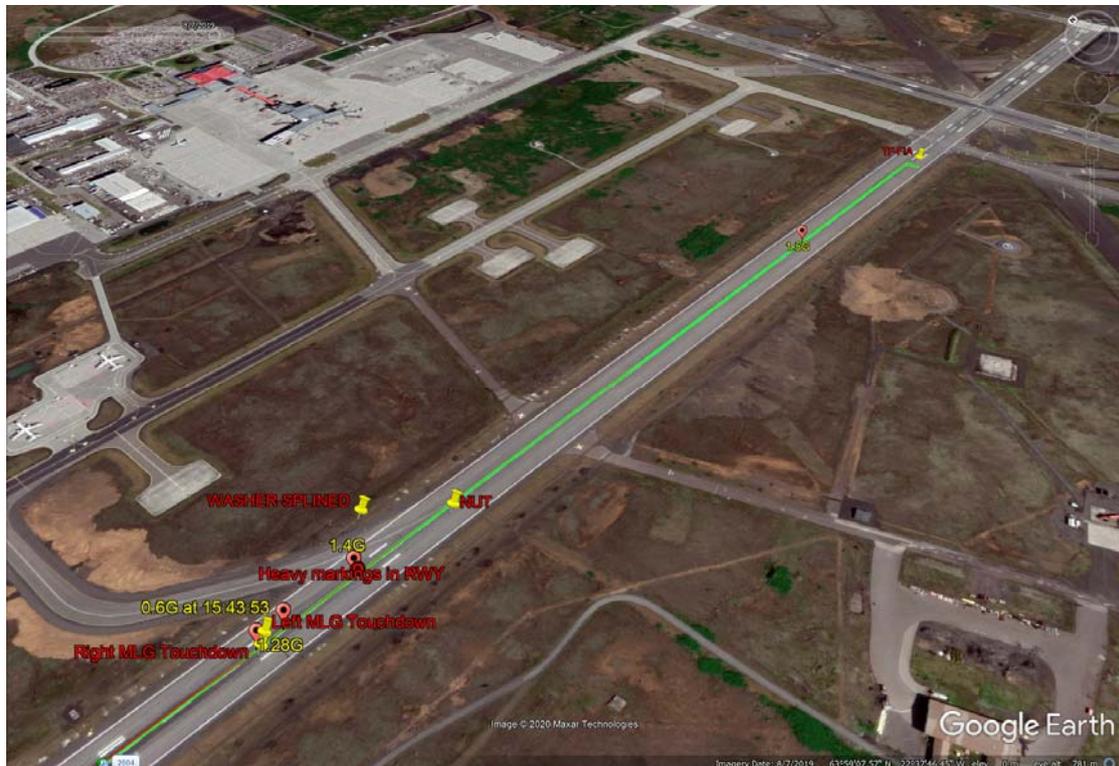
- 15:43:47 De-crab starts few seconds before touch-down
- 15:43:52:25 Right Main Landing Gear touchdown
- 15:43:52:375 1.28G-load max peak
 - Followed by a slight roll to the left
 - Which was corrected by right control wheel input
- 15:43:52:50 Left Main Landing Gear touchdown
 - Aircraft in Ground mode
- 15:43:52:875 Spoilers deploy
- 15:43:53:00 0.6G-load min peak
 - **Right Main Landing Gear Failure**
 - Aircraft goes to Air mode momentarily and then back to ground mode
 - This was followed by a roll to the right, as the right landing gear collapsed
- 15:43:54:25 Nose Landing Gear momentary touchdown
- 15:43:54:50 1.4G-load max peak
 - The roll to the right stopped
 - The right engine hit the runway
 - This was followed by left control wheel input
- 15:43:54:875 The spoilers have retracted
- 15:43:55:25 The aircraft goes back to Air mode

- 15:43:55:50 The aircraft nose pitches up to 4.6°
- 15:43:57:00 The aircraft wings are in level position
 - Followed by the aircraft rolling to the left
 - Which was followed by right control wheel input
- 15:43:58:75 The airplane goes back to ground mode
- 15:44:00:75 The aircraft wings are in level position again
 - Pilot Flying managed to keep the airplane wing level for about 12 seconds with the Right Main Landing Gear collapsed while the airplane slowed down
- 15:44:01:75 Nose Landing Gear touchdown again
- 15:44:11 Right roll of the aircraft as the right wing sunk down
 - The Pilot Flying could no longer maintain the aircraft level
- 15:44:12:125 1.5G-load max peak
 - The right engine hit the runway again
- 15:44:59 The airplane came to rest on RWY 10

Figure 12: Significant points of the landing

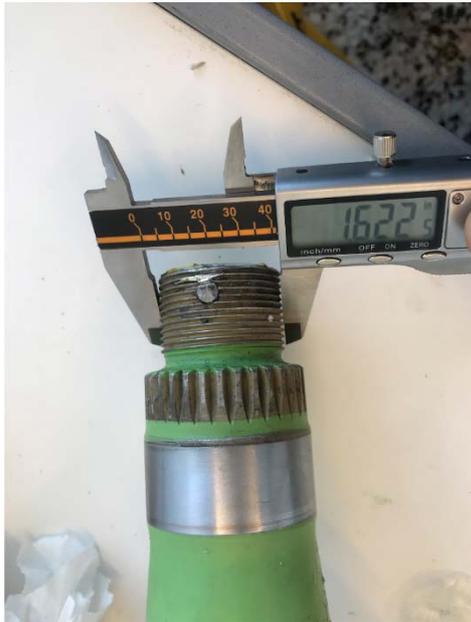
**Figure 13: Swivel threads measured
(Major Diameter)**

The SWIVEL threads were undersized 1/16 inch during an overhaul in December 2008. The SWIVEL threads were then undersized again during an overhaul in November 2019, bringing it to 1/8 inch undersize.

This brought the Major Diameter of the SWIVEL threads down to 1.6241 inch per the overhaul documents. Per Boeing CMM 32-11-72, Repair 4-3, such an undersize was allowed but required a special 1/8 undersized NUT to be fabricated and used.

Initial measurements by the ITSB after the accident has shown the Major Diameter of the SWIVEL threads to be 1.622 inch (Figure 13).

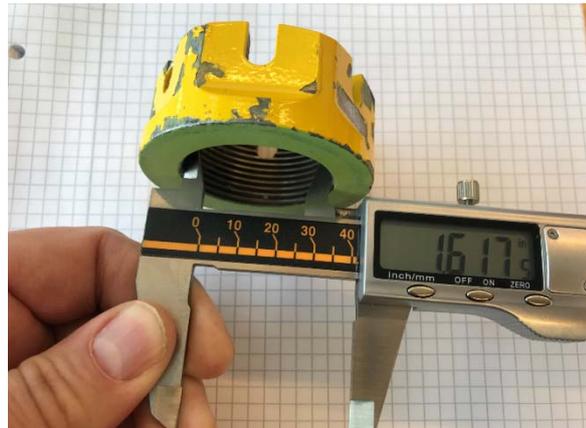
**Figure 14: Nut threads measured
(Minor Diameter)**

For 1/8 inch undersize, the Minor Diameter of the NUT was required to be in the range of 1.5439 to 1.5539 inch.

Initial measurements by the ITSB after the accident has shown the Minor Diameter of the NUT threads to be 1.617 inch (Figure 14).

The preliminary investigation therefore indicates the NUT to be too large for the 1/8 inch undersized SWIVEL threads.

1. Inspect the landing gears. If the landing gears contain fastening component and a mating part of painted yellow color, then inspect the landing gear overhaul records to verify that the parts have been undersized.
2. If the landing gear overhaul records indicate that the parts have been undersized by Landing Gear Technologies, jack up the airplane per the Aircraft Maintenance Manual instructions, disassemble the undersized parts and measure the threaded portion of the undersized parts to verify that their sizes are mating and per the relevant Component Maintenance Manual (CMM) for undersize parts.
3. If, the undersized parts sizes are as required per the CMM, re-assemble per the relevant CMM instructions. Otherwise take the necessary maintenance action to replace with the required parts.
