Final report on aircraft serious incident

Case no.: **19-082F020**

Description: **A loss of engine power, resulting in an emergency landing**

Aircraft	
Type:	Cessna 207
Register:	TF-MAJ
Year of manufacture:	1978
Serial number:	0479
CoA:	Valid
Engines:	Continental IO-520F13B of S/N 1012306

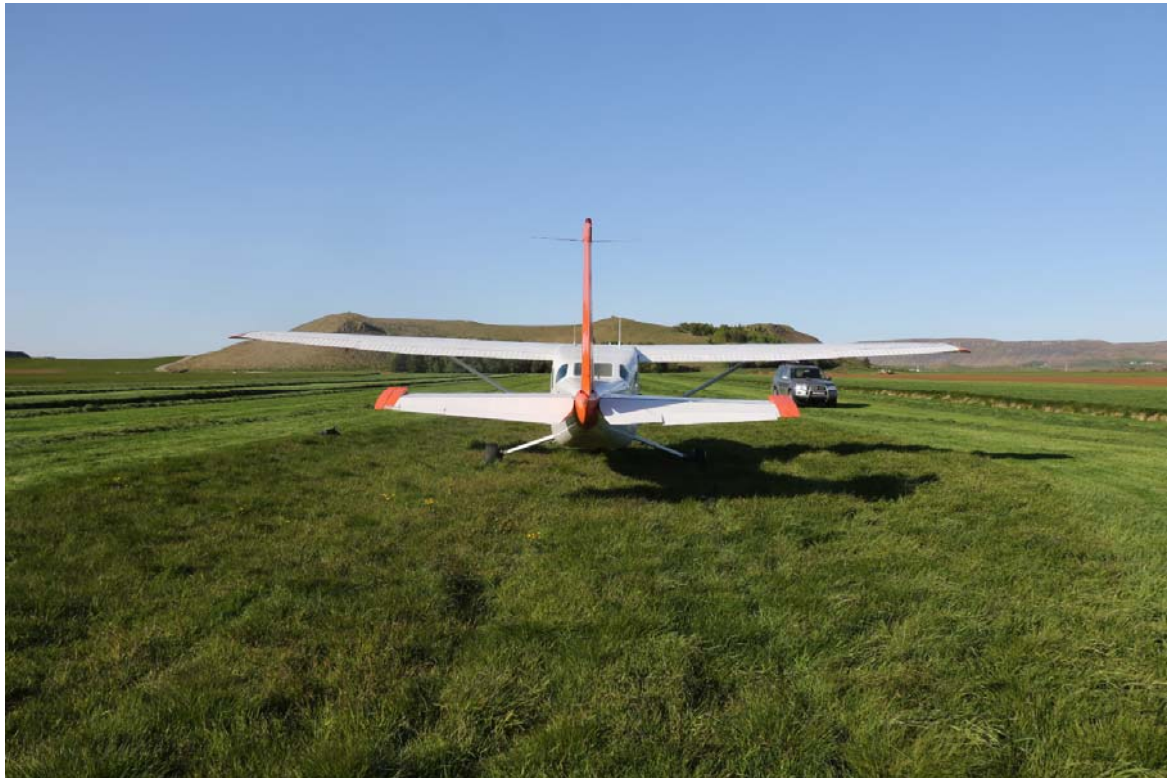
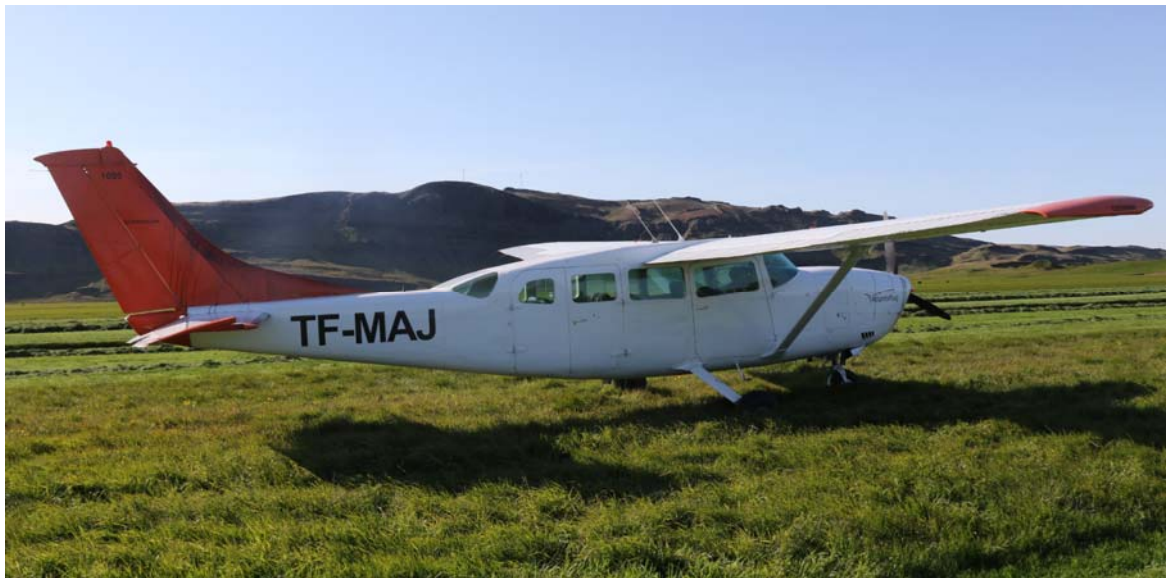
Figure 1: Airplane TF-MAJ (rear and side view) at the landing site at Birtingarholt

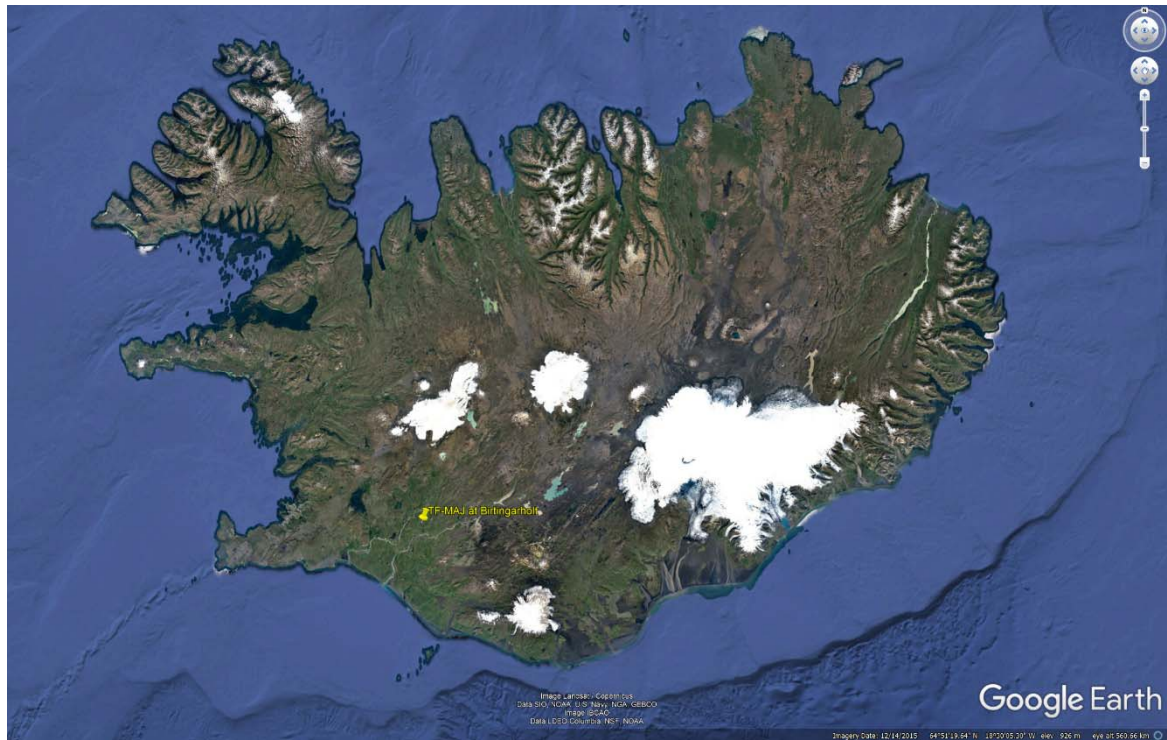
Figure 2: TF-MAJ at Birtingarholt in Iceland

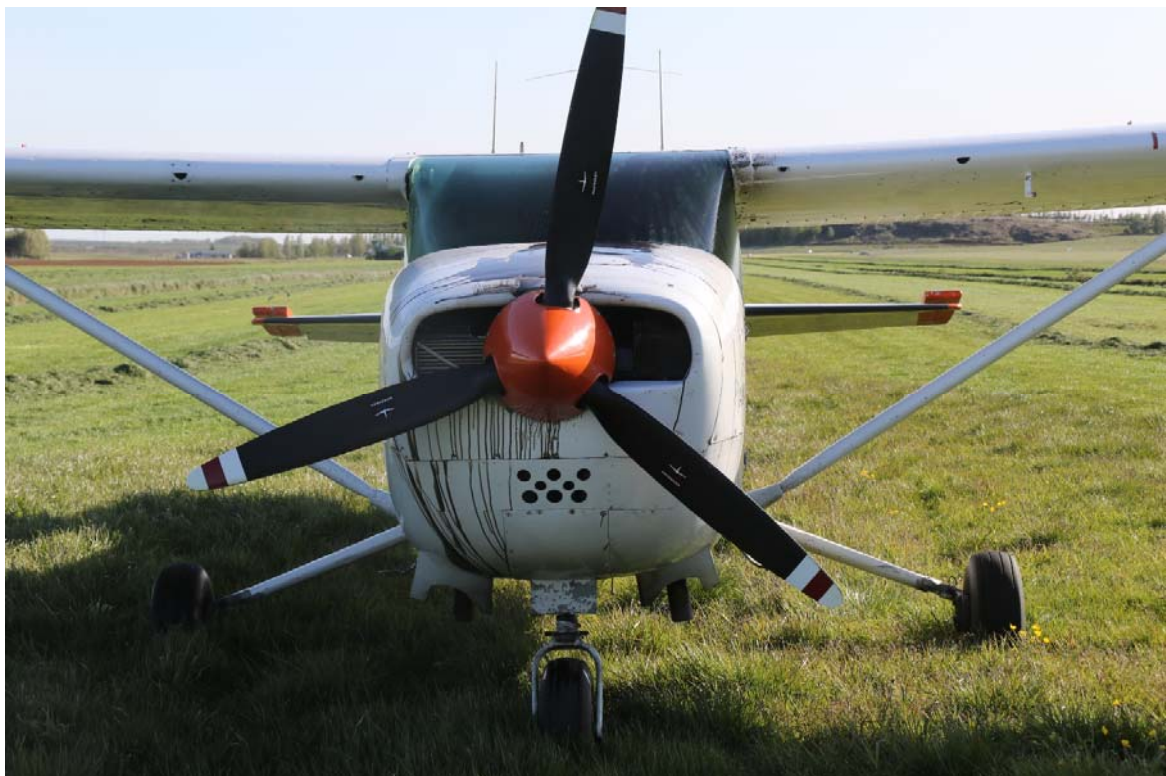
The airplane vibrated and blue colored smoke exited the engine cowling. The engine oil check hatch blew open and engine oil sprayed from the engine compartment.

At an altitude of approximately 3000 feet, the pilot had lost most of the forward vision due to oil being sprayed onto the forward windshield. He therefore had to rely on the side windows during the landing.

Figure 3: TF-MAJ oil leak blocked forward window vision

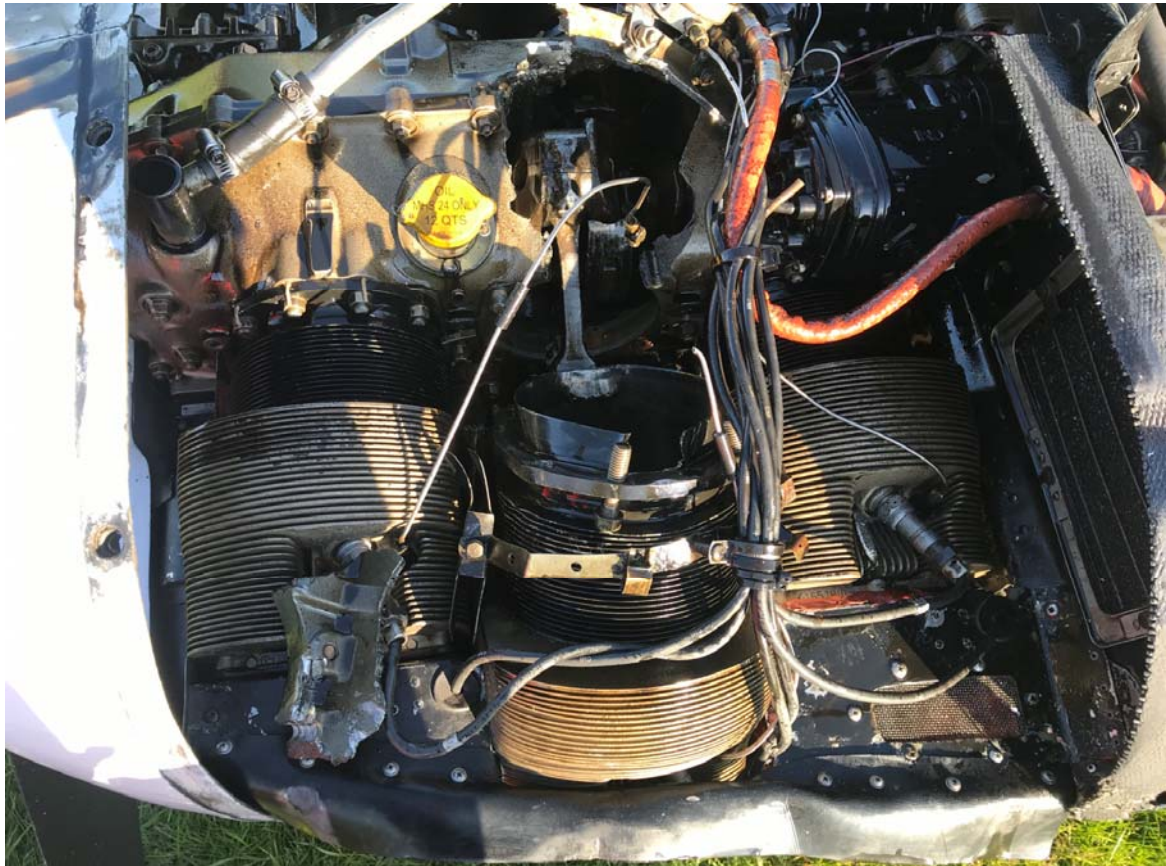
Figure 4: Opening of the engine cowling revealed catastrophic damage to the engine

The on-site inspection of the engine revealed a catastrophic damage to the engine with one cylinder being pushed off its base and a large piece of the crankcase broke off.

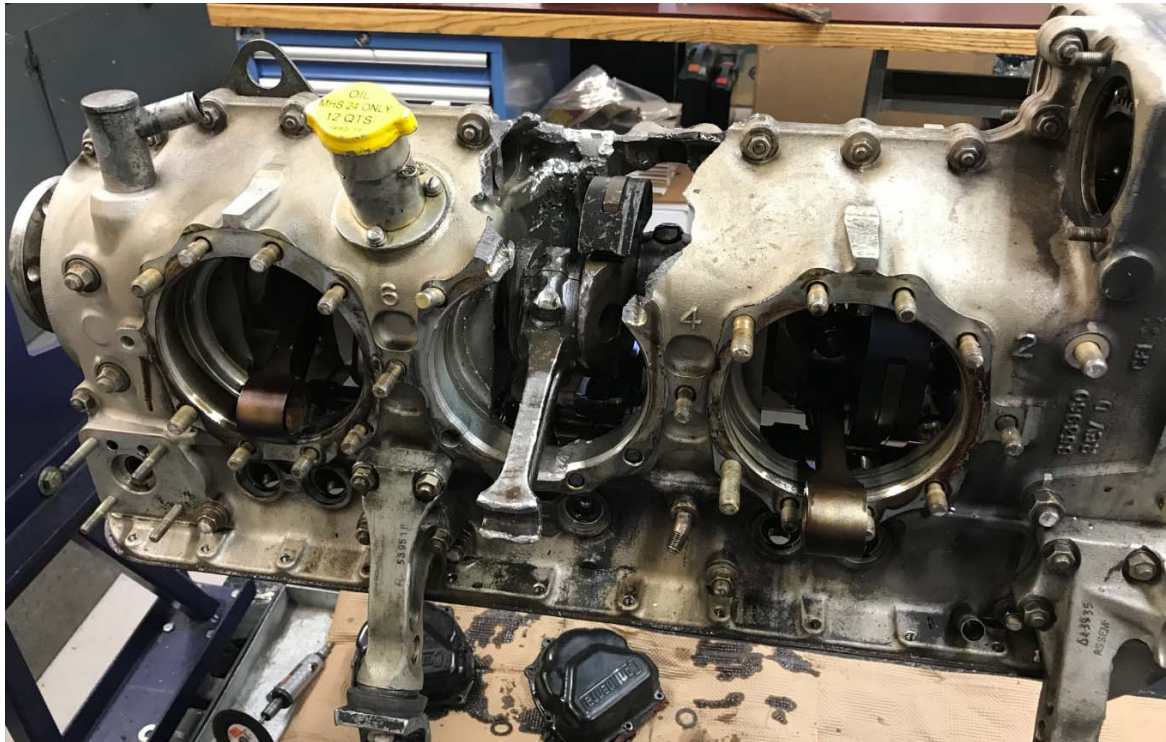
Figure 5: Engine S/N1012306 after the cylinders had been removed

Other damage to the engine was suspected to be secondary damage caused by connecting rod no. 4 failure.

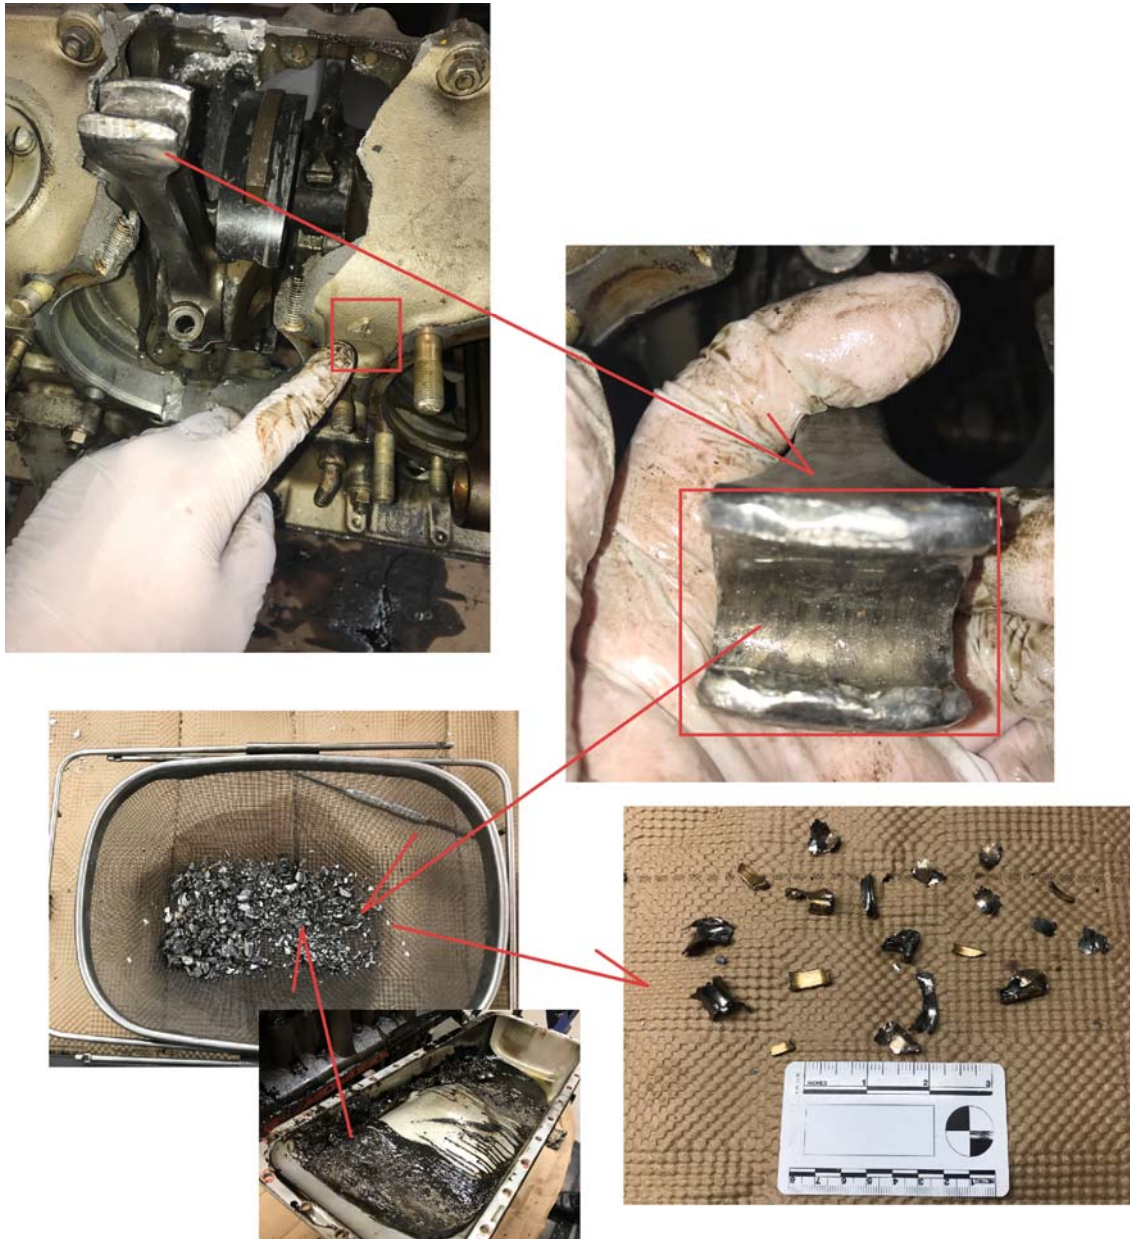
- Connecting rod no. 4 (S/N AE15DA612) failed due to complete connecting rod small end bushing migration and piston pin leaving its seat (see Figure 7)
- Connecting rod no. 3 (S/N AE15DA680) had incurred small end bushing migration, small end bushing turning and small end bushing damage (see Figure 8)
- Connecting rod no. 6 (S/N AE15DA666) had incurred small end bushing migration, small bushing turning and small end bushing damage (see Figure 9)

Figure 7: Connecting rod no. 4 (S/N AE15DA612)

– Small end bushing fragments located in oil sump

Take the necessary quality assurance steps to ensure that connecting rod and the small end bushings conform to the required specifications and standards.

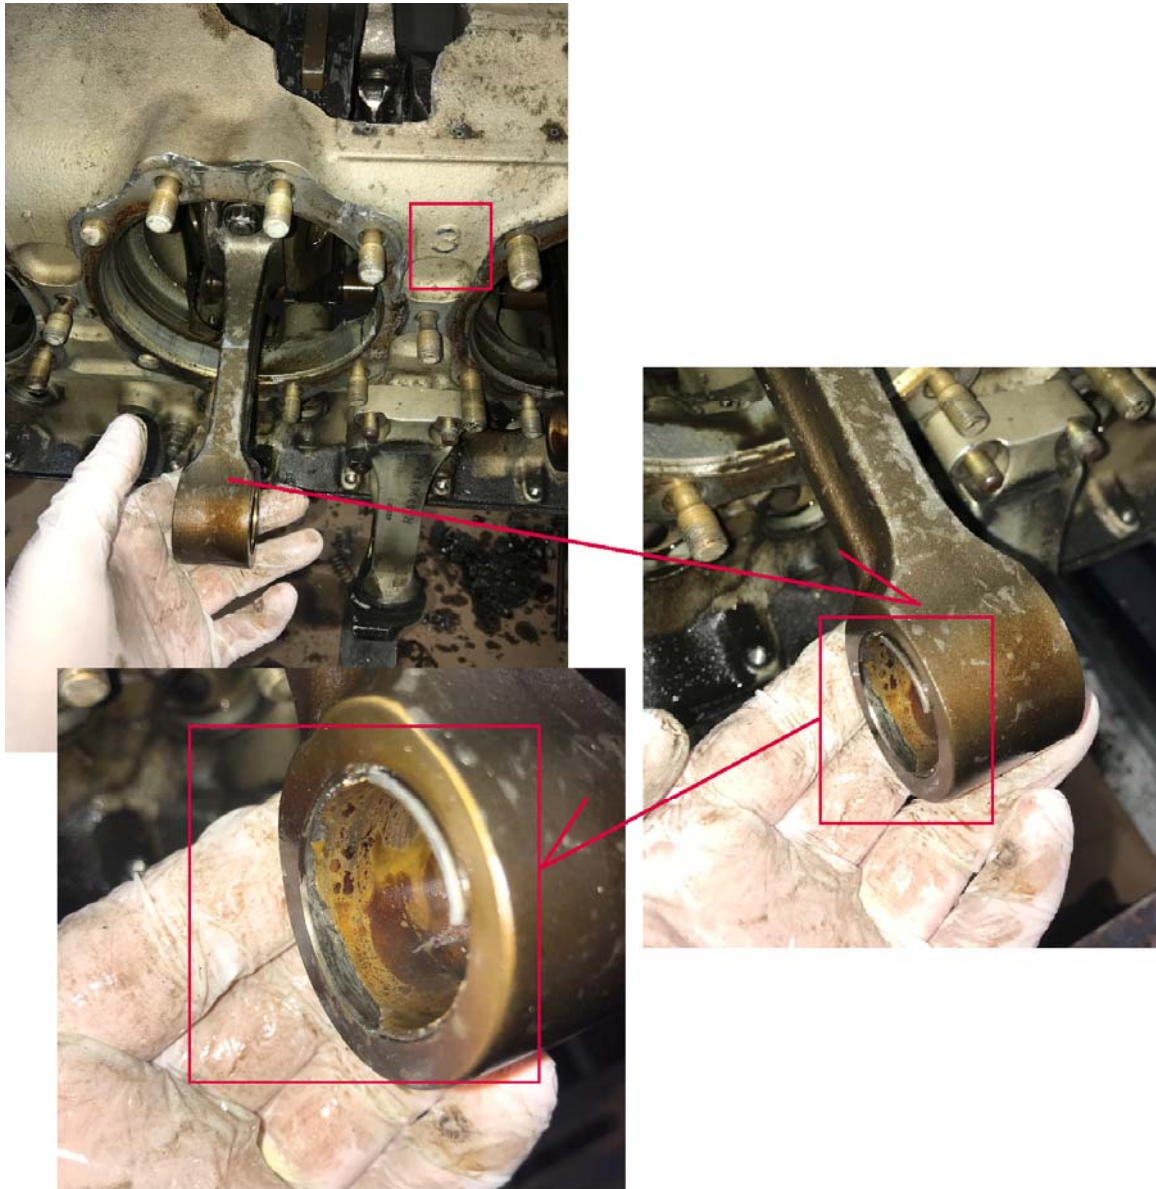
Figure 8: Connecting rod no. 3 (S/N AE15DA680)
– Small end bushing migration and damage

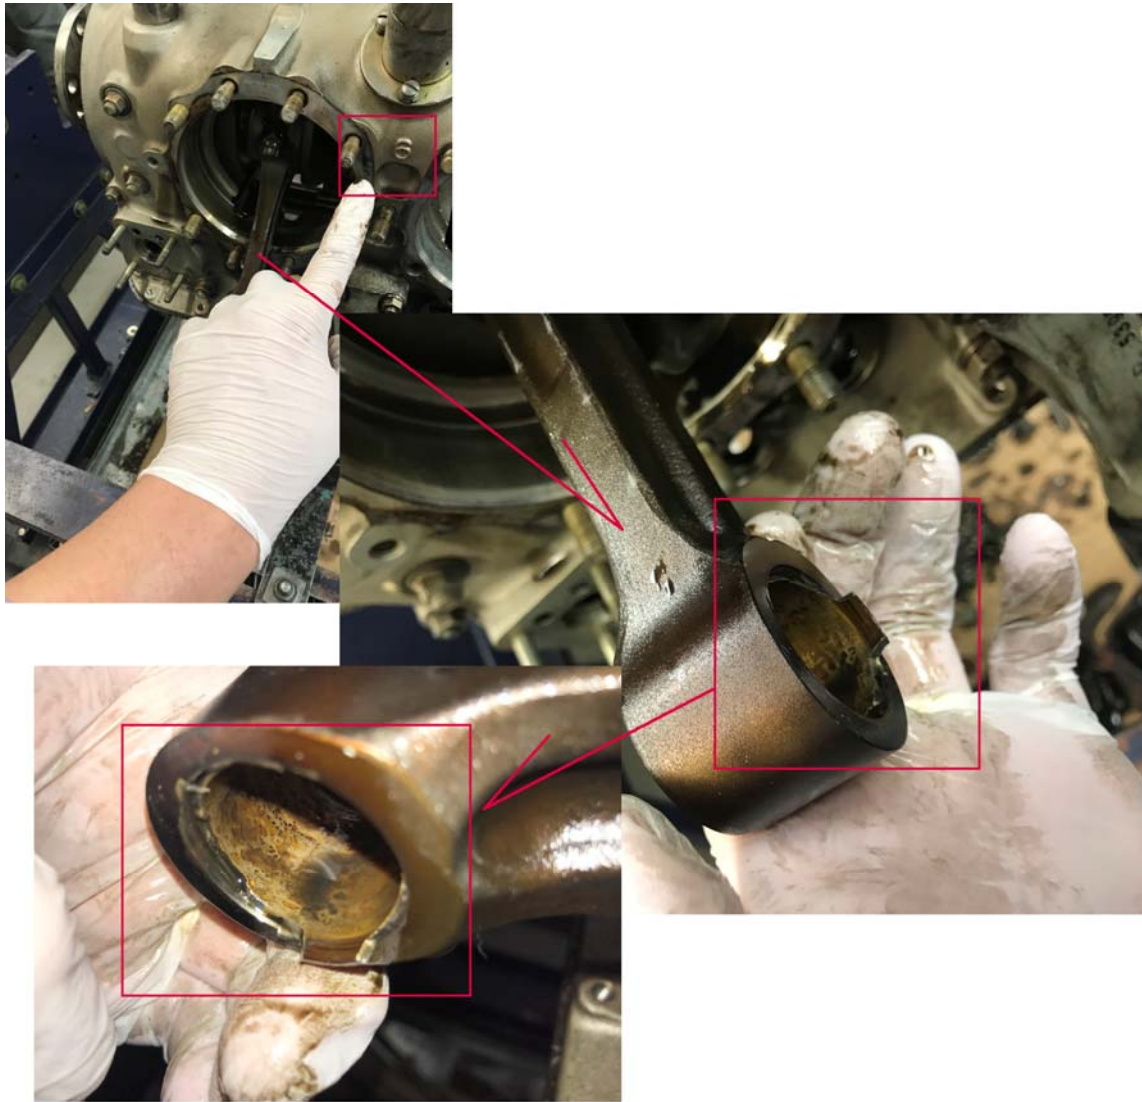
Figure 9: Connecting rod no. 6 (S/N AE15DA666)
– Small end bushing migration and damage
