Final report on aircraft serious incident

Case no.: **19-158F043**

Location: **Keflavik Airport (BIKF)**

Description: **Runway Excursion**

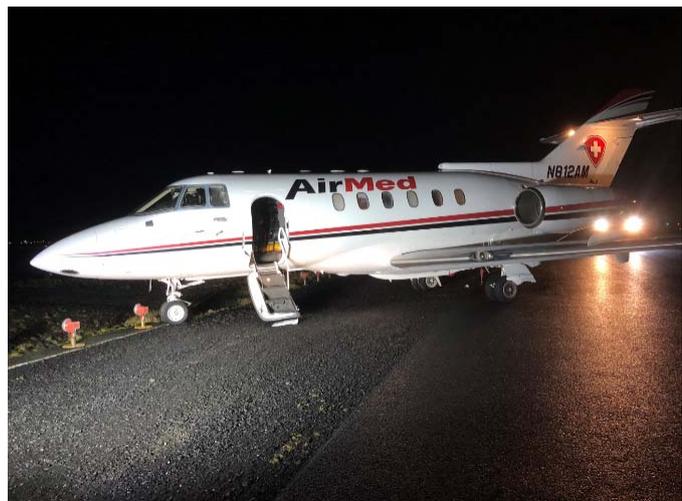
Aircraft N812AM slid off the end of RWY 01, after having only been able to turn partially towards taxiway N.

Figure 1: Aircraft N812AM runway excursion

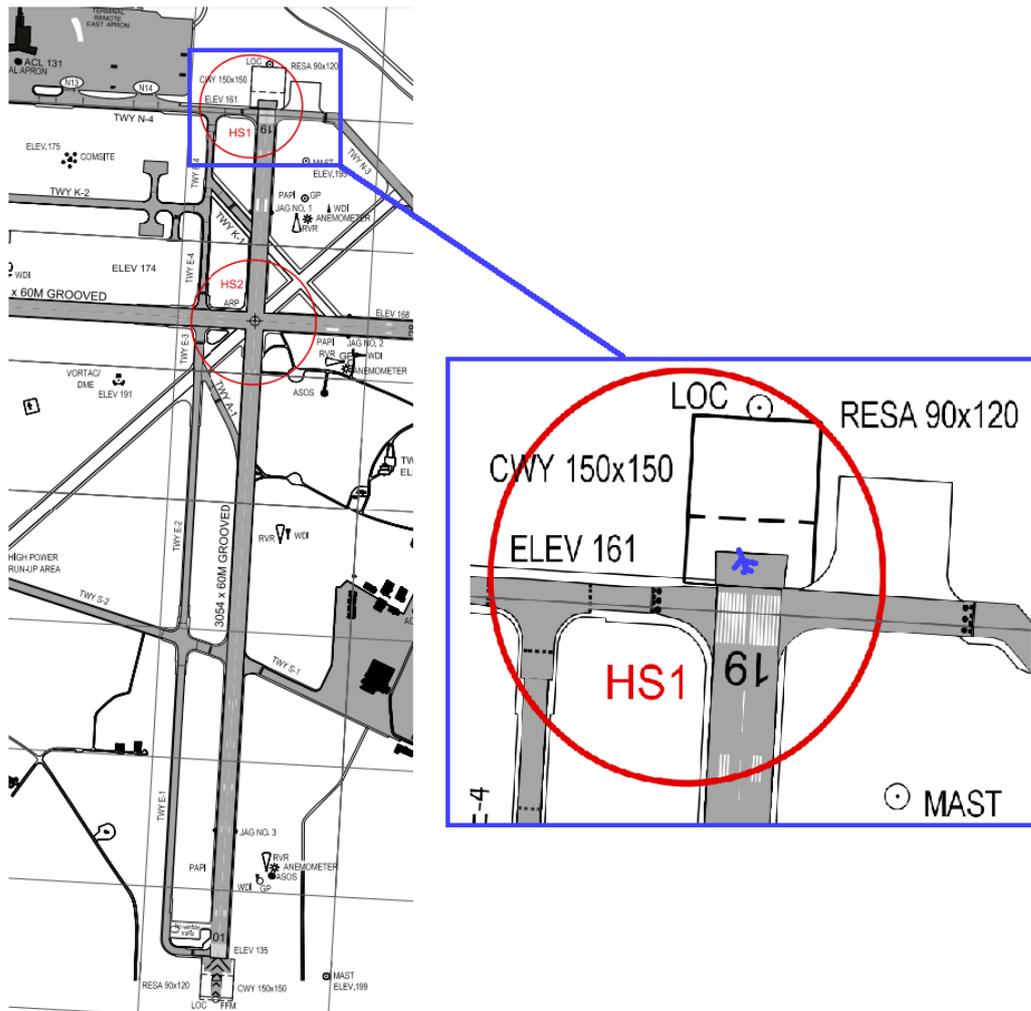
Once the aircraft entered the threshold lines for RWY 19, the aircraft started braking. The aircraft skidded off the runway and entered the safety area at the edge of the runway before stopping.

After exiting the aircraft one of the aircraft crewmembers fell on the paved safety zone area due to its icy condition. The crewmember that fell on the paved safety zone was not injured during the event.

Figure 2: N812AM Runway excursion off the far end of RWY 01 and into the safety zone

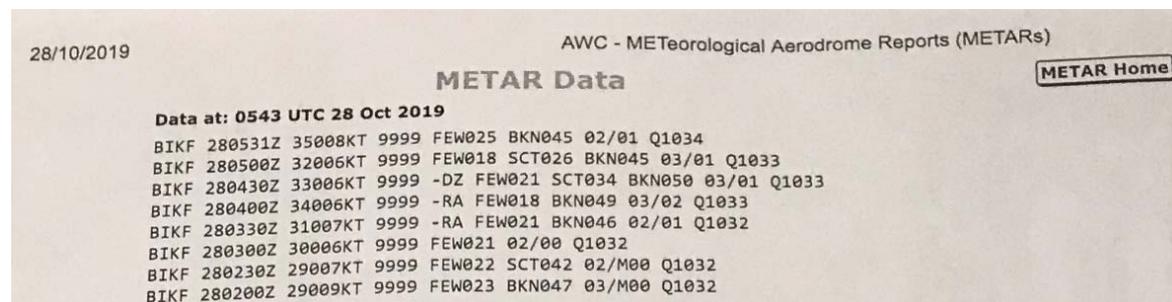
The investigation revealed that the airport operator, Isavia, had experienced difficulties maintaining good runway braking action that night. It had rained between 3:30AM and 4:30AM, but due to low temperature and frozen ground, the rain froze on the runway.

Figure 3: METAR at Keflavik Airport between 2:00AM and 5:31AM

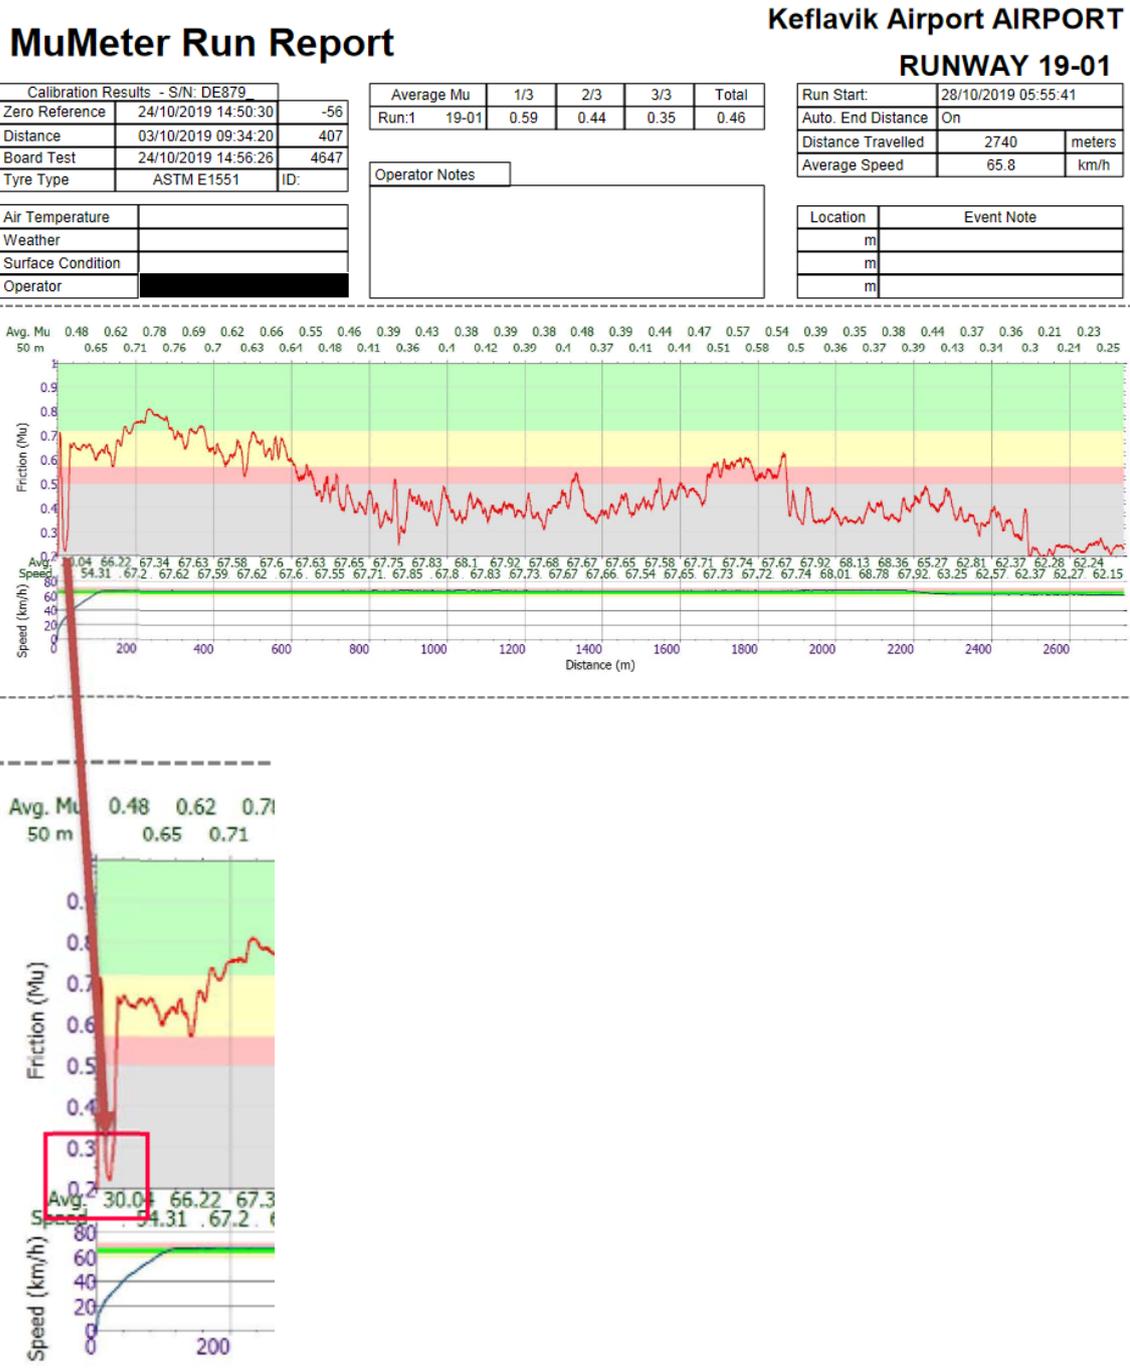
Although the overall runway condition of RWY 01 had become acceptable before the landing of aircraft N812AM at 06:03, a close scrutiny of the braking action measurement taken at 05:55 reveals at the end of the runway, at the RWY 19 threshold, the braking action coefficient went down to 0.22 (See Figure 4).

Figure 4: Braking action measurement taken at 05:55 on RWY 19-01

Per ICAO Annex 14, 0.25 and below is poor braking action.

The ITSB believes the cause of the runway excursion, of aircraft N812AM, to be poor RWY condition at the far end of the runway (as per Figure 4).

During braking action measurement, if abnormally worse braking actions are measured at the runway ends that do not concur with the average 1/3 runway value being measured, pilots should be notified.

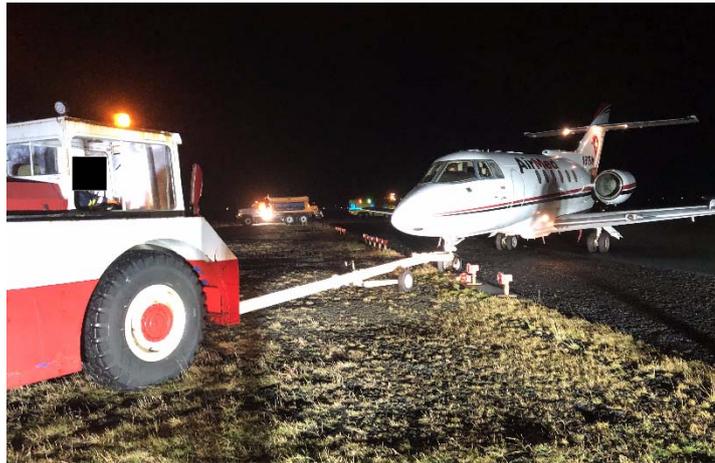
Figure 6: Airplane N812AM being moved at 06:46

As Isavia did not report the serious incident, until the runway excursion site had been disturbed, and aircraft N812AM was already being moved from the site, the on-site evidence had already been destroyed. Therefore it was not possible for the ITSB to perform on-site investigation of the serious incident site.
