### Final report on aircraft serious incident

Case no.: **17-018F005**

Date: **23. February 2017**

Description: **Declaration of an emergency due to low fuel**

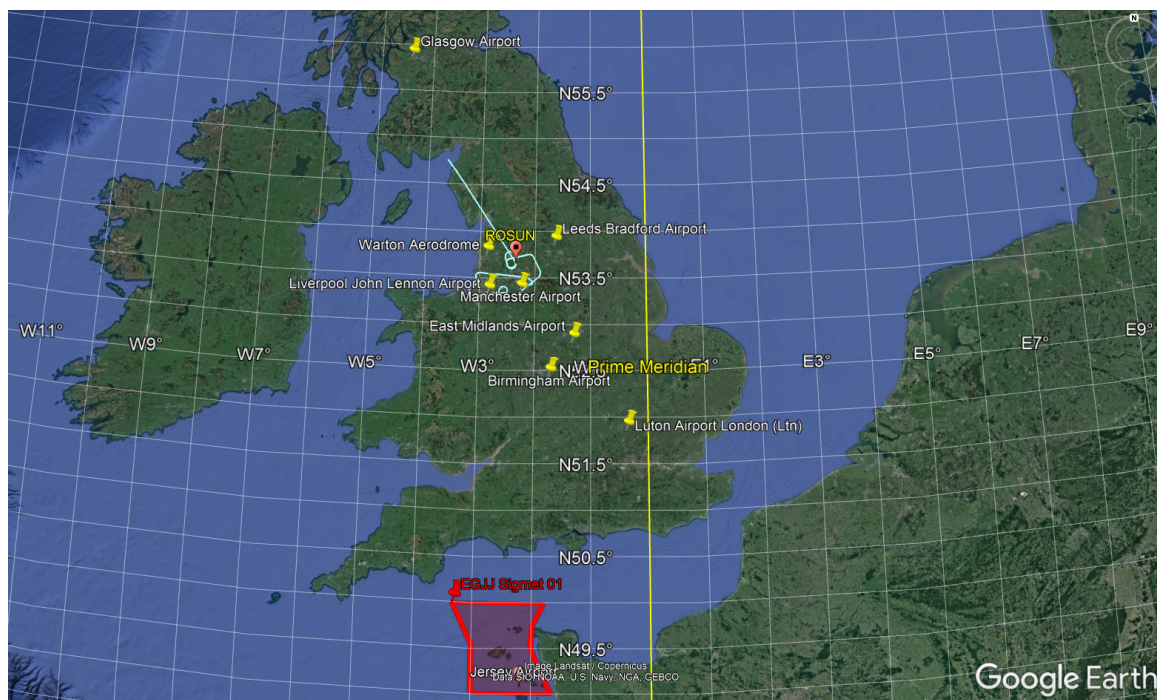
**Figure 9: EGJJ SIGMET 01 – Severe turbulence forecasted within the (red) area**

EGJJ SIGMET 01, issued for EGJJ (Channel Islands), was valid from 06:00Z to 10:00Z on the day of the serious incident. It forecasted severe turbulence from the surface and up to 3000 feet. It also stated that the severe turbulence was intensifying.

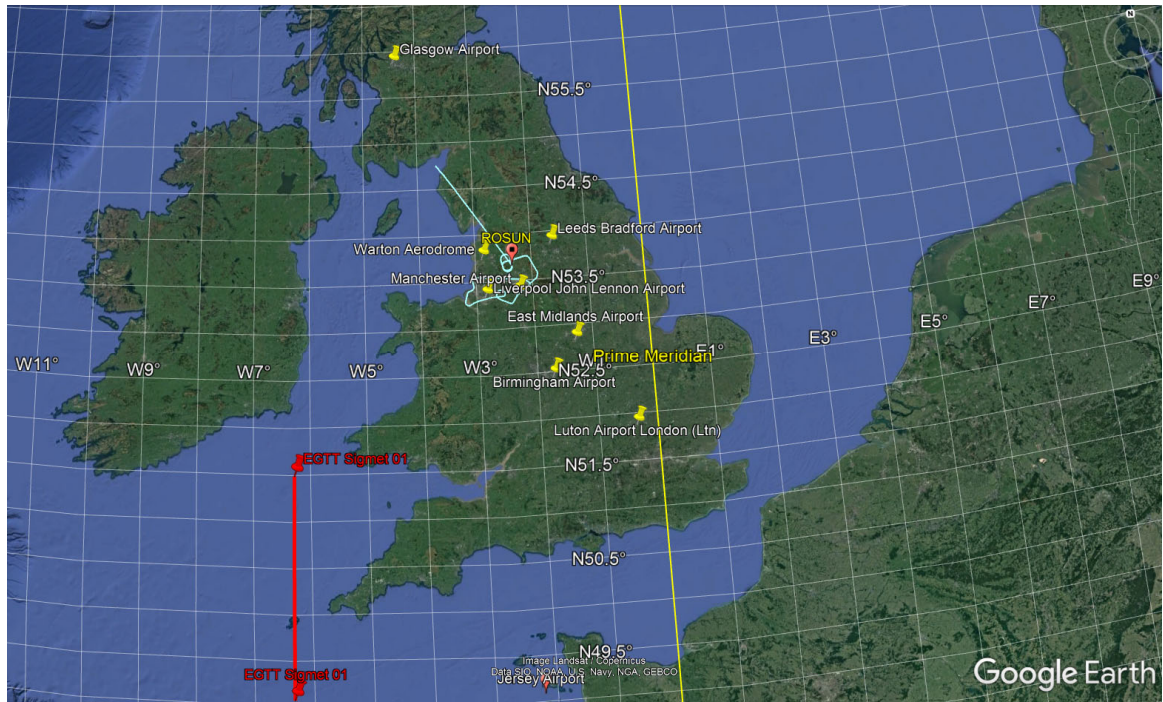
**Figure 10: EGTT SIGMET 01 – Severe turbulence forecasted west of the (red) line**

EGTT SIGMET 01, issued for EGTT (London Area Control), was valid from 03:00Z to 07:00Z on the day of the serious incident. It forecasted severe turbulence west of the line (see red line in Figure 10), from the surface and up to FL060. It also stated that the severe turbulence was moving east-north-east at a speed of 30 knots and it was intensifying.

The three SIGMETs in the flight plan, particularly EGTT SIGMET 01 as it was intensifying and moving east-north-east towards the destination airport, warranted a close scrutiny at both the fuel planning as well as the selection of an alternate airport.

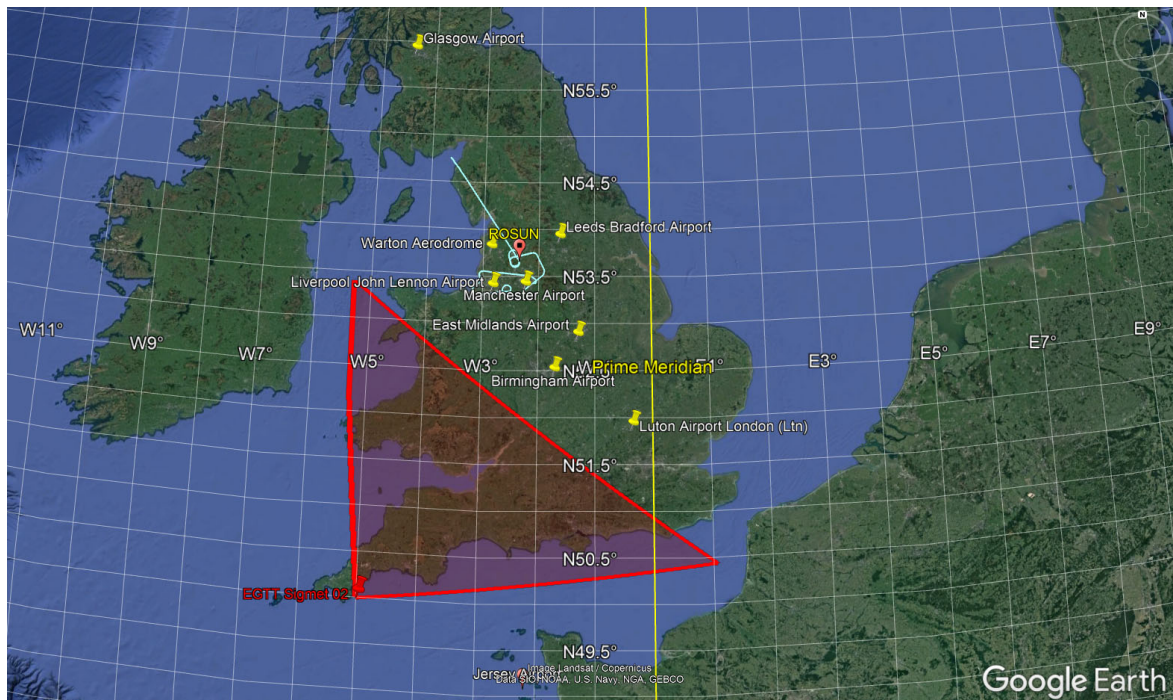
**Figure 11: EGTT SIGMET 02 – Severe mountain waves forecasted within the (red) area**

EGTT SIGMET 02, issued for EGTT (London Area Control), was valid from 03:00Z to 07:00Z on the day of the serious incident. It forecasted severe mountain waves within the area between FL040 to FL260. It also stated that the effective area was moving east-north-east at a speed of 10 knots.

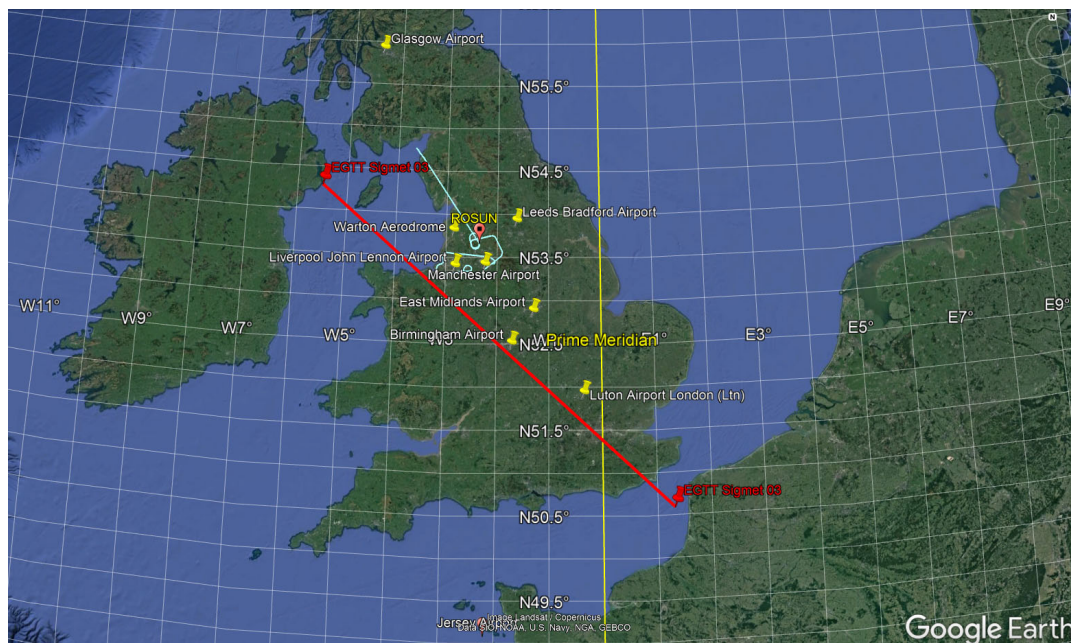
**Figure 12: EGTT SIGMET 03 – Severe turbulence forecasted southwest of the (red) line**

EGTT SIGMET 03, issued for EGTT (London Area Control), was valid from 07:00Z to 11:00Z on the day of the serious incident. It forecasted severe turbulence southwest of the line from the surface and up to FL060. It also stated that the severe turbulence was moving east at a speed of 30 knots and it was intensifying.

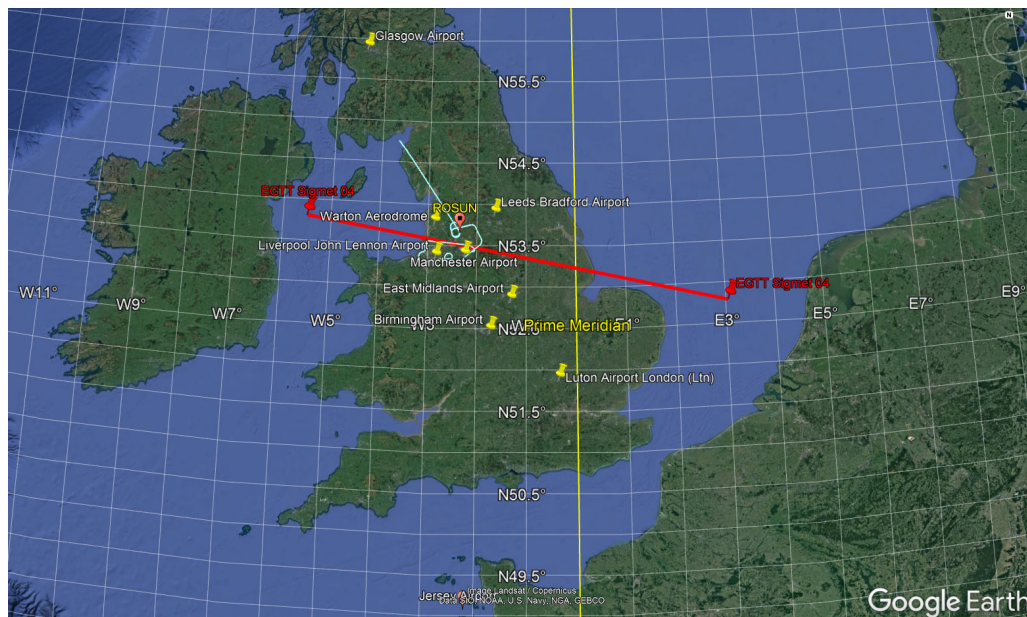
**Figure 13: EGTT SIGMET 04 – Severe mountain waves forecasted south of the (red) line**

EGTT SIGMET 04, issued for EGTT (London Area Control), was valid from 07:00Z to 11:00Z on the day of the serious incident. It forecasted severe mountain waves south of the line between FL040 to FL260.

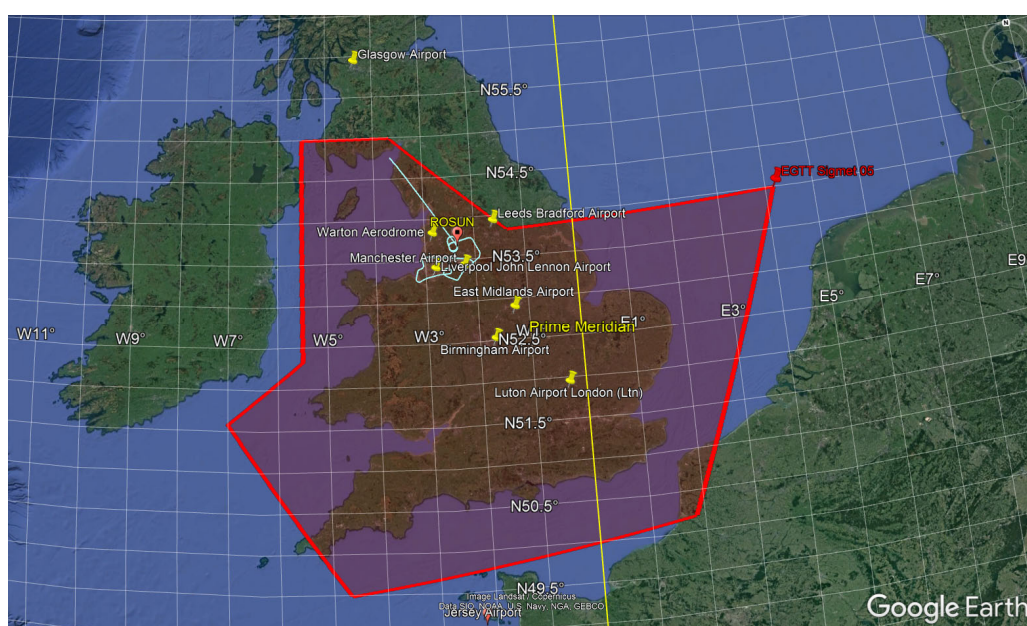
**Figure 14: EGTT SIGMET 05 – Severe turbulence forecasted within the (red) area**

EGTT SIGMET 05, issued for EGTT (London Area Control), was valid from 11:00Z to 15:00Z on the day of the serious incident. It forecasted severe turbulence within the area from the surface and up to FL060. It also stated that the severe turbulence was moving east at a speed of 20 knots.

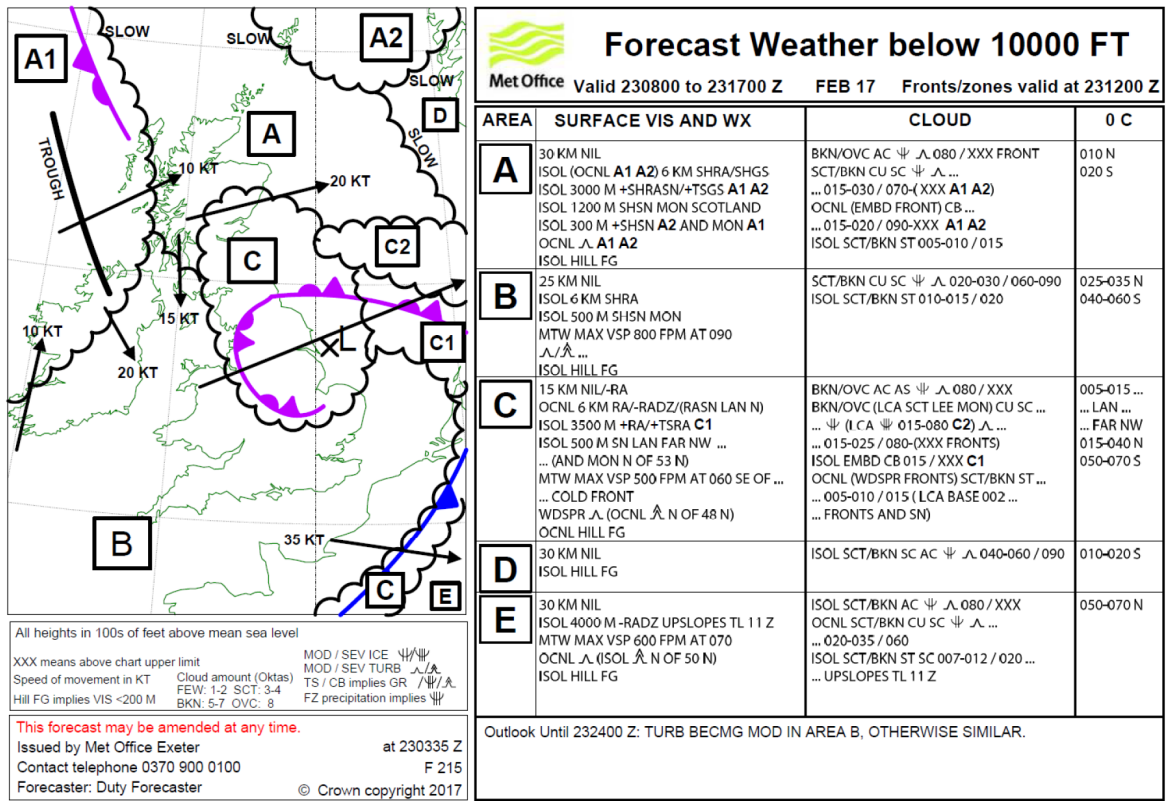
Figure 15: UK MET Office Chart F215 valid between 0800 and 1700 UTC on Feb 23rd 2017

UK MET Office Chart F215 (see Figure 15) was valid between 0800 UTC and 1700 UTC on 23rd February 2017. Zone C was located over the area of Northern England, where the fuel emergency occurred, with area B approaching from the west.

The chart suggested thick frontal clouds in zone C, with bases generally in the 500-1000FT range, but as low as 200FT on the fronts themselves. Occasional rain was forecasted in the area as well.
