Case: **21-001F001**

Location: **Taxiway Bravo at Keflavik Airport (BIKF)**

Description: **Aircraft slid off taxiway**

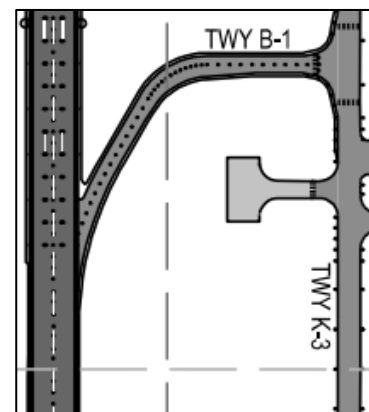
According to the flight crew of flight 3998, the braking action on RWY 28 was good. Once the aircraft was turned onto taxiway Bravo (TWY B-1), as instructed by ATC, the braking action became very poor.

The Commander realized the aircraft did not turn as commanded to the right on taxiway Bravo, regardless of the tiller being turned completely to the right, resulting in the aircraft sliding off the taxiway.

The investigation revealed that taxiway Bravo had not been sanded during the evening or the night prior to the incident, nor had its braking action been measured.

taxiway clearing (ITSB report 18-034F008 regarding TF-FIV on 10. March 2018), the airport operator, Isavia, has reviewed its internal procedures and training to ensure proper exchange of information between Ground Operations and the Tower regarding individual runway and individual taxiway conditions.

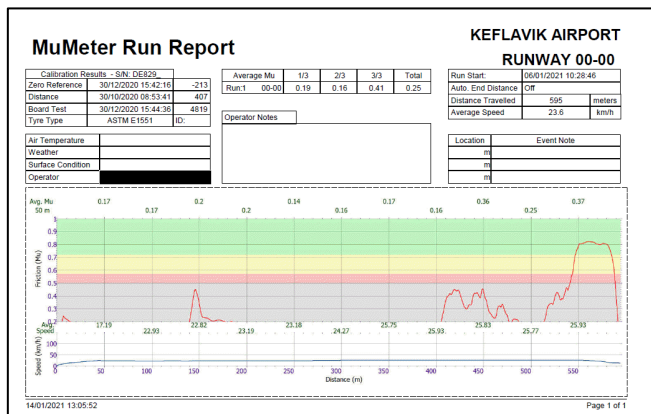
The investigation revealed that the last report issued by the Ground Services to the Tower regarding the condition of the taxiways had been at 19:07 in the evening before the incident, when TWY's were reported with MEDIUM braking action and as SANDED.

No distinction was made between the individual taxiways in the report to the Tower.

After the incident, at 10:28, the braking action at taxiway Bravo was measured as 19-16-41.
