LOKAÐ MEÐ BÓKUN

Case.: **21-035F006**

Location: **Reykjavik Airport, RWY 13**

Description: **Landing mishap**

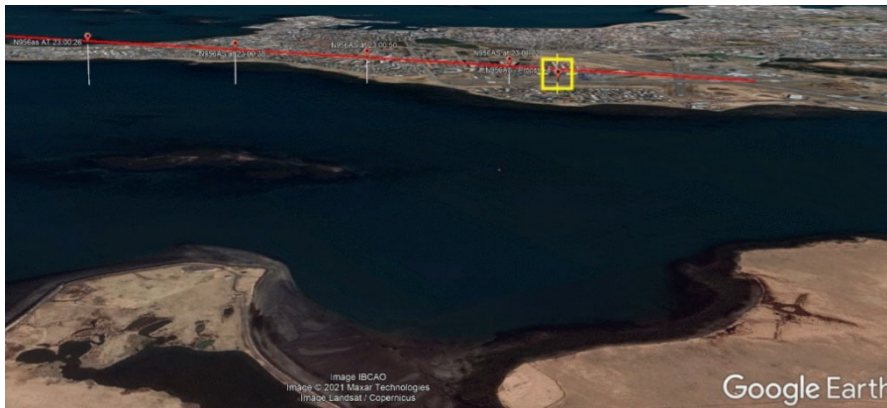
The ITSB analysed radar recordings of the final approach profile of aircraft N956AS. From the recordings, and taking into account the weather, it was apparent that the final approach was fairly straight, with an airspeed of about 115 mph and a rate of descent of about 500

ft/min, until it crossed the threshold of RWY 13. The final approach profile was however

quite shallow and when the aircraft crossed the threshold it was still about 200 feet above the runway. Based on this profile the aircraft touchdown point

would have been at the far end of the runway.

Propeller markings on RWY 13 did however confirm that the aircraft only travelled additional 0.11 NM down the runway compared to its last radar plot, before the propeller hit the runway. The touchdown point was 0.15 NM down from the RWY threshold.

The ITSB calculations showed that between the final radar point and the aircraft touchdown point on the runway, the rate of descent was between 1500 ft/min and 2200 ft/min. This range depended on the speed range of 66 mph (stall speed) and 115 mph (airspeed on the approach).

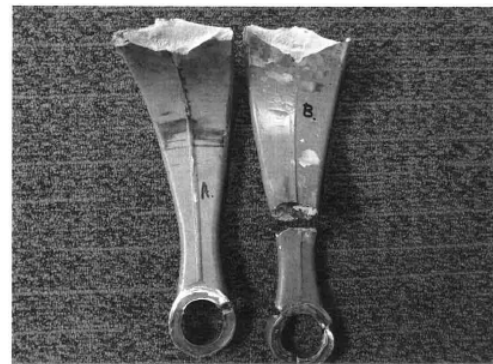
The ITSB had material analysis performed to determine the cause of the nose landing gear fracture surfaces. The material analysis confirmed that the fracture surfaces were due to overload and no indication of metal fatigue was observed on the fracture surfaces.
