LOKAÐ MEÐ BÓKUN

Case no.: **22-110F022**

Location: **Enroute to Ísafjörður (BIIS) from Akureyri (BIAR)**

Description: **Right nacelle fuel filter drain failure**

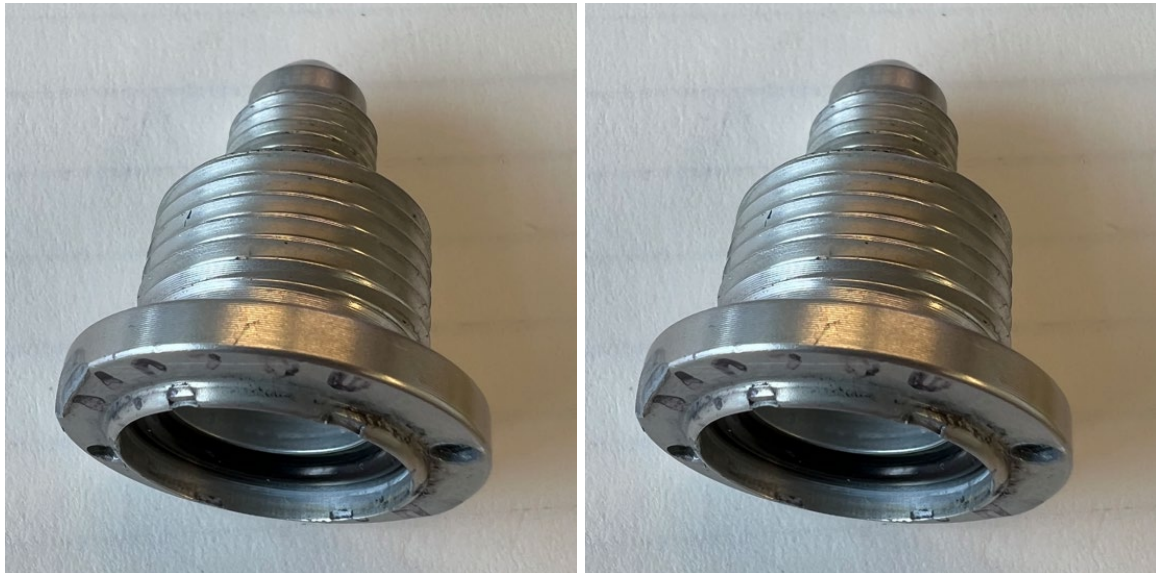
After landing it was discovered that the right nacelle firewall fuel filter drain, on the lower side of the cowling forward of the firewall, had failed and was missing its core part. As a result, the right-wing fuel tank drained completely, and the right engine shut down due to fuel starvation (Figure 2-4).

Figure 2: Failed drain valve located just forward of the firewall on lower side nacelle cowling

SIA-Iceland believes that water accumulated in the fuel system, at its lowest point at the Firewall Fuel Filter Drain, as the flight operator was only draining these two drains at two-week intervals instead of during daily preflight inspection.

This allowed accumulated water at the fuel filter drain to freeze, slowly migrating out the core part of the Firewall Fuel Filter Drain.

As a result, the core part of the Firewall Fuel Filter Drain on the right nacelle migrated completely out, allowing the fuel in the right wing to drain out of the aircraft during the serious incident flight (Figure 3).

Since the serious incident, the flight operator has changed its procedures, draining the Firewall Fuel Filter Drains daily.

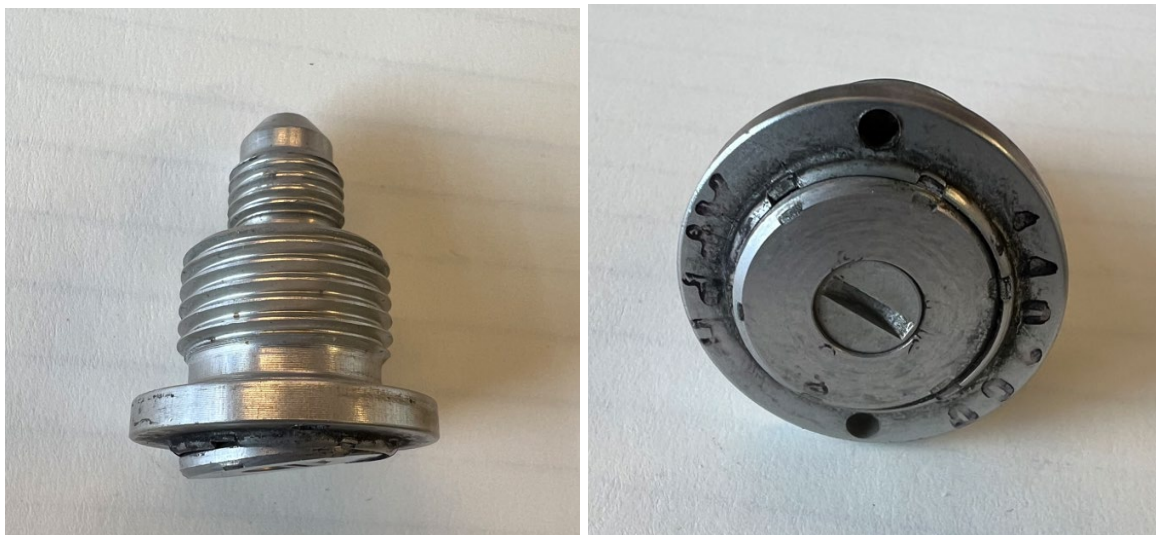
Figure 4: Left nacelle firewall fuel filter drain

The left nacelle firewall fuel filter drain was also inspected after the serious incident. The inspection revealed that the core part of the fuel filter drain had partially migrated out and was likely very close to failure. If the migration would have continued to such failure, that would also have caused loss of fuel in the left wing with fuel starvation of the left engine. See Figure 4.

This also allowed the core part of the Firewall Fuel Filter Drain on the left nacelle to partially migrate out (Figure 4).

After the incident, the partially failed left nacelle firewall fuel filter drain was removed and the left-wing fuel tanks were drained. When draining the fuel from the left-wing fuel tanks, some water was discovered in the fuel.
