DIRECTORATE OF CIVIL AVIATION

AIRCRAFT ACCIDENT REPORT

TF-RAN, SIKORSKY S-76A

8 NOVEMBER 1983

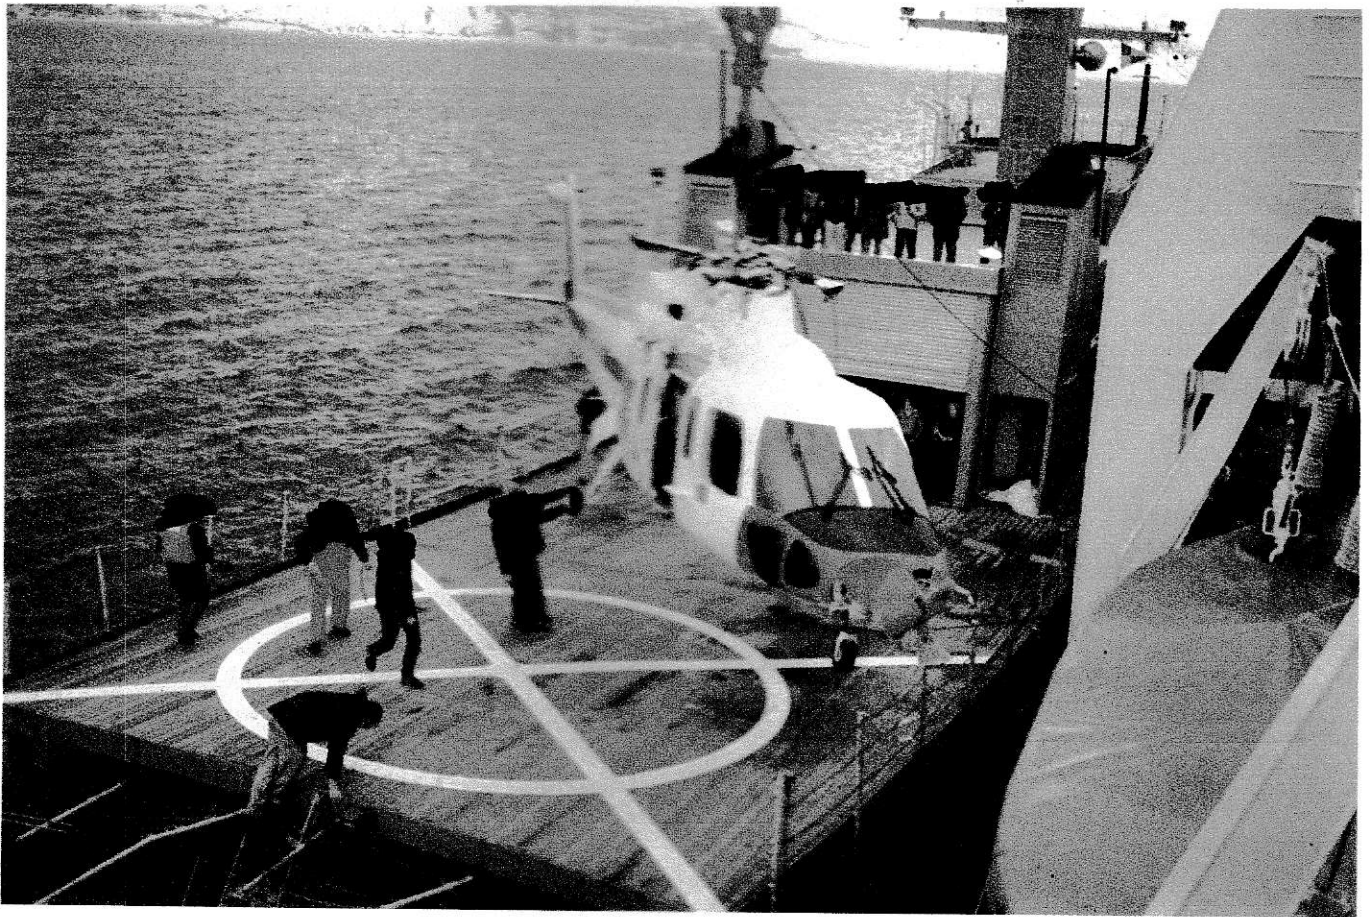
The two right hand chin windows were broken and the sliding door was missing, the door tracks were fully extended and the upper track was bent sharply upwards. The left hand aft door was wide open and the tail rotor assembly was broken off, hanging on its control cables.

Wreck as recovered on the helideck of *Okinawa*. Chin and door windows broken and sliding door missing.

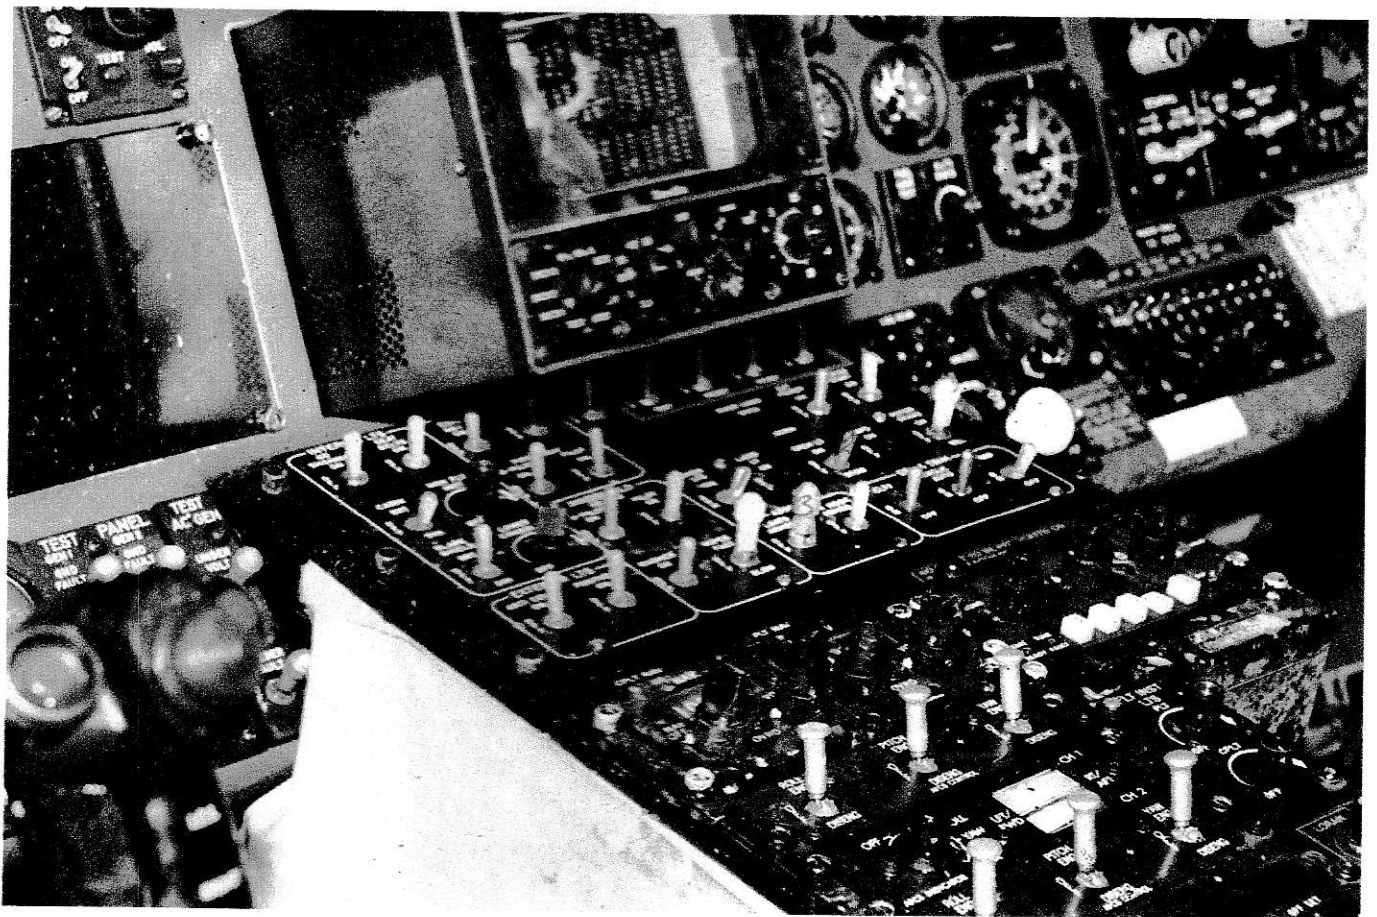
The emergency floats had not been deployed and the arming switch was in the "OFF" position. Both pilot doors had been unlocked and the captain's (R/H) door window was broken inwards. The co-pilot was not buckled in his seat and he was without a helmet, when recovered.

View of the pedestal switches. 1. Emergency light switch. 2. Search light switch. 3. Float arm switch.

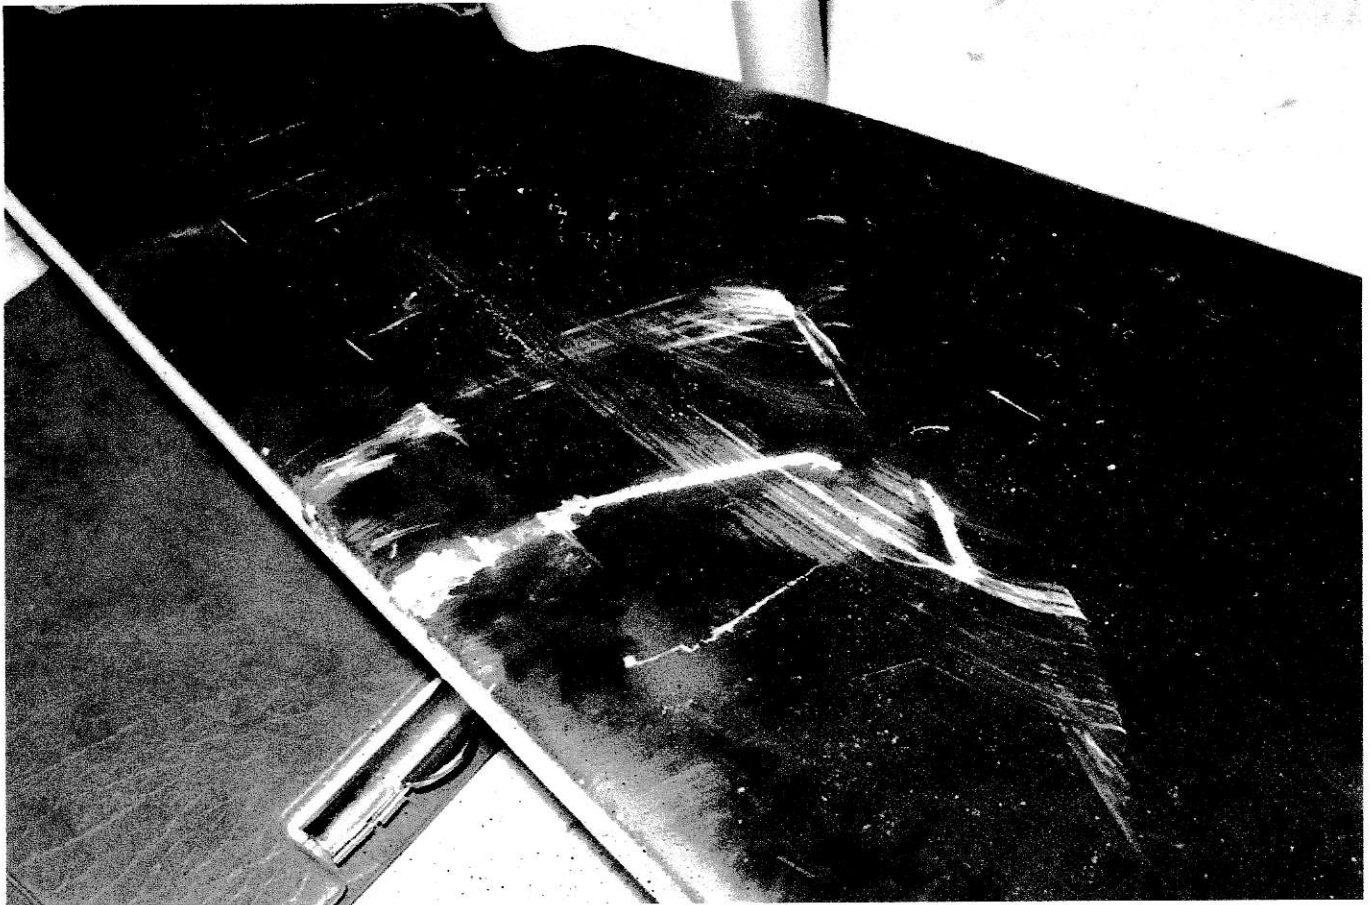
Examination of the "black" blade stub, revealed damage to the lower leading edge, scratches and smears on the underside of the blade, which was very probably caused by the sliding door. (See pictures Appendix 5.3.).

There was a mark on the main rotor pylon and the hoist neck, indicating that the door had been deflected up into the main rotor and deflected forward by the main rotor blades. This is substantiated by the damage and smears on one (black) rotor blade.

The black main rotor blade stub. View of the marks on the underside caused by the sliding door strike.

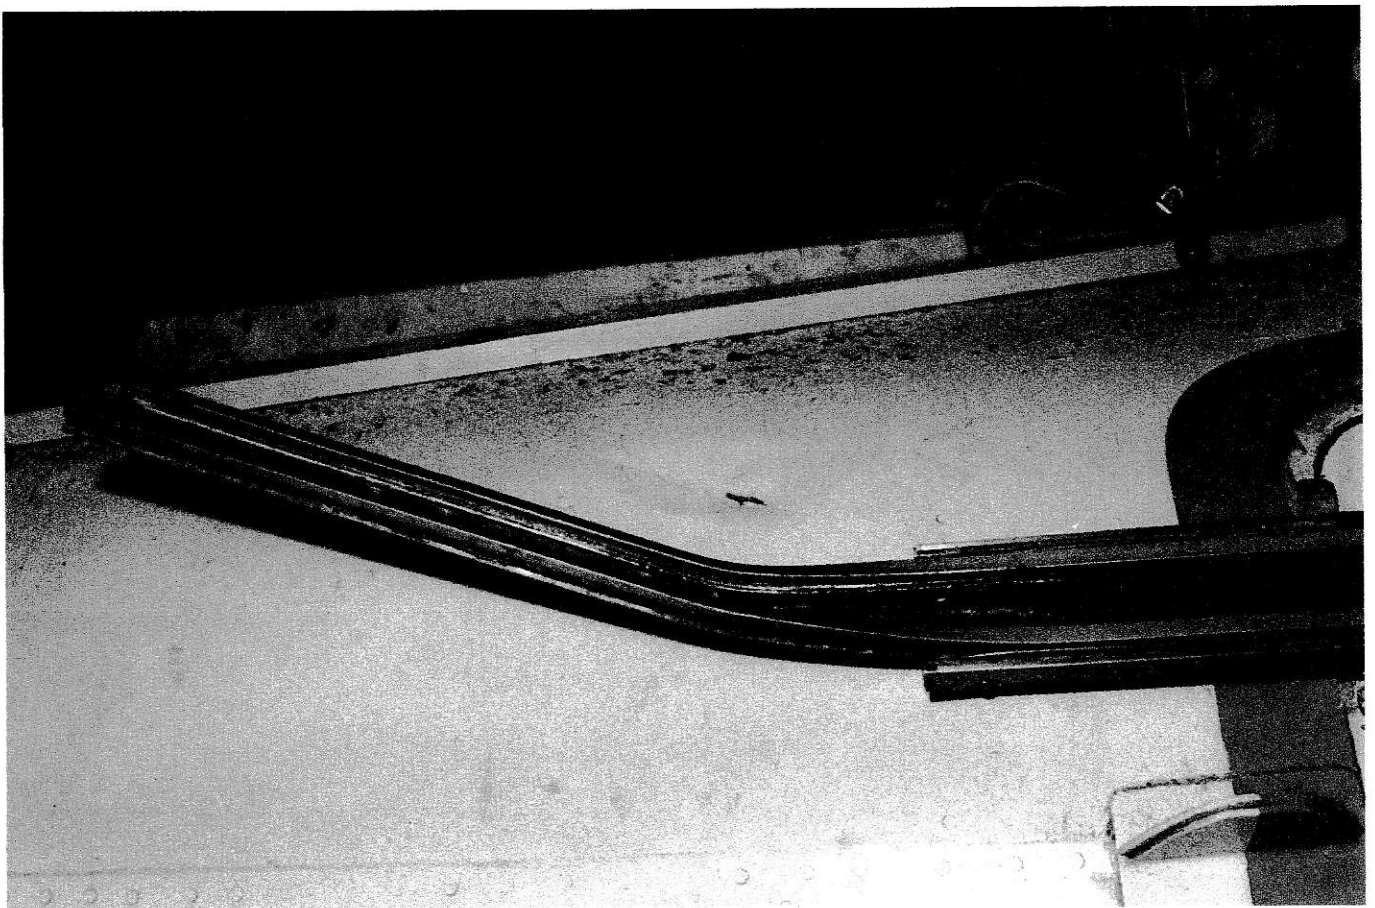
The inner tracks were missing from both the upper and lower assemblies and both intermediate tracks were fully extended. The aft end of the intermediate track in the upper assembly was bent significantly upwards.

The forward and intermediate sliding door track. Showing the up and forward bending and the dent on the fuselage caused by the door.

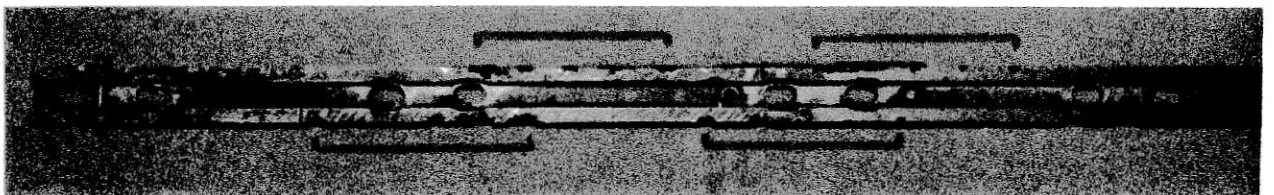
FIGURE 10

Examination of the lower track assembly revealed only four ball marks or impressions instead of the expected twelve. This could indicate either misassembly or prior ball loss condition before the accident. Also three out of four expected intermediate end cap ball marks were missing. Further examination also revealed, that the end cap cage fasteners were installed improperly, when compared to the upper door track and a new assembly, which leads to the conclusion that such misassembly may have taken place prior to delivery to the ICG.

BALL EXIT REGIONS FOR EACH TRACK

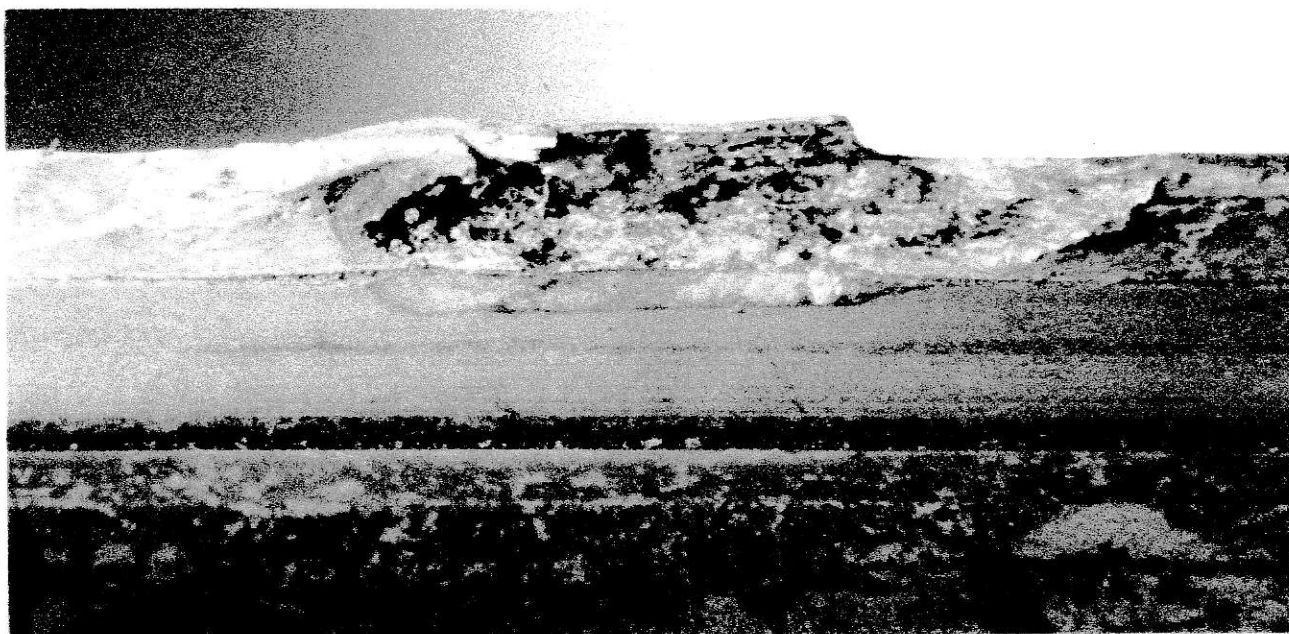
TRACK EDGE DEFORMATION ON OUTER EDGE

VIEW B
LEADING BALL EXIT POSITION
