## CLOSED WITH A BOOKING

Case number.: **23-073F024**

Location: **At Varanasi airport in India**

Description: **Tail strike during landing**

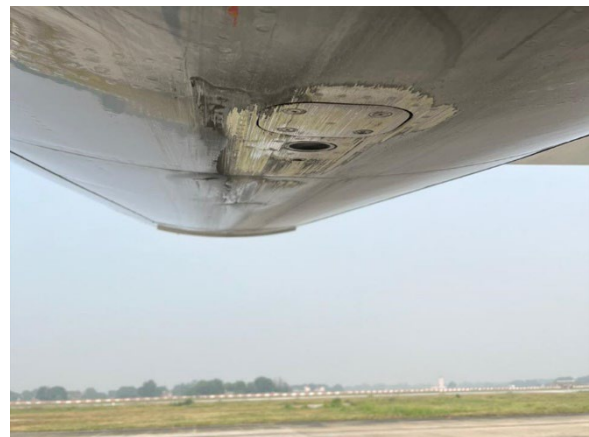
Aircraft TF-LLL (Boeing 757-200) was landing, at runway 27 at Varanasi airport (VEBN) in India at 05:38<sup>1</sup> on 10. November under flight number ICE1253, when it incurred a tail strike. The Commander of the flight was the Pilot Flying.

When the tail strike occurred, significant damage occurred in the lower aft fuselage, aft of the pressurized area, around STA 1743.

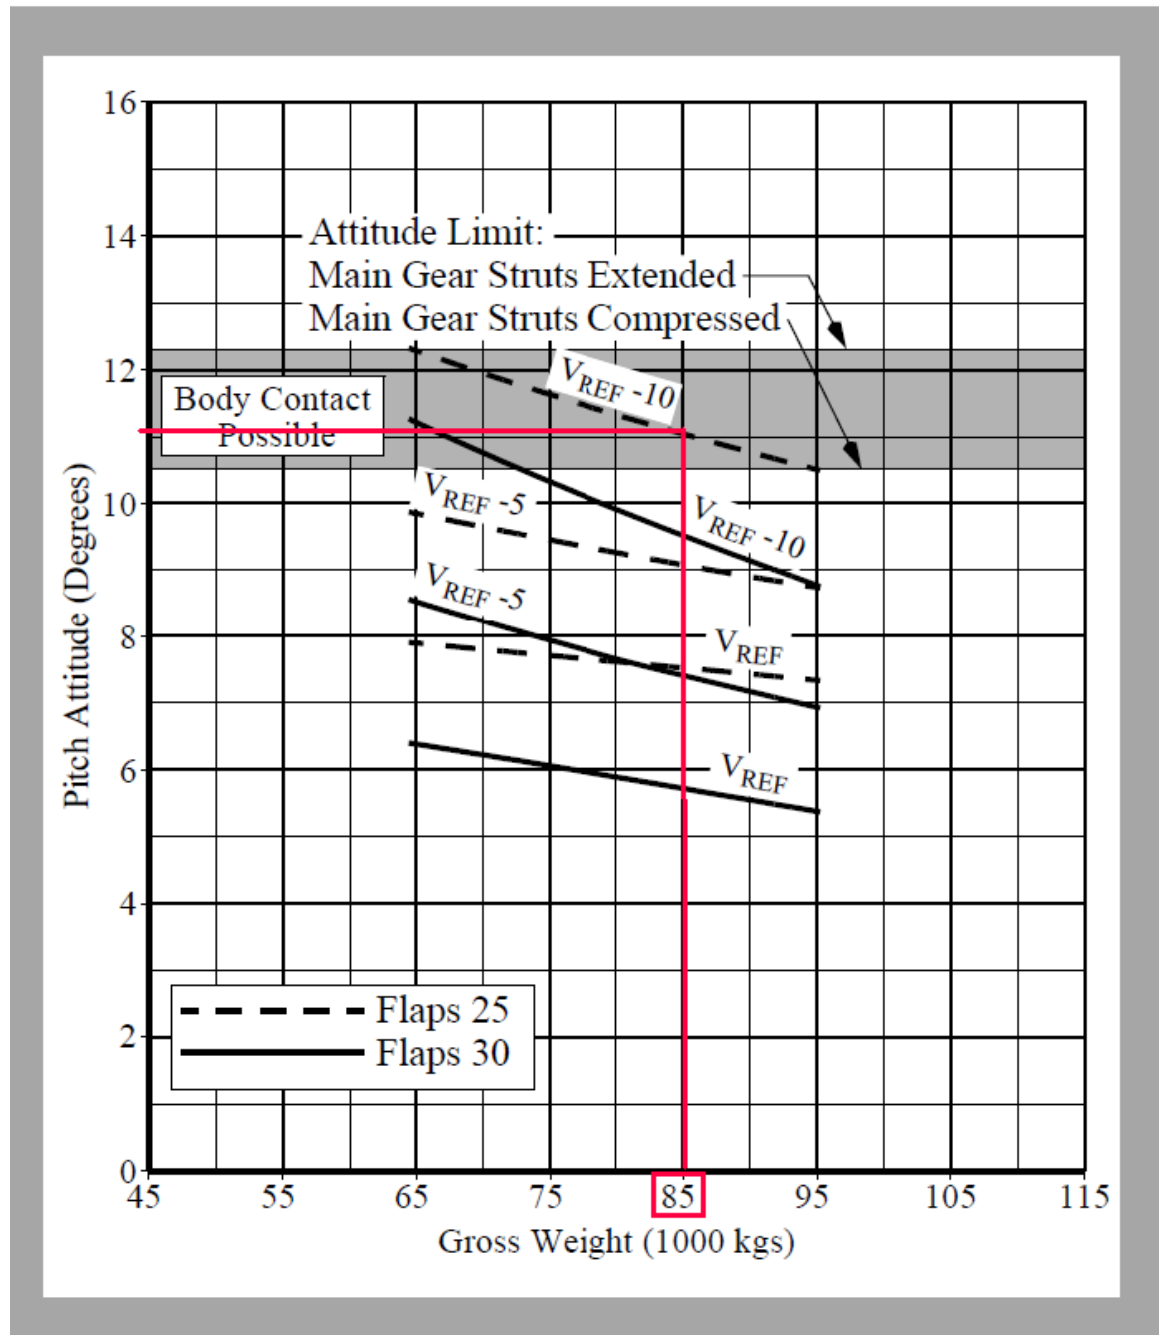
## Touchdown Body Attitudes - Kilograms

At 05:38:48 the air speed was down to 124 knots and the aircraft pitch had increased up to 10.5°, which is the maximum pitch attitude possible with the main gear struts compressed without encountering a tailstrike.

At 05:38:49 the air speed was down to 120 knots and the aircraft pitch attitude had increased up to 11.4° and that angle was maintained for about one second. SIA-Iceland determined that the aircraft dragged the tail along the runway during this period.

SIA-Iceland determined that the cause of the serious incident was that after main wheels touchdown and the speedbrakes being automatically activated, the control column was pulled again. This caused the aircraft's pitch attitude to increase further, until a tailstrike occurred about five seconds after main wheel touchdown.
