Final report on aircraft serious incident

Case no.: **23-016F005**

Date: **13. February 2023**

Description: **Uncontrolled descent**

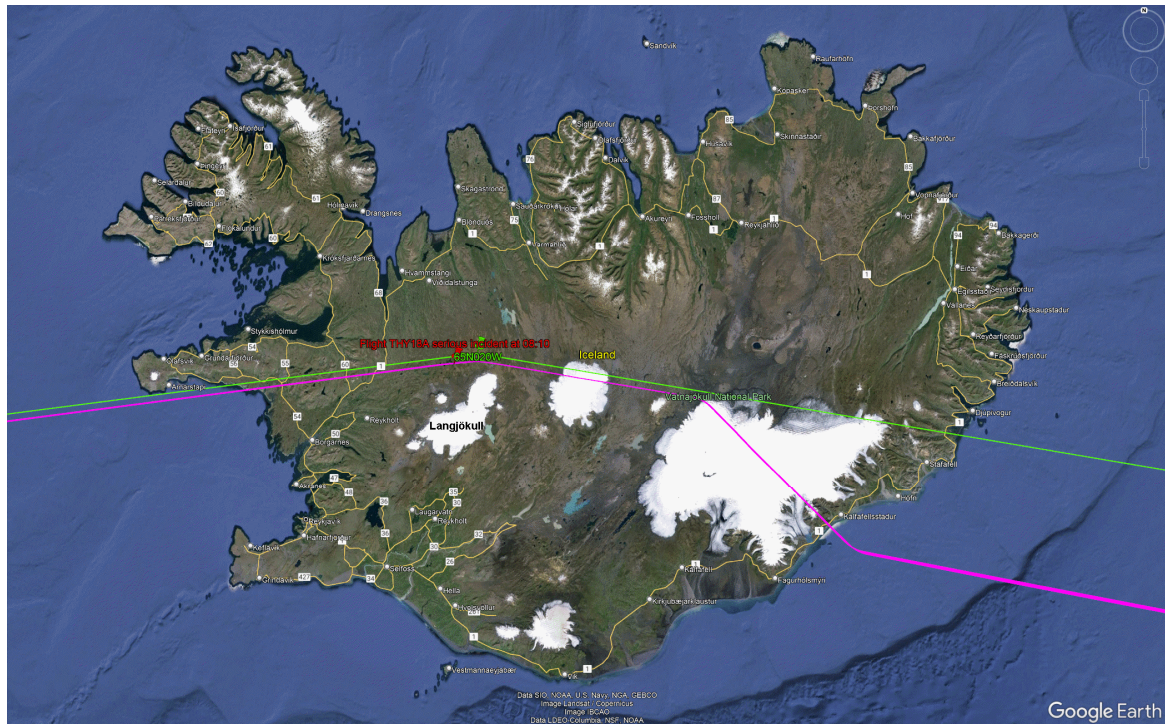
Figure 1: Serious incident occurred when at FL350 north of the glacier Langjökull (green line is the planned route and the magenta line is the actual flight track).

The turbulence encounter resulted in an aircraft upset condition, with an extremely low pitch angle and high rate of descent. The flight crew struggled to control the lateral and vertical path simultaneously and the aircraft lost close to 8000 ft of altitude in approximately one minute, with the highest rate of descent of 17,100 feet per minute. The airspeed increased beyond the airspeed limit. This occurred regardless of the flight crew's effort to keep the airspeed within its limit. During the upset, multiple stick shaker activations occurred. The aircraft's lowest altitude was FL273.

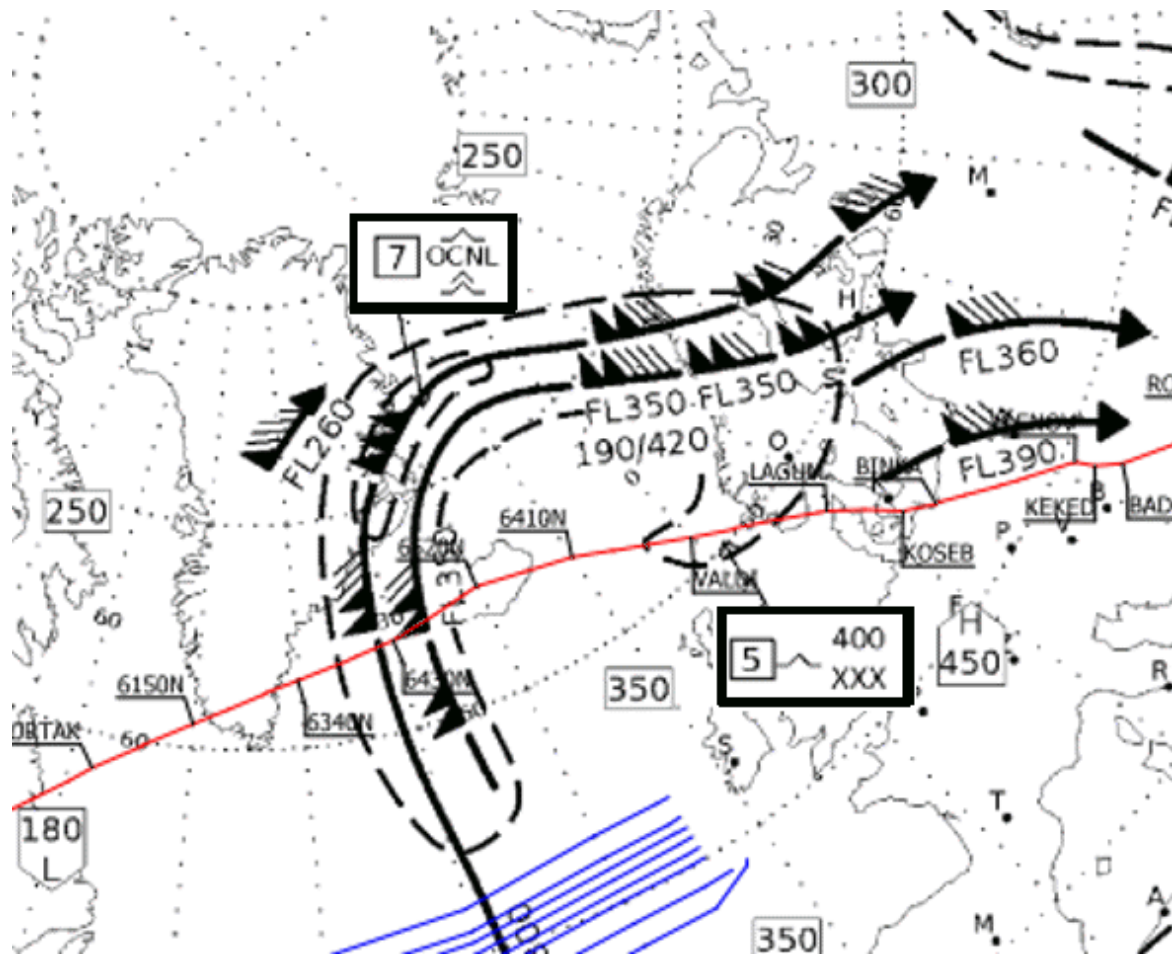
The significant weather chart provided in the flight documents and valid at 06 UTC on 13 February 2023 in the North-Atlantic (see Figure 3 and Figure 5), indicated a forecasted moderate and occasionally severe turbulent region in the area north and northwest of Iceland between FL280 and FL390, about two hours before the serious incident occurred.

Figure 5: Forecasted weather in the North-Atlantic at 06 UTC 13 February 2023.

Flagnote 5 indicates moderate turbulence and flagnote 7 indicates moderate and occasional severe turbulence.

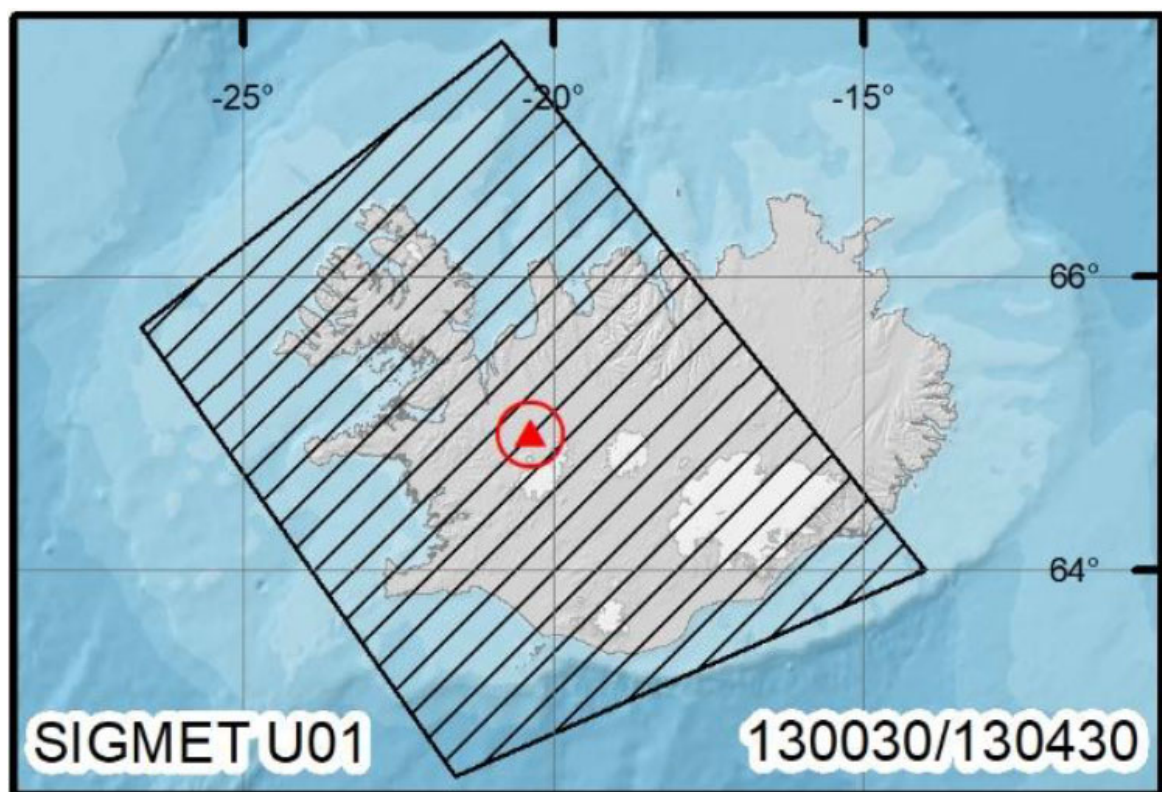
SIGMET U01, which was provided in the flight documents and previously shown in chapter 1.5, was a low level SIGMET, valid from the surface and up to FL100, for the region shown in Figure 6.

Figure 6: SIGMET U01 valid from ground up to FL100, where severe turbulence was forecasted. Red triangle marks the location of the serious incident. (Source: IMO technical report).

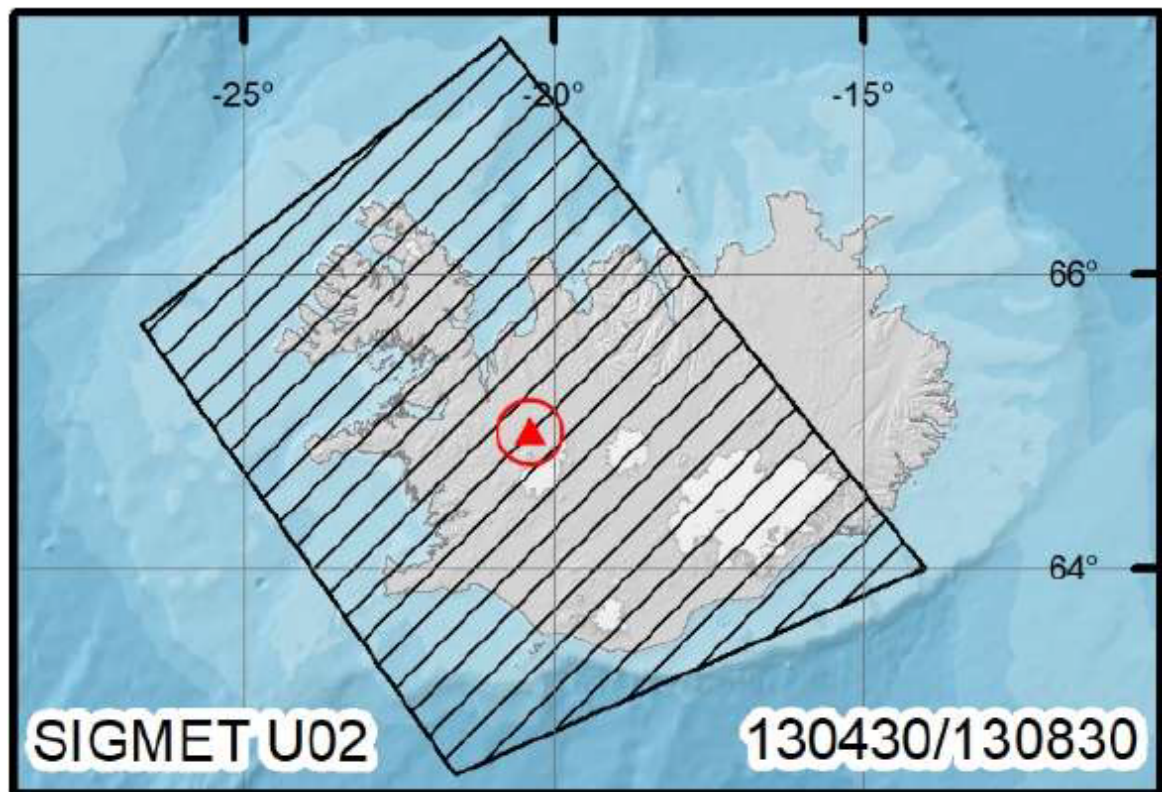
Subsequently during the flight at 04:04, 3 hours and 38 minutes prior to the aircraft encountering the severe turbulence, SIGMET U02 was issued, which indicated that a severe turbulence was forecasted up to FL100 in the area shown in Figure 7.

Figure 7: SIGMET U02 valid from ground up to FL100, where severe turbulence was forecasted. Red triangle marks the location of the serious incident. (Source: IMO technical report).

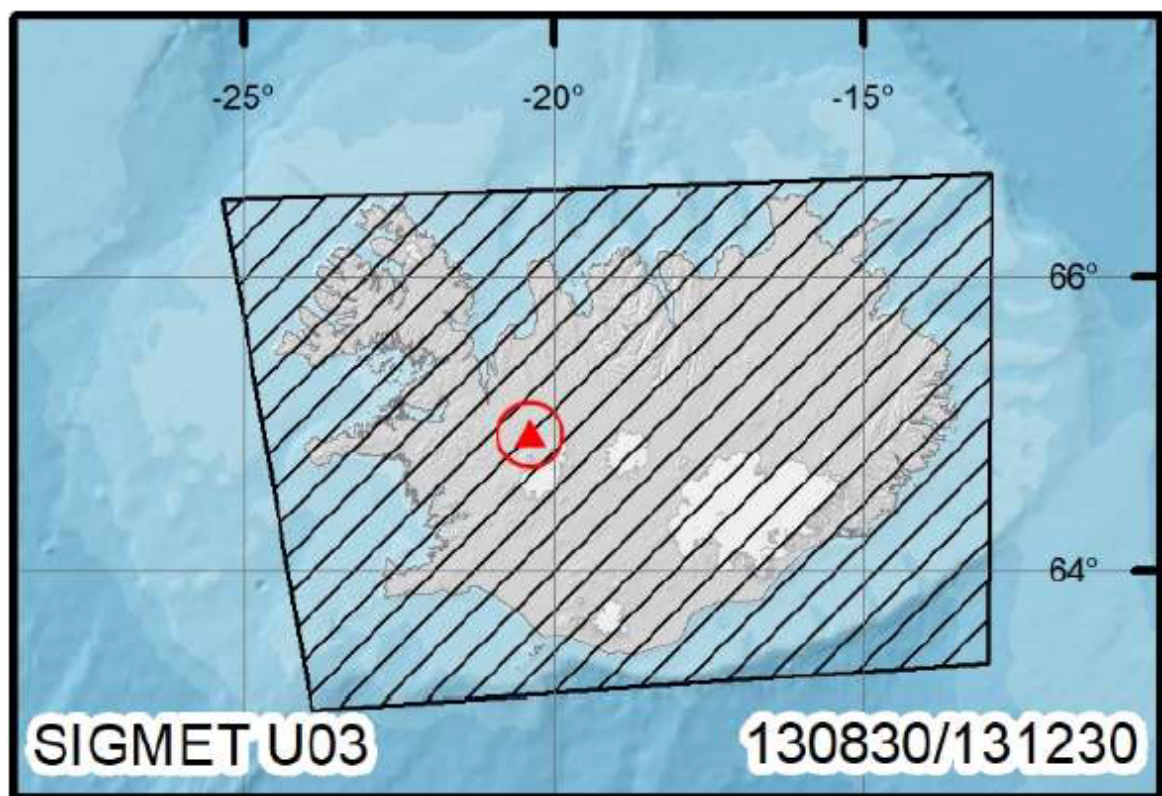
At 08:04, 5 minutes prior to the aircraft encountering the severe turbulence, another SIGMET U03 was issued, which indicated that a severe turbulence was forecasted up to FL120 in the area shown in Figure 8.

Figure 8: SIGMET U03 valid from ground up to FL120, where severe turbulence was forecasted. Red triangle marks the location of the serious incident. (Source: IMO technical report).

These two SIGMETs were not relayed to the flight crew via the Aircraft Communications Addressing and Reporting System (ACARS) during the flight, as they were not valid for the cruising altitude that flight TK0018 was flying at (FL350), while enroute over Iceland.

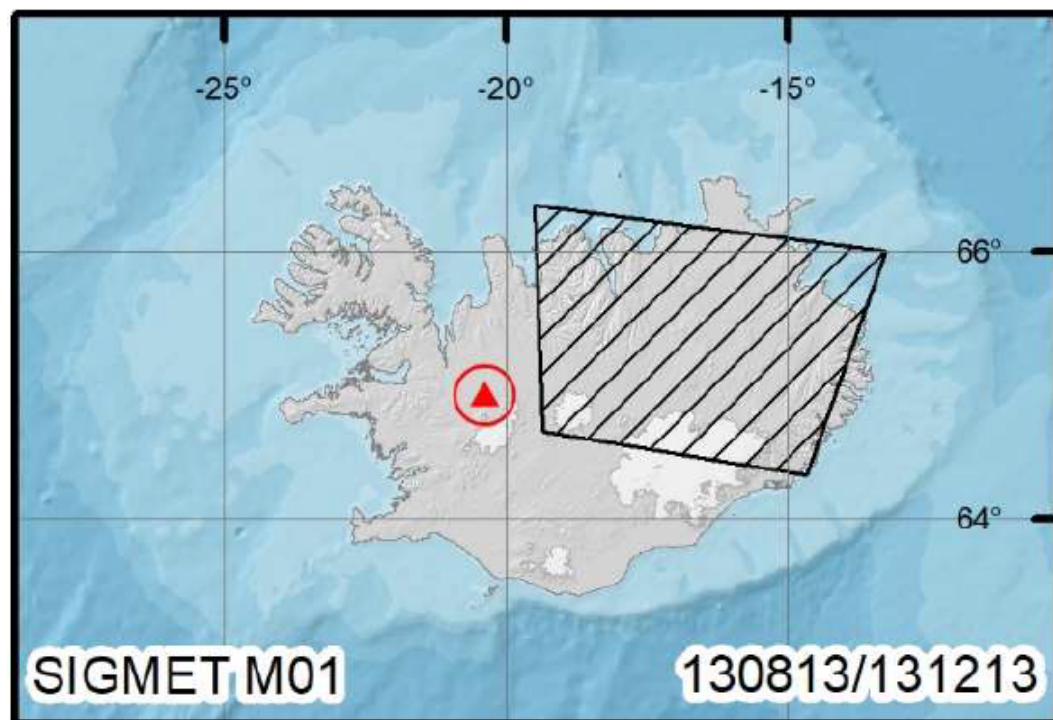
Figure 9: SIGMET M01 valid between FL300 and FL440, forecasting mountain waves. Red triangle marks the location of the serious incident. (Source: IMO technical report).

At 08:18, during communication with the flight crew of flight TK0018, ATC advised that they had just received a SIGMET (SIGMET M01) for the area in which the flight was located (see Figure 9).

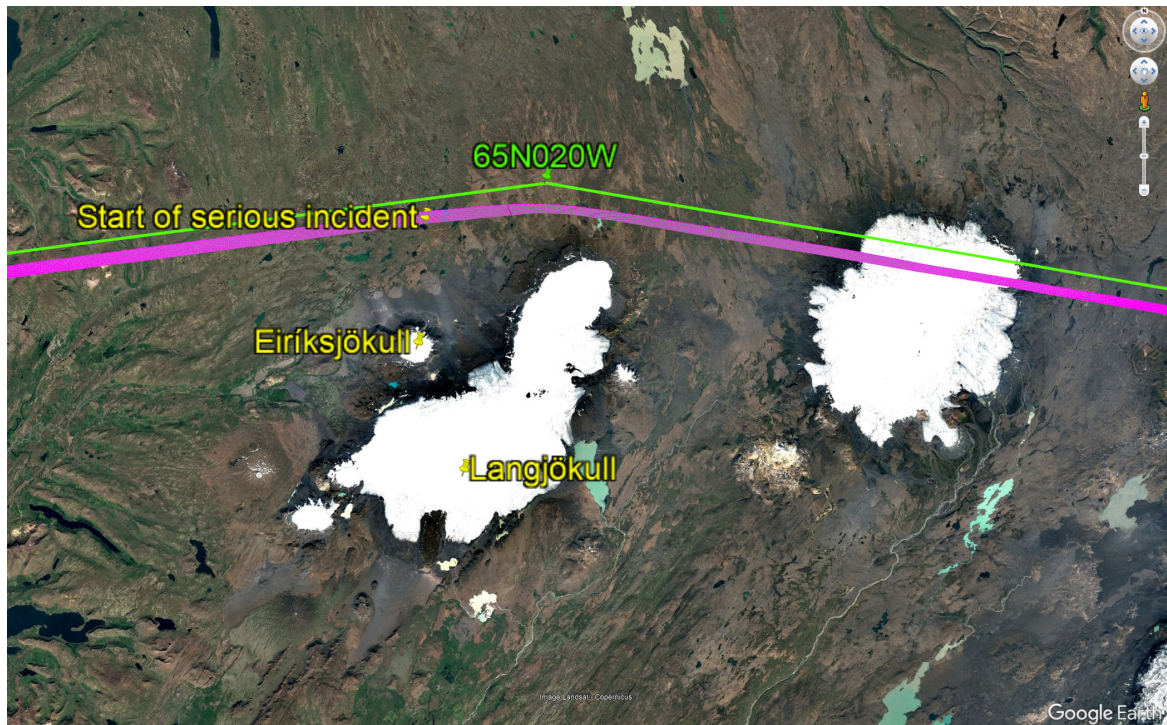
The flight track of flight TK0018 was north of the glacier Langjökull, or more precisely 18.5 km north of the glacier Eiríksjökull. The serious incident occurred at 08:09 at 64°56'27.744"N and 20°23'10.788"W, while the aircraft was flying at FL350 (see Figure 10).

Figure 10: The flight plan (green line), the flight track (magenta color line) and the serious incident location, north of the glacier Langjökull.

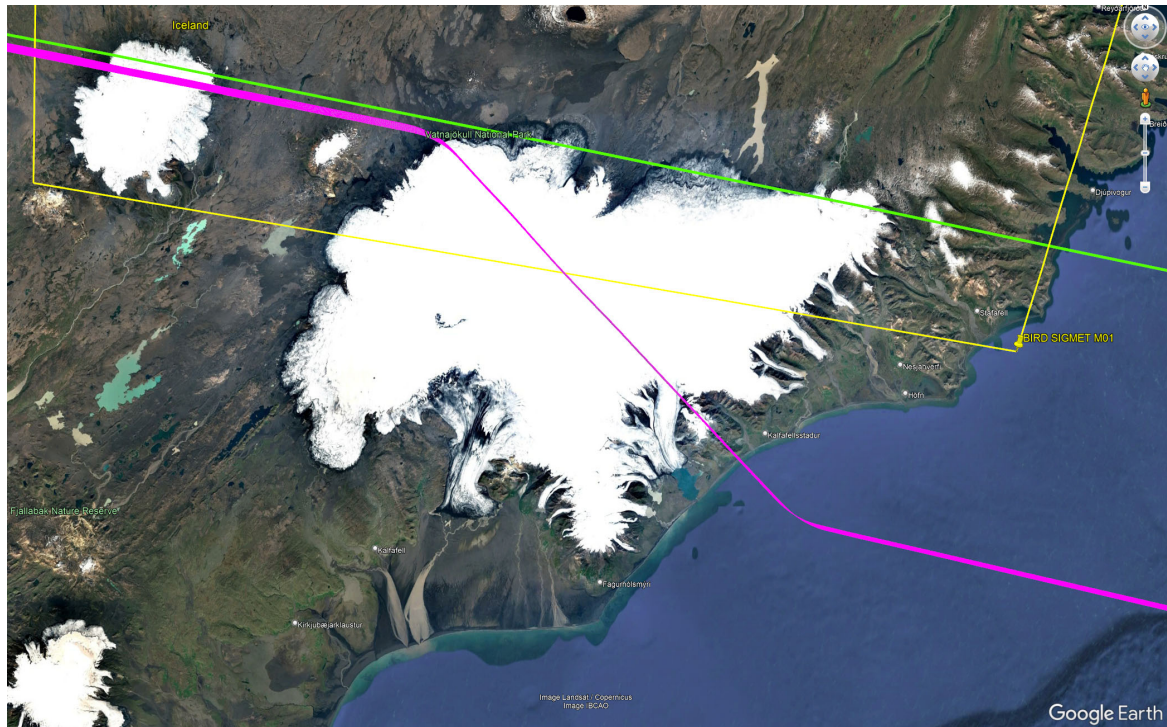
ATC then informed the flight crew, that if they would like to get out of the SIGMET area, ATC could vector them out of it. The flight crew accepted the vectoring and at 08:19 ATC vectored flight TK0018 to the right, out of the SIGMET area (see Figure 11).

Figure 11: ATC vectors the flight out of the SIGMET M01 area, heading 150°, over the Vatnajökull glacier (magenta color line).

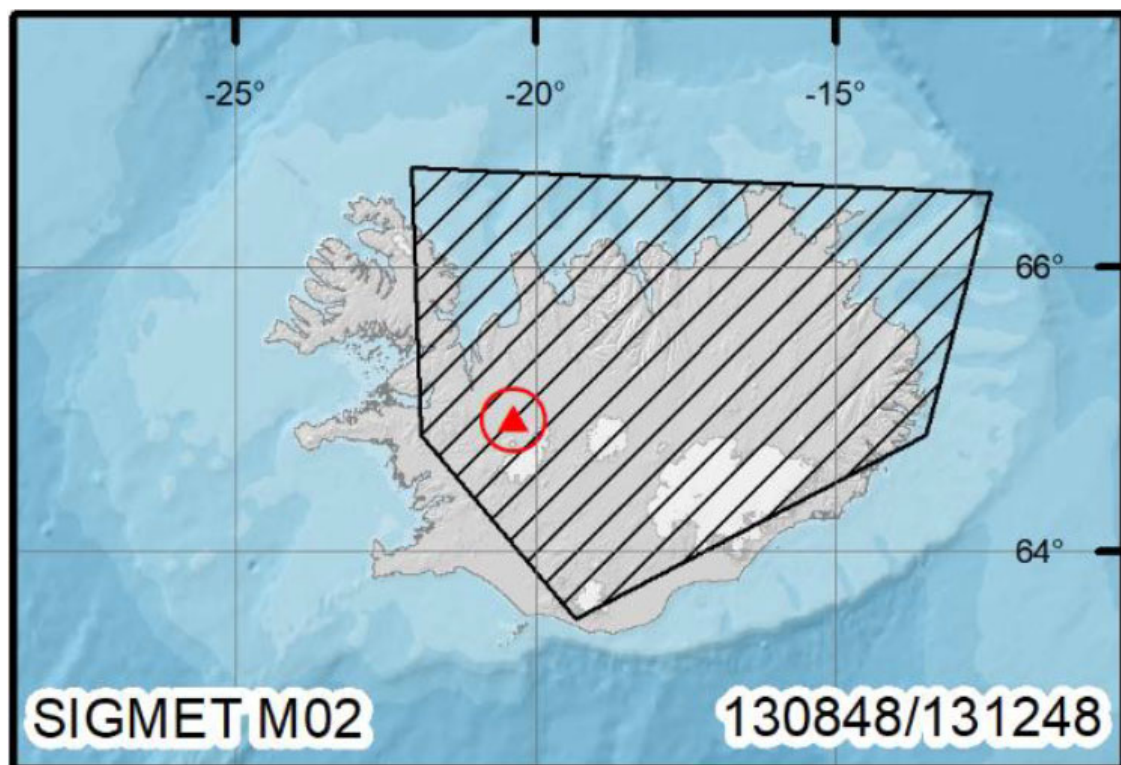
As the location of the severe turbulence encounter was not within the SIGMET M01 area, the meteorologist issued new SIGMET M02 at 08:49, where the mountain wave area was enlarged and a notification of observed severe mountain waves within the area was added (see Figure 12).

Figure 12: SIGMET M02 valid between FL290 and FL440, severe mountain waves observed.
Red triangle marks the location of the serious incident.
(Source: IMO technical report).

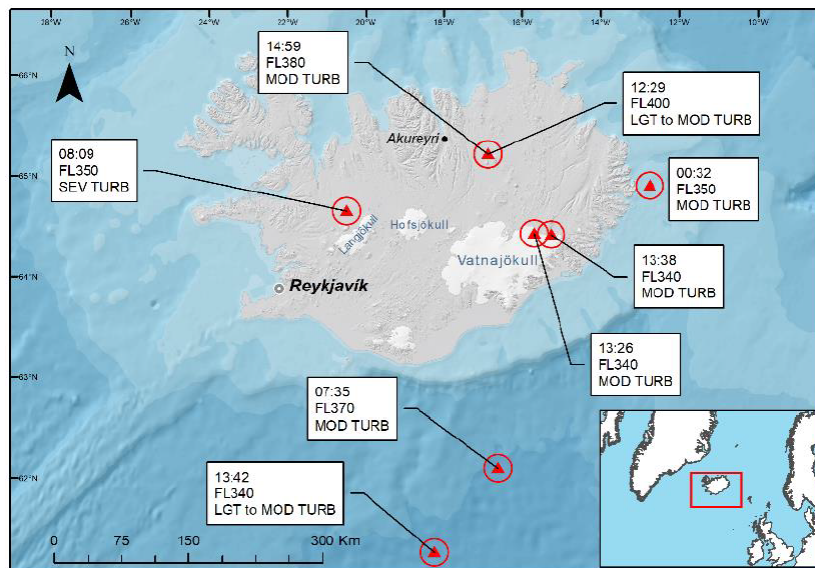
A few Pilot Reports (PIREPs) were received during the day of the serious incident, regarding turbulence in the Reykjavik FIR (BIRD) (see Figure 13).

Figure 13: Pilot's Reports (PIREPs) of turbulence in the Reykjavik FIR around the event (Source: IMO technical report).

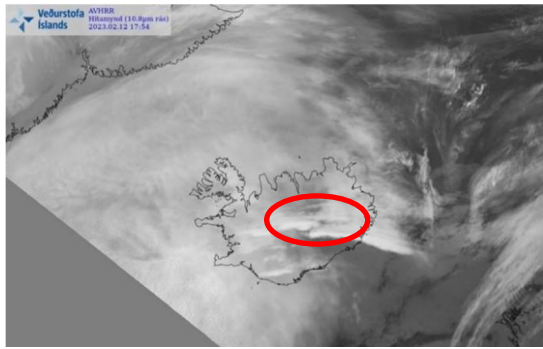
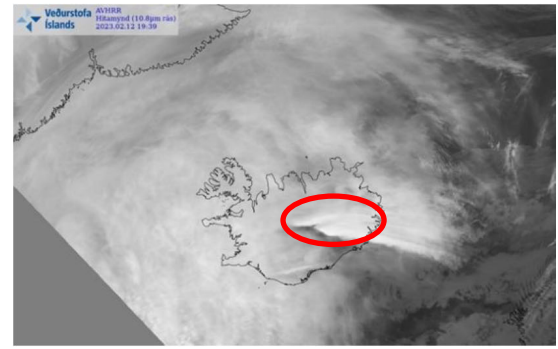
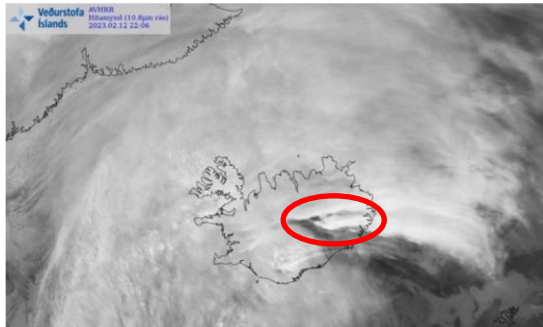
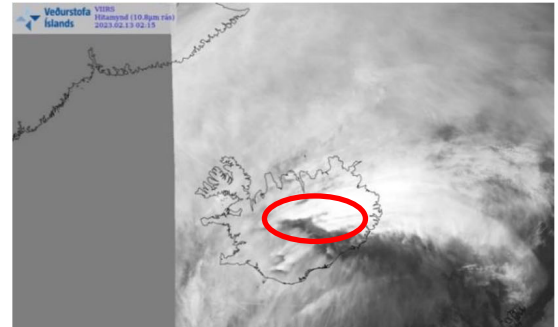
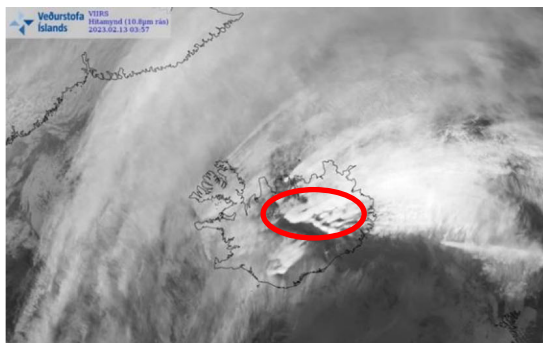
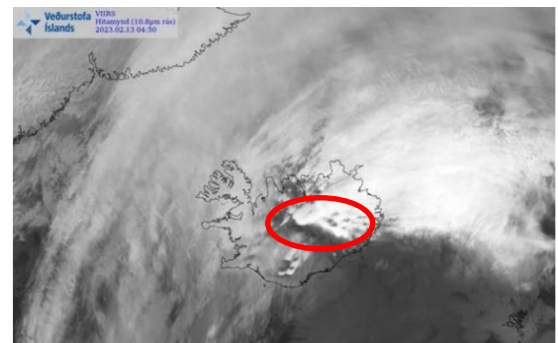
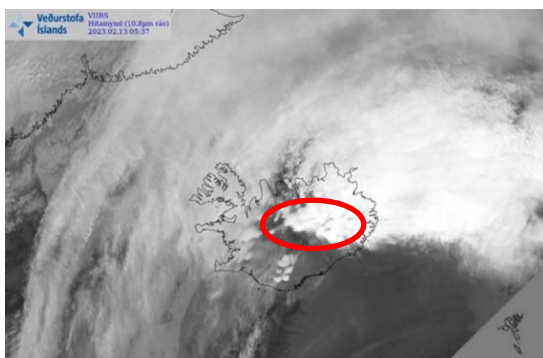
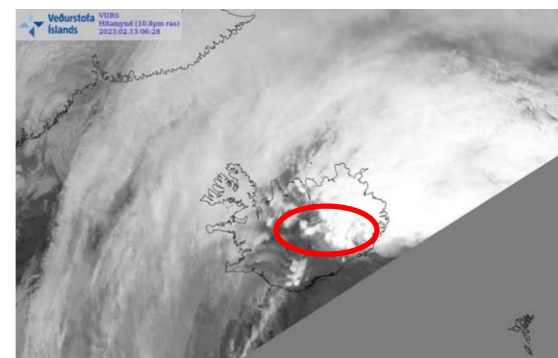
On 13th of February 2023 the moisture in the troposphere was sufficient to give indications of vertically propagating mountain waves over Iceland. The first indications of mountain waves over Iceland could be seen on the AVHRR and VIIRS¹³ infrared heat images captured in the afternoon of 12th of February. In Figure 21 a), there are already indications of mountain waves, although these indications are small and hard to spot. The mountain waves became clearer later during the evening and then shadow areas could be spotted north of the glaciers, as can be seen in c) and d) of Figure 21. A shadow area is a sign that a powerful downdraft is occurring in the area, which causes the cloud cover to dissipate due to evaporation. Next to the downdraft area there was an area of powerful updraft area, which caused moist air to rise to even higher altitudes. This moist air was captured in the images as whiter and colder cloud tops (mountain wave tops). From the images in Figure 21, it can be interpreted that the mountain waves grew significantly through the night and became more intense. From the timeline in Figure 21, it can be interpreted that the satellite weather data indicated powerful mountain waves over Iceland many hours before the serious incident occurred.

Figure 21: AVHRR and VIIRS infrared heat images captured in time stamped order a)-h) from 12. February to 13. February 2023.

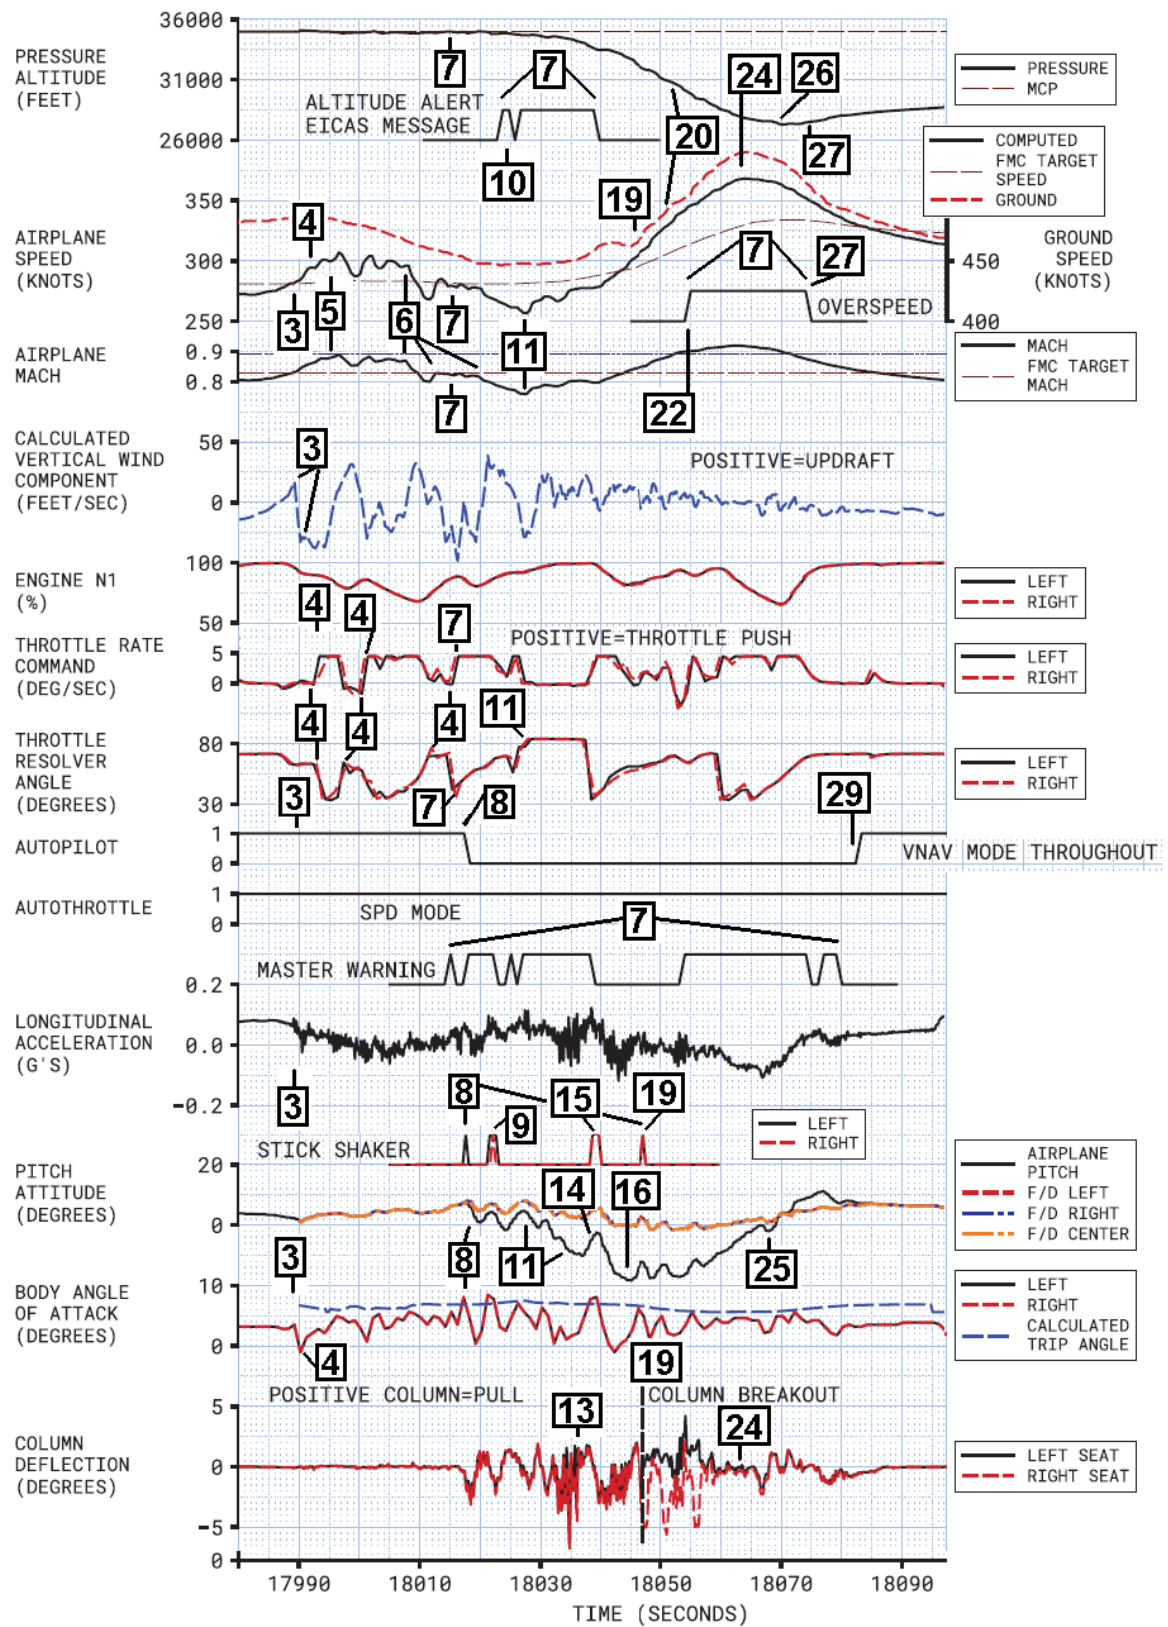
24) At 08:10:54 UTC (timestamp 18,063 in Figure 23, Figure 23 and Figure 27), the airspeed had reached a maximum of 368 knots (approximately Maximum Operating Velocity [VMO] + 18) and Mach 0.92 (MMO + 0.03) while the pressure altitude was approaching 27,500 feet. Opposing control column forces between the left seat and right seat were still observed, with the control column positions now together at around 0 degrees.

26) At 08:11:00 UTC (timestamp 18,069 in Figure 23, Figure 23 and Figure 27), the lowest pressure altitude observed was 27,295ft.
