### Final report on aircraft serious incident

Case no.: **24-045F014**

Date: **8. September 2024**

Description: **Loss of cabin pressure**

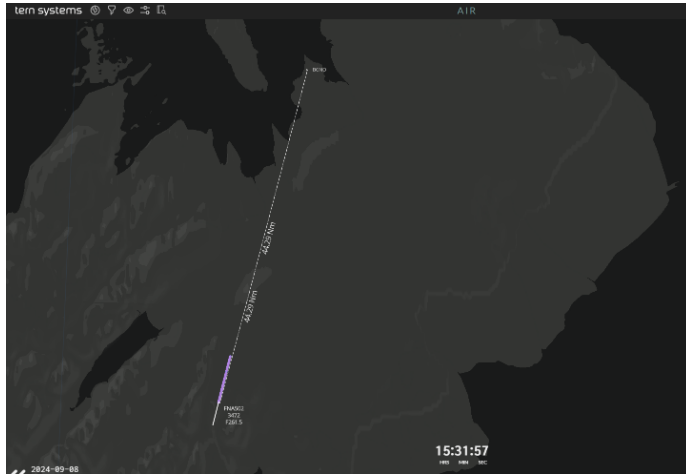
According to the radar recordings, the highest altitude the aircraft reached was FL261.5 at 15:31:57 UTC, when the aircraft was located about 44 Nm south of BGNO (Figure 1).

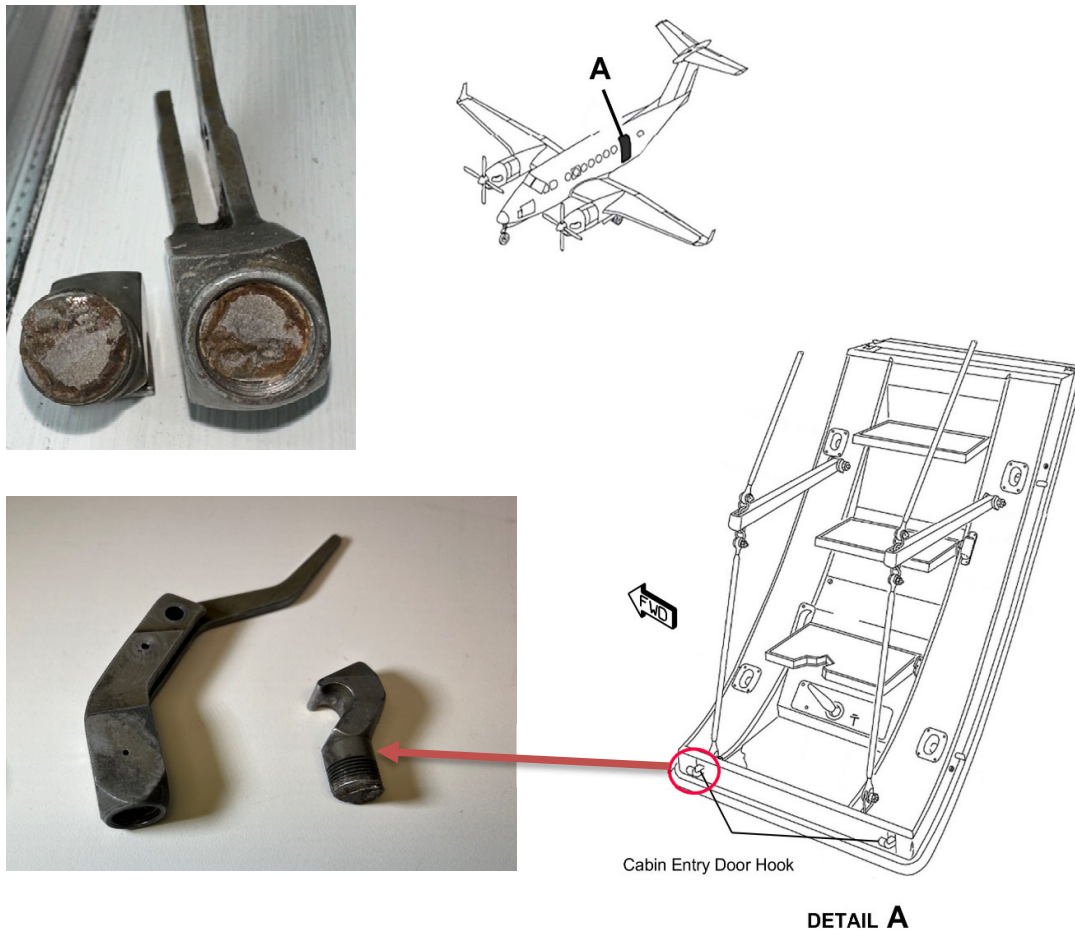
**Figure 2: Location of the forward upper cabin entry door hook**

After landing the Commander briefed the passengers on what had occurred. When the cabin door in the aft cabin was opened, the forward upper cabin entry door hook fell down, as it was fractured (Figure 2).

The forward upper cabin entry door hook has the P/N 101-430029-1. According to the manufacturers documents<sup>2</sup>, the forward upper cabin entry door hook is a 10,000 flight cycles Airworthiness Limitation Item, along with the rest of the cabin airstair door upper hook mechanism (including pins, brackets, spring, arm and hooks).

Review of the maintenance records of airplane TF-NLA revealed that the forward upper cabin entry door hook, P/N 101-430029-1, had accumulated 8585 cycles since the aircraft was new. This part had never been replaced, and it had accumulated close to 86% of its life limit. It had therefore not reached its airworthiness limit when it failed.

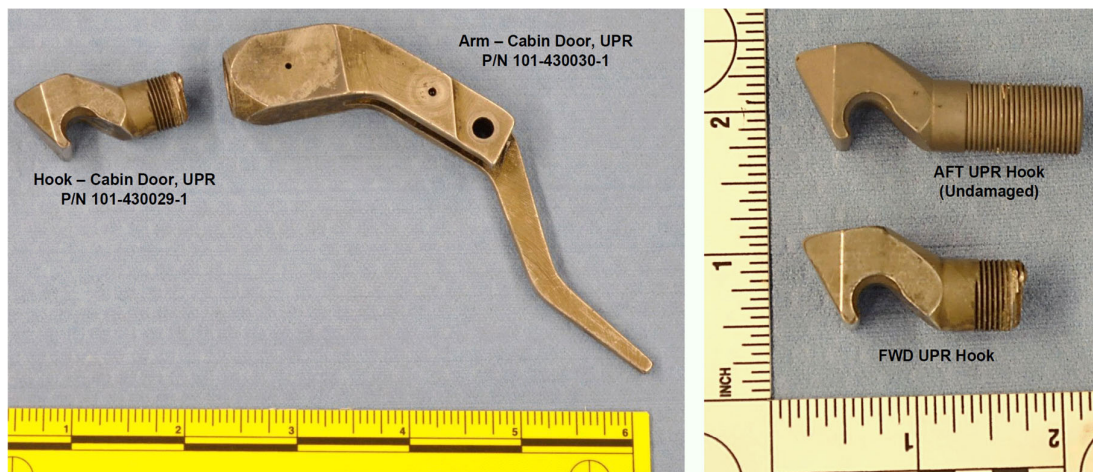
**Figure 3: The fractured forward upper hook, the forward upper arm and the aft upper hook**

SIA-Iceland launched an investigation into the failure of the forward upper cabin entry door hook. The fractured P/N 101-430029-1 hook was brought for detailed inspection at the manufacturer's site (Figure 3), along with the accompanying forward upper cabin entry door arm, P/N 101-430030-1, and the undamaged aft upper cabin entry door hook. The inspection was attended by representatives from SIA-Iceland, the aircraft manufacturer, the NTSB and the FAA.

The fracture in the forward upper cabin entry door hook was most likely caused by intergranular corrosion crack propagating from multiple planes at the threaded portion of the hook and growing inwards towards the center of the fracture surface. The outer slanted area of circular fracture surface was corroded, which indicates an aged fracture area event. The inner flat area was not corroded, which indicates a second fracture event most likely when the part failed.

As the part most likely failed due to intergranular corrosion under normal operation loads, at about 86% of its life limit, while the microstructure of the fractured hook was consistent with quenched and tempered 4340 high strength low alloy steel, SIA-Iceland determined that the life limit of the part needs to be reconsidered (lowered), or a design change implemented.

SIA- Iceland recommends to Textron Aviation to reconsider (lower) the 10,000 flight cycles airworthiness life limit of the door hooks, or to perform design changes to improve its endurance.

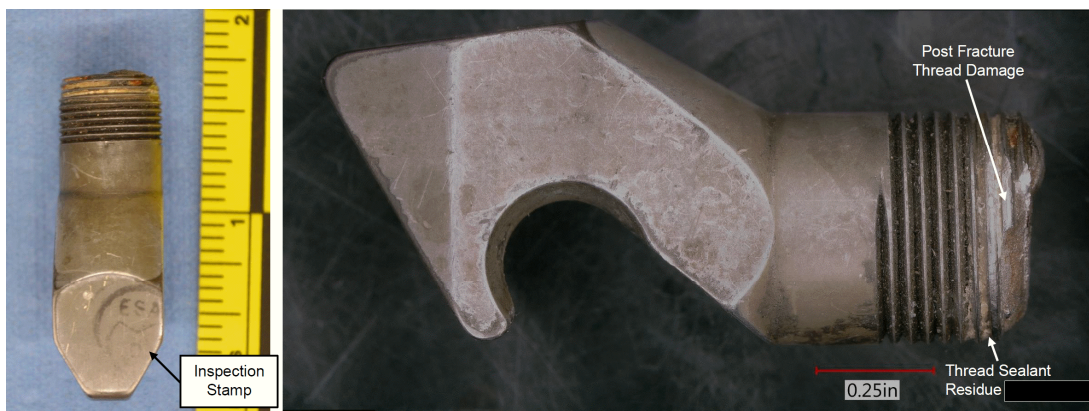
**Figure 4: The fractured forward upper hook**

The forward upper cabin entry door hook was fractured approximately half-way through the threaded length. The remaining portion of the fractured hook was contained in the accompanying arm. The threads near the fracture location contained sealant residue and were affected by post-fracture mechanical damage. No plastic deformation of the hook (i.e., bending or necking) was noted. The fractured hook was marked with an inspection stamp (Figure 4).

The fact that the fractured forward upper hook had an inspection stamp was important, because it indicated that it was not affected by Beechcraft Service Letter MTL-52-02. The fractured hook had therefore not required replacement prior to 12 January 2024 per Service Letter MTL-52-02. This service letter had been published because cabin entry door hooks may have been improperly CAD plated or improperly manufactured.

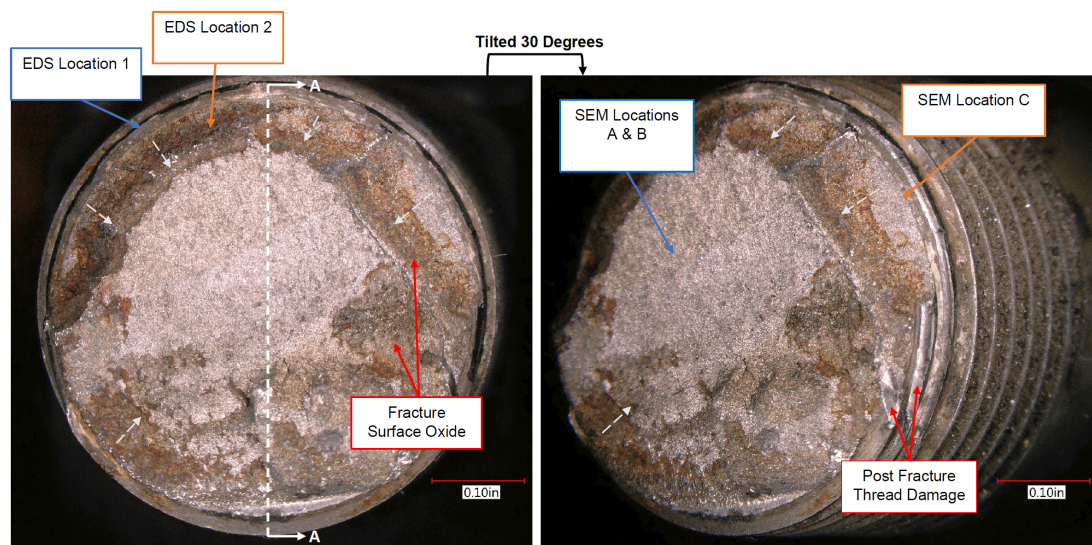
**Figure 5: Optical microscope images of the forward upper hook fracture surface**

The fractured surface of the forward upper hook was inspected using an optical microscope. Oxidation products were observed around the edge of the fracture surface which indicated corrosion and that the crack was present for an extended period of time (Figure 5). The fracture initiated from multiple locations around the circumference of the part and propagated inwards.

High magnification SEM images of several locations on the fracture surface revealed that the features of the fracture surface at every imaged location were consistent with intergranular fracture. Small pockets of ductile dimples were located near the center of the fracture surface. Crack branching was also observed.

The outer slanted and oxidized area of circular fracture surface (Figure 5) indicates an aged fracture area event, while the inner flat area indicates a second fracture event.

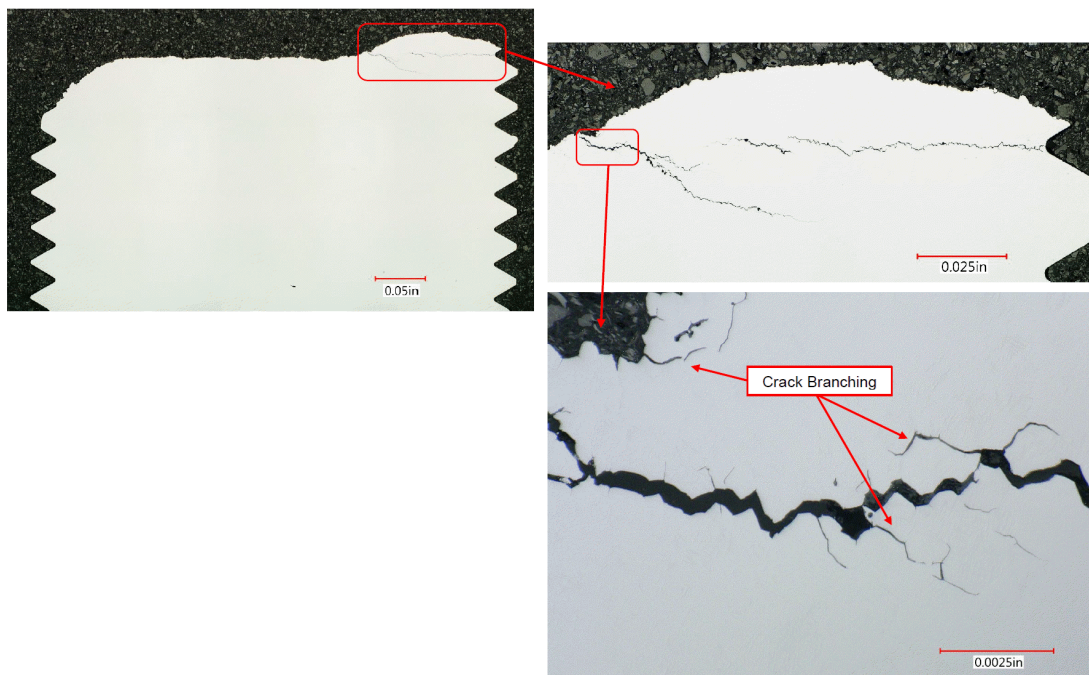
**Figure 6: Cross-sectional examination of the fractured forward upper hook**

Cross-sectional examination of the forward upper hook was performed (Figure 6). The fracture exhibited significant crack branching. No additional cracking was observed at the neighboring threads. The microstructure of the hook was consistent with quenched and tempered low alloy steel. The lack of grain deformation around the threads indicates that threads were machined and not rolled. The grain direction orientation was consistent with the engineering drawing requirement. Due to the thin nature of the cadmium plating layer the thickness was not verifiable.
