REPORT ON SERIOUS INCIDENT

Case nr.: **22-042F006**

Location: **Enroute from Malaga, Spain, to Keflavik, Iceland**

Description: **Declared an emergency due to possible low fuel availability**

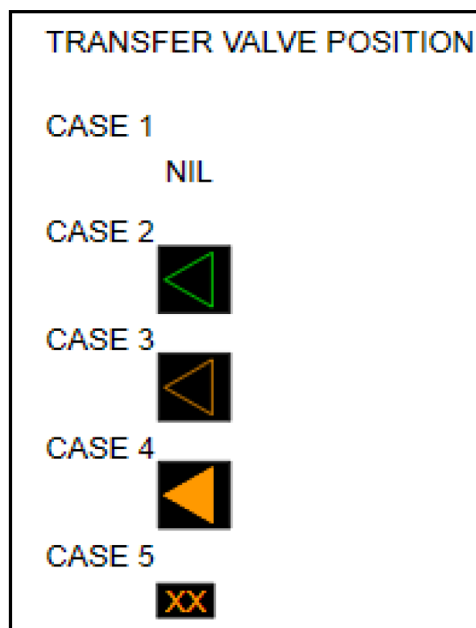
Figure 6: Transfer valve positions.

The following two fuel checks performed by the flight crew were as expected, but when they performed the third one, they noticed a hollow amber triangle on the ECAM (see Case 3 in Figure 6). From this they interpreted that the transfer valves from the outer wing fuel tanks to the inner wing fuel tanks were in transition position, neither fully open nor fully closed.

When a rear or forward ICTV is neither fully open nor fully closed and DC2 BUS is ON.

The hollow amber triangle on the ECAM (see Case 3 in Figure 6) appeared at 22:26, or at the same time as the seven advisory messages from the ECAM System. This went unnoticed on the following two fuel checks but was picked up by the flight crew on the third fuel check after the advisory messages appeared.

The unnoticed hollow amber triangle on the ECAM (see Case 3 in Figure 6) causes latent technical conditions as the flight crew was not aware that circuit breaker FIN 6PN was OFF, causing the loss of signal from the ICTV.

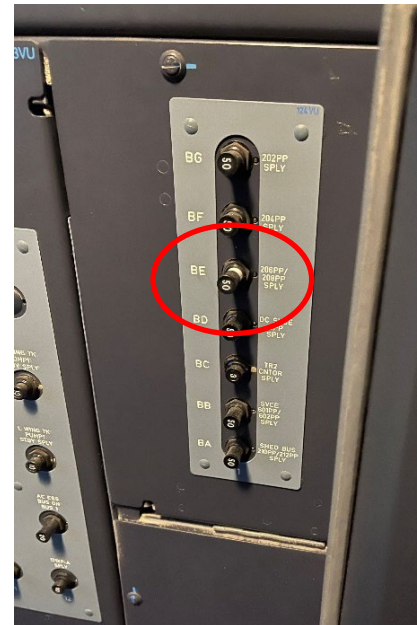
Figure 7: Circuit breaker FIN 6PN

The field investigation revealed that one circuit breaker, FIN 6PN, of P/N NSA931321-500, for the 206PP and the 208PP busbars was tripped. This is located on the wall behind the first officer, behind the observer seat (Figure 7).

During the maintenance after the flight, no fault was found, which could have caused the circuit breaker to trip. The circuit breaker was replaced, and the aircraft continued its scheduled flights.

The circuit breaker was tested with the assistance of the accredited representative of the Safety Investigation Authority of France (BEA³) and technical advisors from Airbus. Functional tests revealed that the circuit breaker was still functional and found no major electrical discrepancies compared with the NSA931321 technical specification. The tripping ability was also tested and found to be satisfactory.

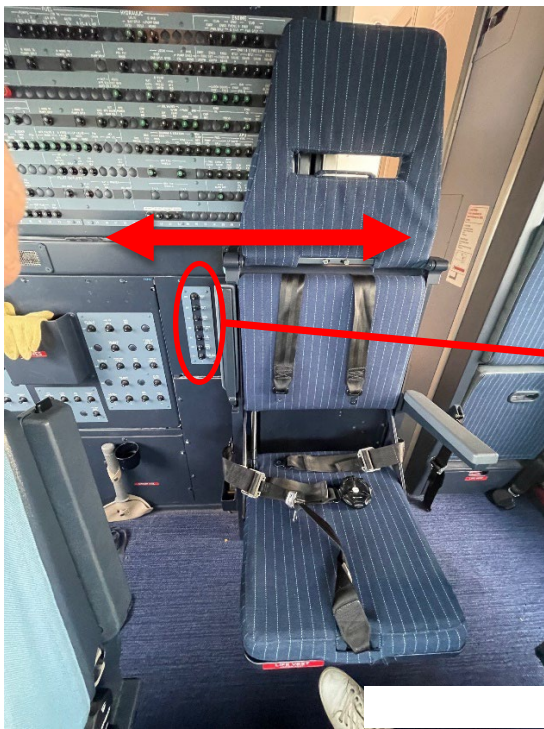
Figure 8: Observer seat close to C/B panel.

The observer seat on the flight deck is near the panel where the circuit breaker that tripped is located (Figure 8 and Figure 9). The seat and seatbelt can be moved to the left and right, depending on whether they are being used. While moving the seat, the seatbelt can reach the circuit breaker panel, get caught on the circuit breaker and trip it.

SIA-Iceland believes that the observer seat movement from its stowed position may have tripped circuit breaker FIN 6PN, thereby cutting the power off from busbar 206PP, which prevented the FWD Inter Cell Transfer Valves (ICTVs) and Fuel Quantity Indicating Computer from operating normally.

Figure 8 and Figure 9 are taken at the operator aircraft and show an erroneous layout of the shoulder harness on the observer seat. On Figure 10, the correct routing is shown on the right.

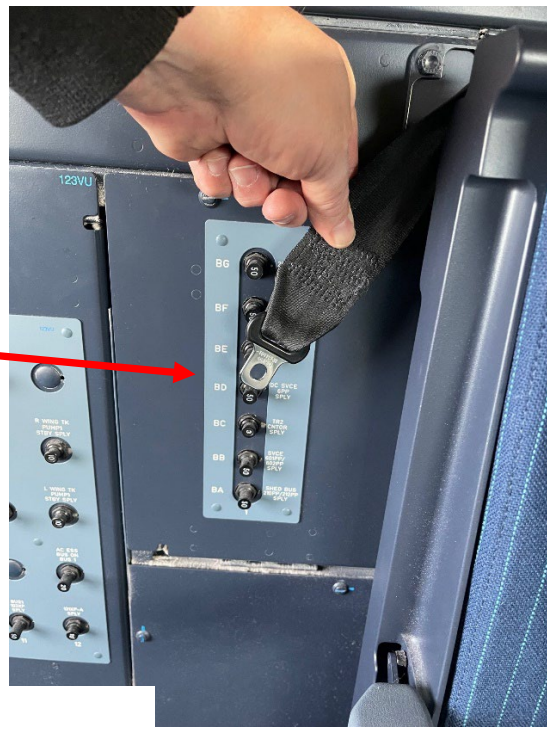
Figure 9: Seat belt reaches C/B FIN 6PN.

During the investigation it was determined that the most probable cause of the C/B FIN 6PN tripping was due to contact with the seat belt from the observer seat, while the seat was being moved from its stowed position, causing the fault messages from the ECAM (power loss on 206PP and 208PP). No malfunction of the C/B FIN 6PN was identified during the investigation.

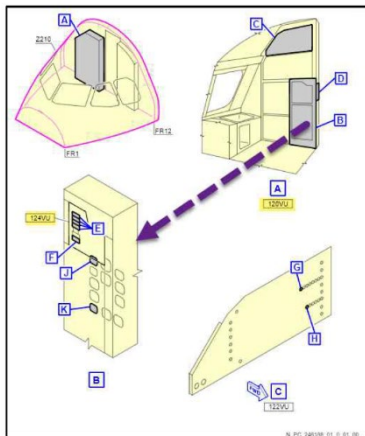
Figure 12: Location of observer seat.

Airbus, the aircraft manufacturer, has published an optional Service Bulletin (SB), SB A320-25-1590, which permits installing a transparent protection cover in front of part of panel number 123VU. This protection cover prevents inadvertent tripping of the circuit breaker (Figure 11 and Figure 12). However, this protection cover does not extend far enough to fully cover panel 123VU, nor does it cover panel 124VU, where circuit breaker FIN 6PN is located.

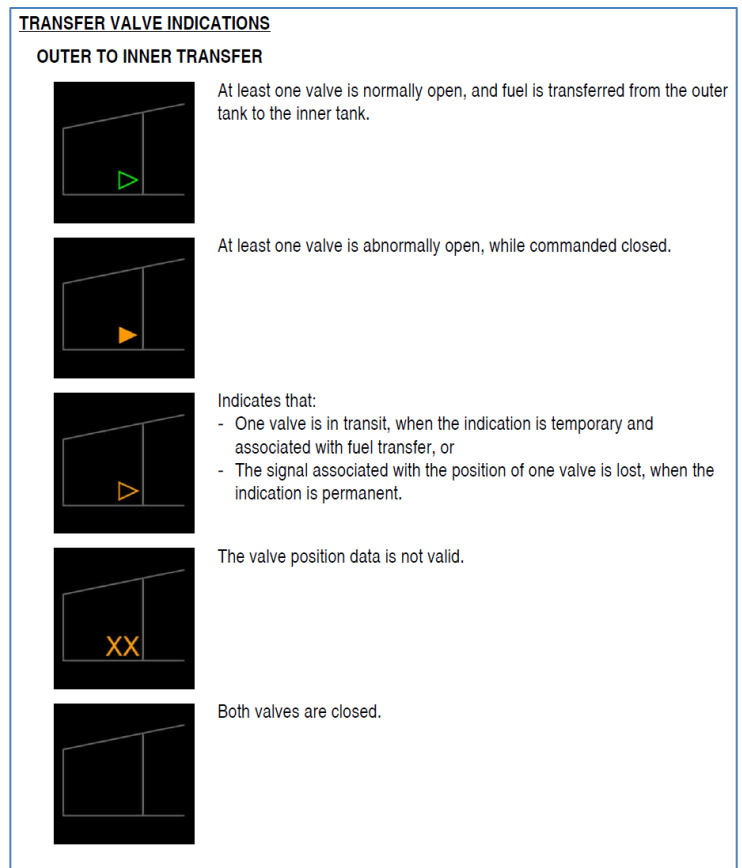
Figure 13: Outer to inner wing tank fuel transfer indications.

During the investigation of this incident, the manufacturer changed the explanation text in the FCOM to prevent misunderstandings about the different transfer valve indications. Figure 13 shows how the explanation text in Figure 6 has been improved. The outer to inner transfer valve hollow amber triangle indication text has been updated to state that when displayed

permanently, the signal associated with the position of one valve has been lost.
