# AIRCRAFT SERIOUS INCIDENT REPORT

Emergency situation due to near fuel starvation

M-01310/AIG-13

N96VF Beechcraft Corporation, G36 West-northwest of Keflavik, Iceland September 27<sup>th</sup>, 2010

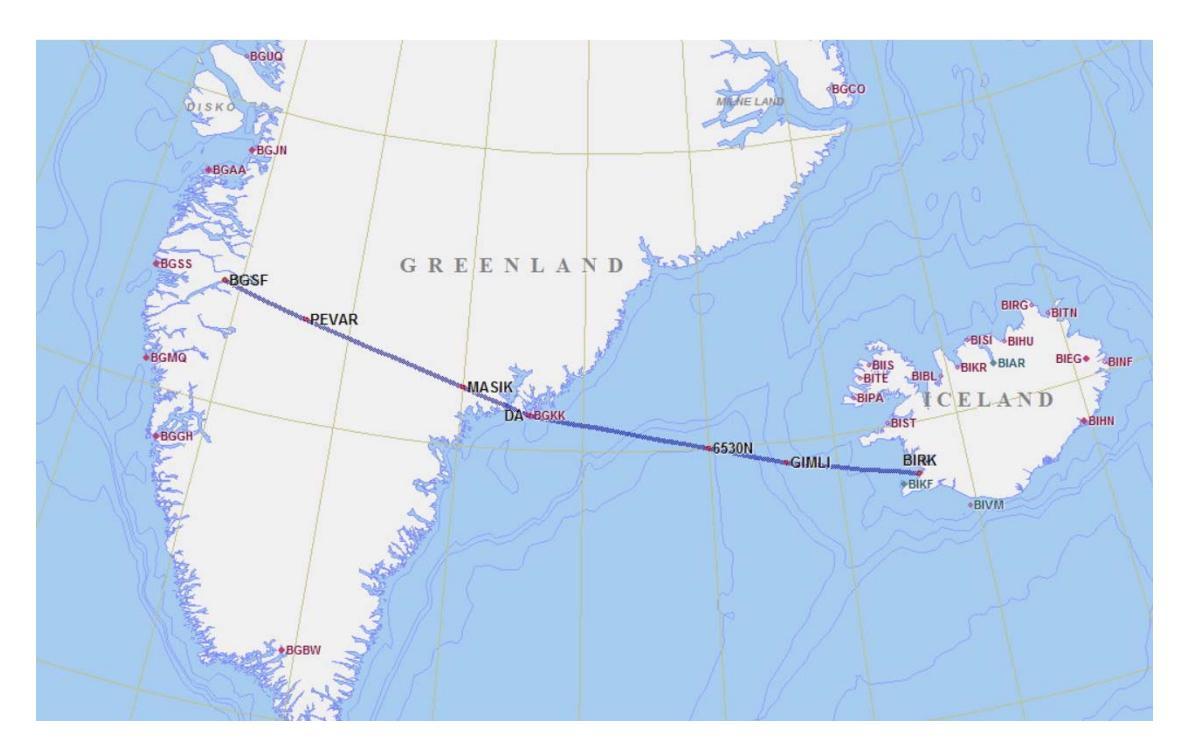
Figure 1: Planned flight route

N96VF, a Beechcraft G36, was being ferry flown from North America to Europe. On board was an experienced pilot, as well as the owner of the airplane, who was also a pilot. When in Sondrestrom, Greenland, they intended to make a fuel stop in Kulusuk, Greenland, but due to the late departure from Sondrestrom the airport at Kulusuk would be closed by the time N96VF arrived there. They therefore decided to proceed directly to Reykjavik, Iceland. At 18:39:34 on September 27th 2010, the pilots contacted ATC and filed a flight plan to Reykjavik Airport (BIRK). The flight plan was for FL150 and a six hour flying time. Figure 1 shows the planned flight route between Sondrestrom (BGSF) and Reykjavik (BIRK), overflying Kulusuk (BGKK).

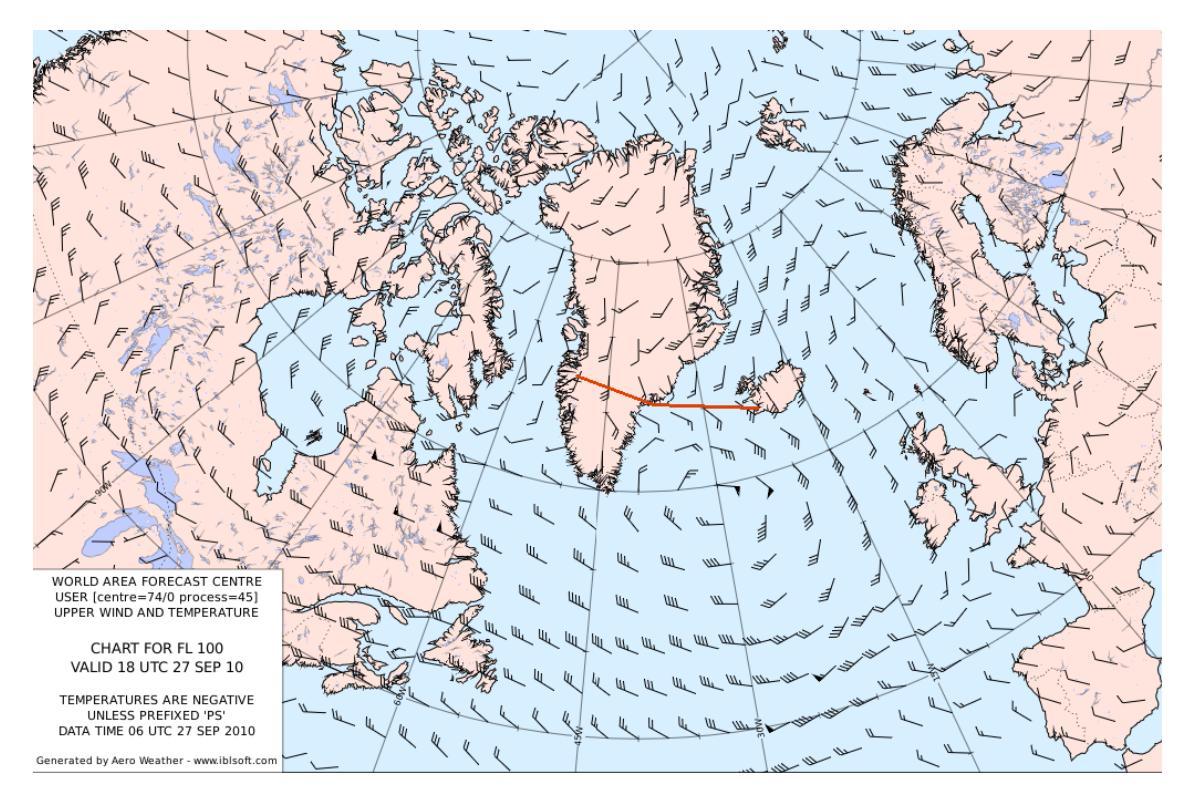
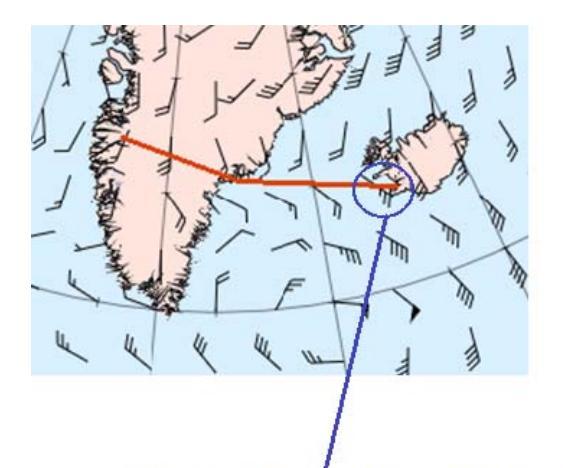
Figure 2: North Atlantic wind forecast at FL100 for 18:00 UTC on September 27<sup>th</sup> 2010

The maximum headwind from Figure 2 is estimated as follows:

Estimate 30° angle between flight path and wind direction Headwind component: (25 knots)(cos 30°) = 18 knots Figure 3 shows North Atlantic wind forecast at FL180 at 18:00 UTC on the 27<sup>th</sup> of September 2010.

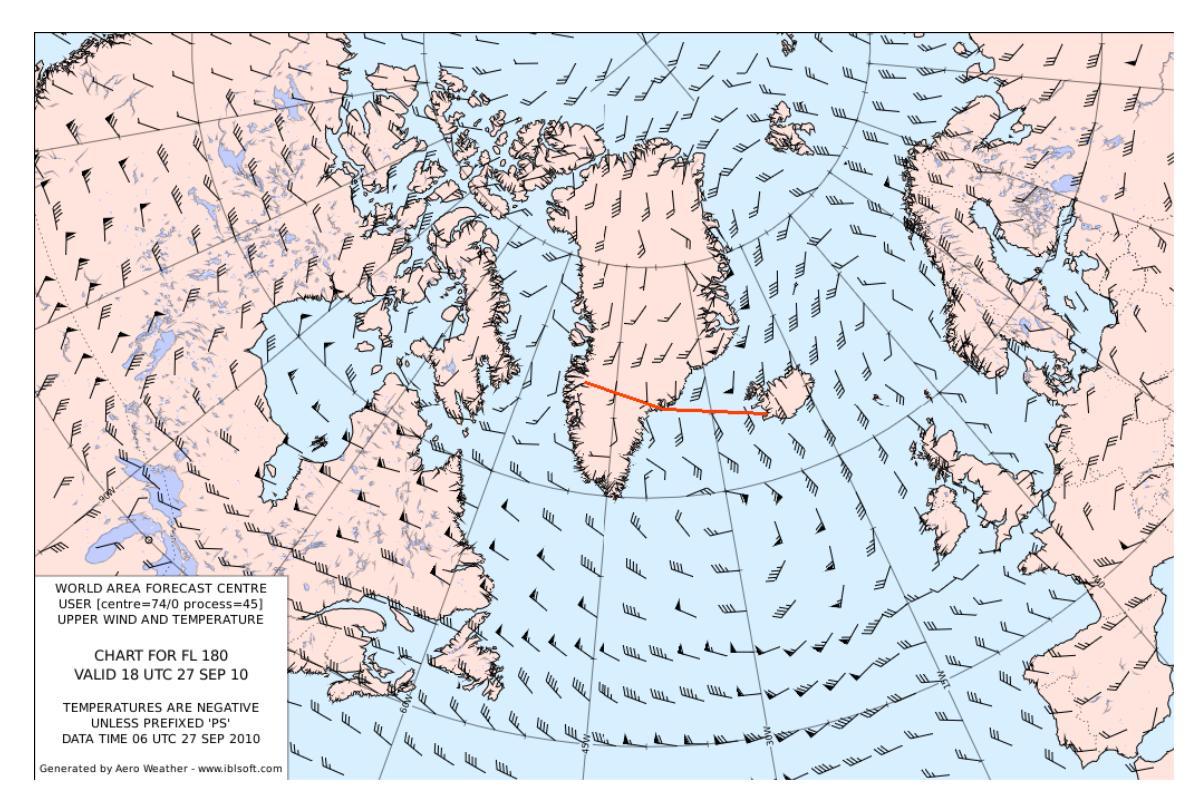
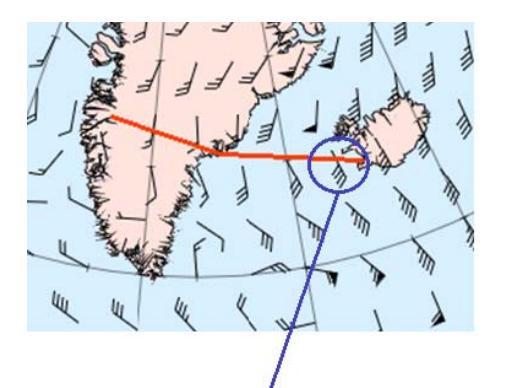
Figure 3: North Atlantic wind forecast at FL180 for 18:00 UTC on September 27<sup>th</sup> 2010

Estimate 50° angle between flight path and wind direction Headwind component:  $(40 \text{ knots})(\cos 50^\circ) = 26 \text{ knots}$

The flight plan was for FL150, so the estimated headwind at FL150 at 18:00 UTC, is:

$$18 \ knots + \left(\frac{5}{8}\right)(26 \ knots - 18 \ knots) = 23 \ knots$$

After the headwind rose to 50 knots, the maximum headwind at the planned FL150 per the 18:00 UTC forecast was therefore underestimated by:

```
50 knots – 23 knots = 27 knots
```

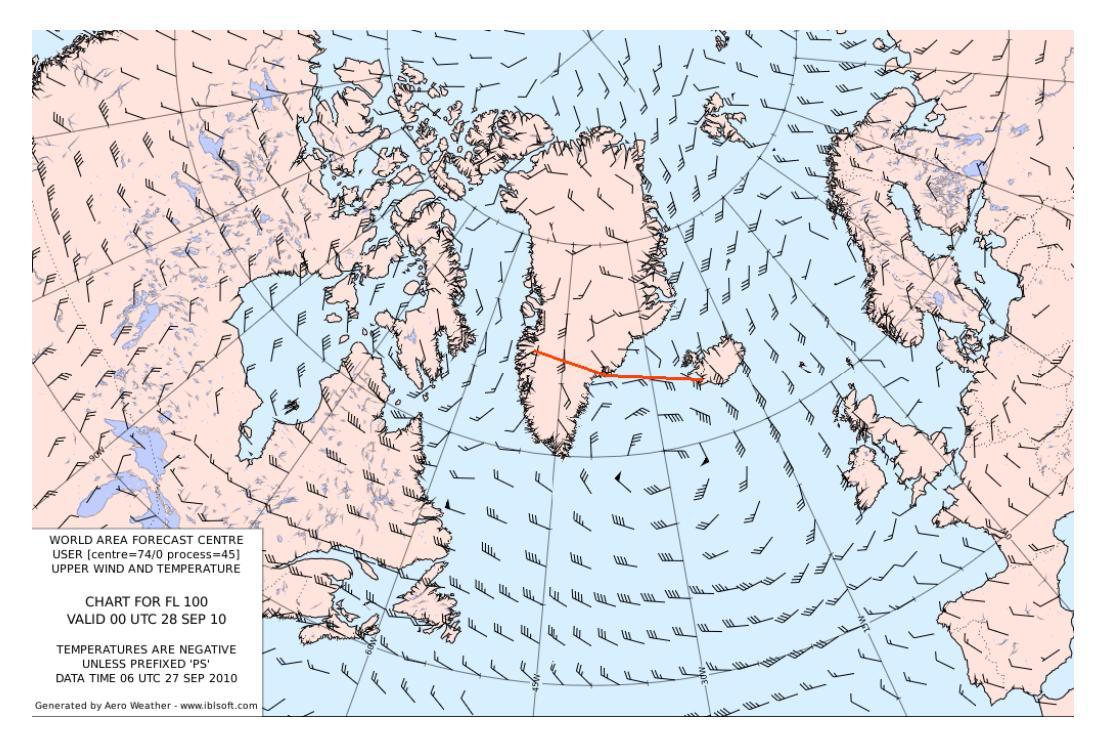
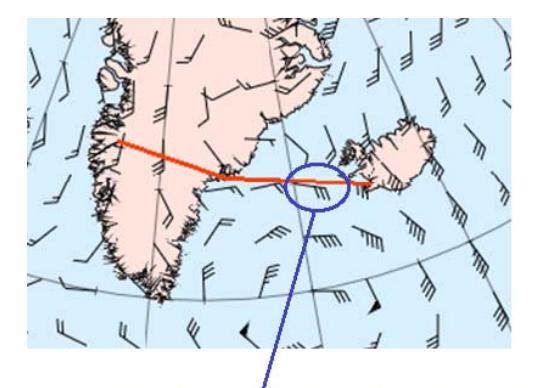
Figure 4: North Atlantic wind forecast at FL100 for 00:00 UTC on September 28<sup>th</sup> 2010

The maximum headwind from Figure 4 is estimated as follows:

Estimate  $15^{\circ}$  angle between flight path and wind direction Headwind component: (30 knots)(cos  $15^{\circ}$ ) = 29 knots

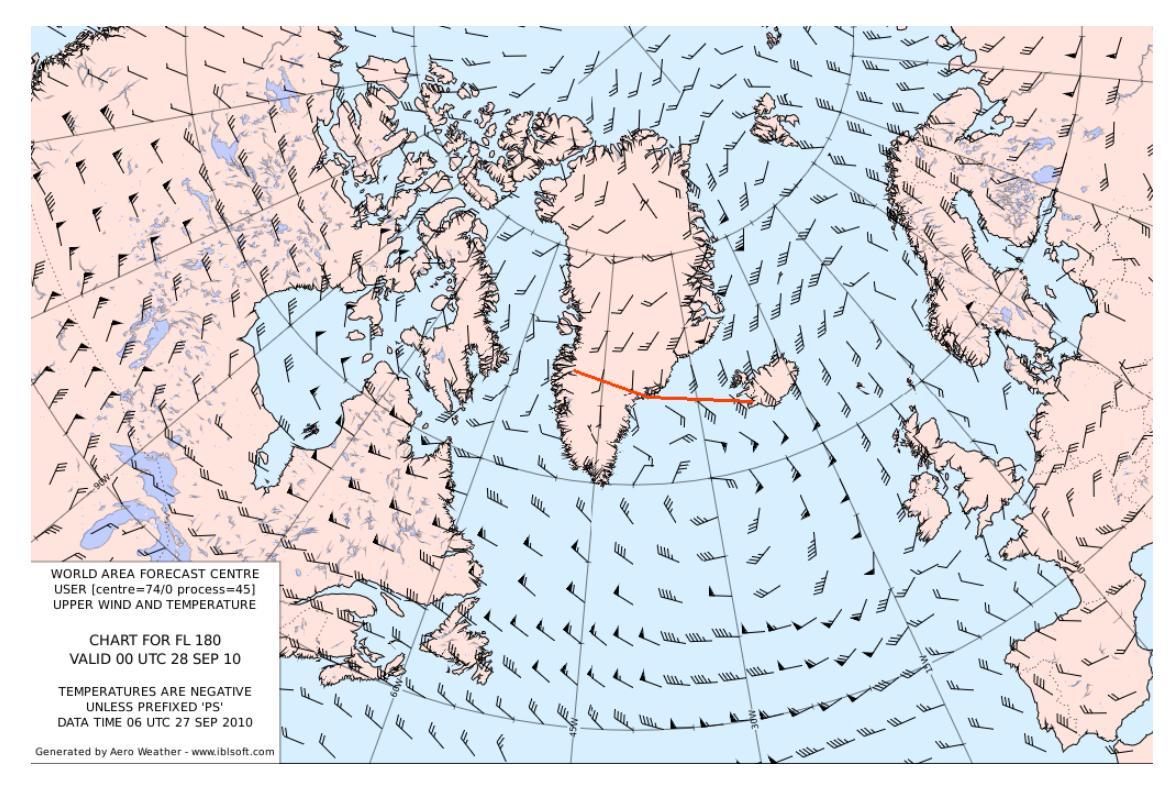
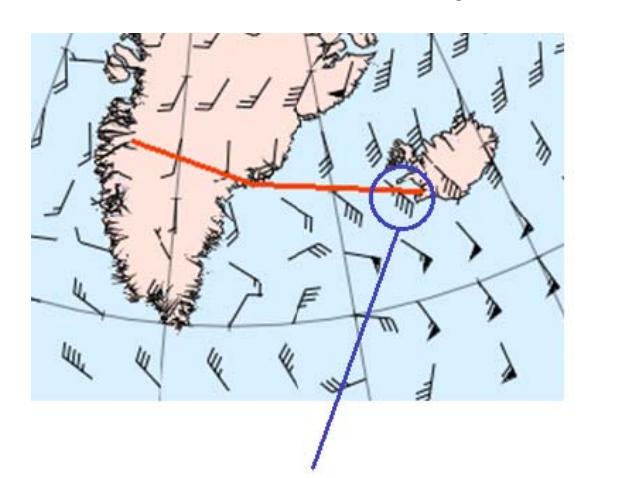
Figure 5: North Atlantic wind forecast at FL180 for 00:00 UTC on September 28th 2010

The maximum headwind from Figure 5 is estimated as follows:

Estimate  $35^{\circ}$  angle between flight path and wind direction Headwind component: (45 knots)(cos  $35^{\circ}$ ) = <u>37 knots</u>

The flight plan was for FL150, so the estimated headwind at FL150, is:

29 knots + 
$$\left(\frac{5}{8}\right)$$
 (37 knots - 29 knots) = **34 knots**

After the headwind rose to 50 knots, the maximum headwind at the planned FL150 per the 00:00 UTC forecast was therefore underestimated by:

50 knots – 34 knots = **16 knots**
