# AIRCRAFT ACCIDENT FINAL REPORT

Landed short of runway

M-05608/AIG-16 N558RS Piper PA 46 (Malibu Mirage) Egilsstaðir Airport Iceland September 11, 2008

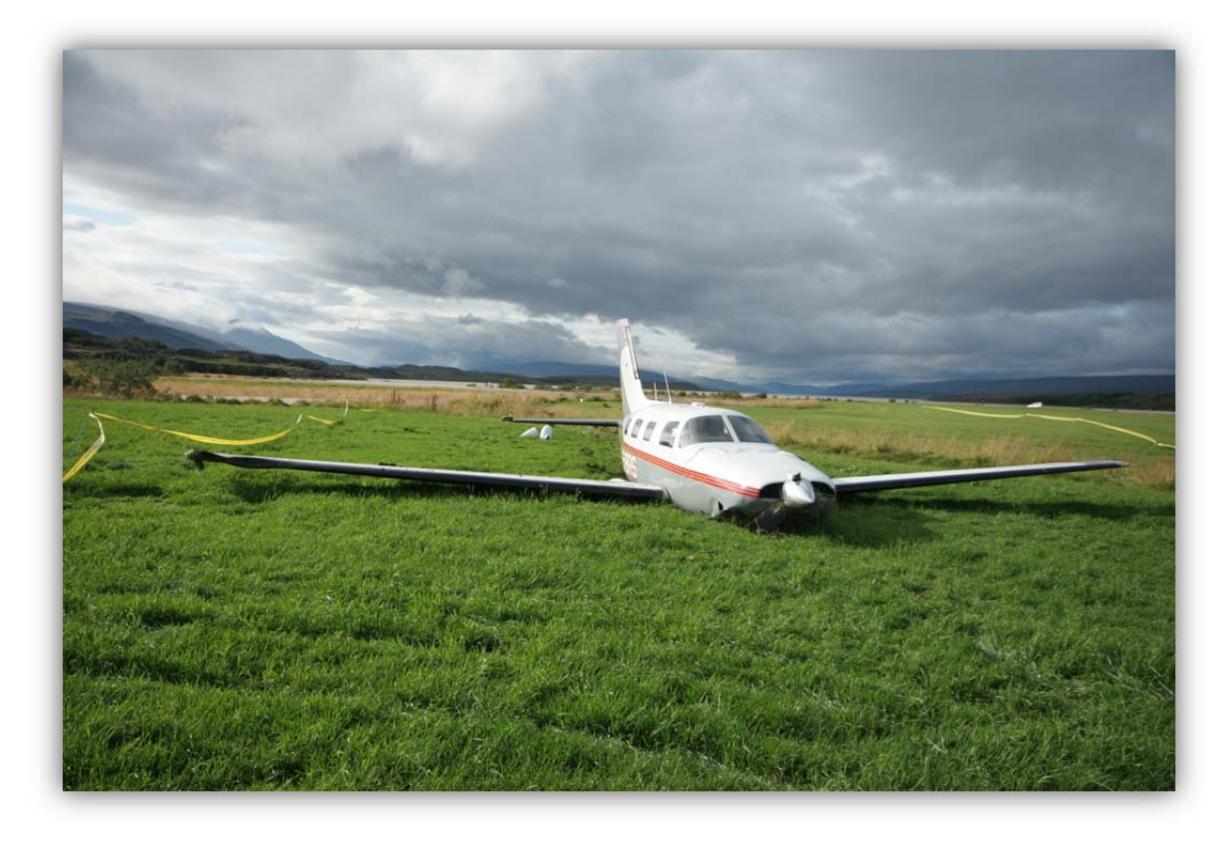
The landing gear broke off. The wing attachments fractured partially and the fuselage crumbled. All the propeller blades broke off. When inspecting the aircraft from the inside, damage could be found to the structural frame. It was evaluated that the aircraft was damaged beyond economical repair, see Figure 1.

Figure 1: The damage to the aircraft was evaluated to be beyond economical repair

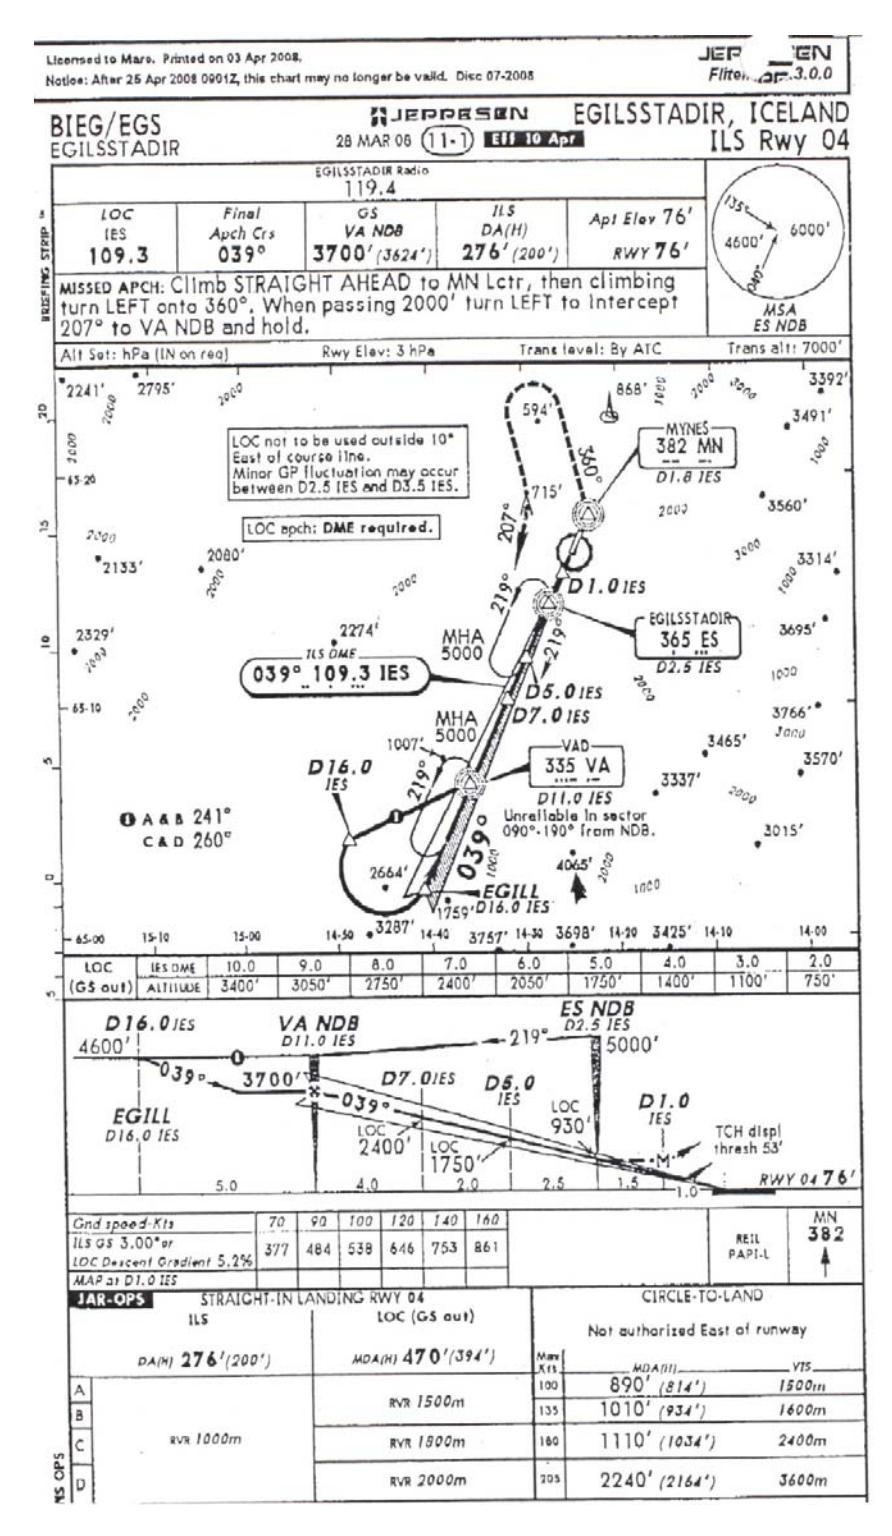
Figure 2: Jeppesen approach chart

The pilot followed the Instrument approach chart for Egilsstadir Airport, ILS RWY 04, published by Jeppesen. On this chart, it is noted that a minor GP fluctuation may occur between 2.5 and 3.5 DME see Figure 2. The pilot did not notice any fluctuation on the ILS. The pilot used the following chart for the approach to BIEG.

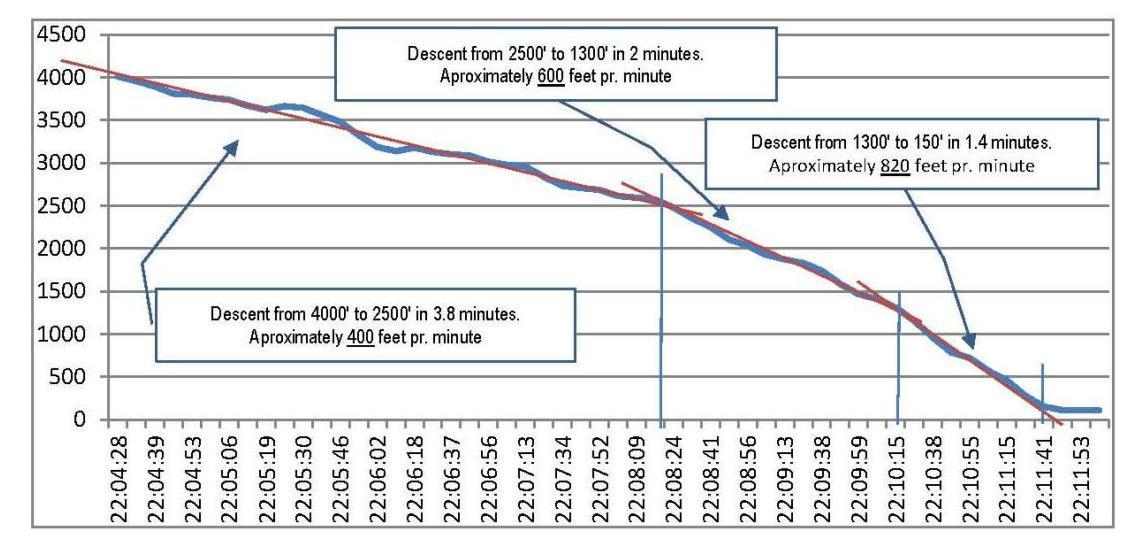
#### Figure 3: Calculated decent rate on the approach.

The pilot intercepted the LLZ around 16 Nm from RWY 04 and followed the glide slope down to 1 Nm prior to RWY 04. The following figure shows the recorded flight path from the handheld GPS that was on board the aircraft. From the information it was possible to calculate the descent rate as approximately 820 feet pr. minute for the last 1.150 feet. According to Figure 2, at a ground speed of 100 kts, his descent rate should have been 538 ft/min.

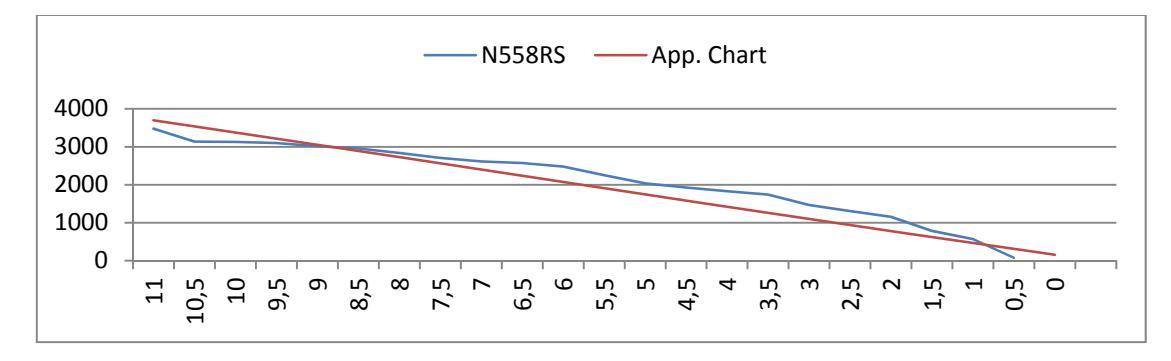
By looking at the GPS information of the pilot's handheld GPS vs. the glide slope (GS) information on the published Instrument approach chart, the aircraft was approximately 300' below the GS when the aircraft passed the FAF (3.700'). At 9 DME the aircraft went above the GS and remained above it until 1 DME. At that time the aircraft descended below the GS until it hit the ground.

Figure 4: Glide path of the aircraft (N558RS) vs. glide slope (from the App. Chart).

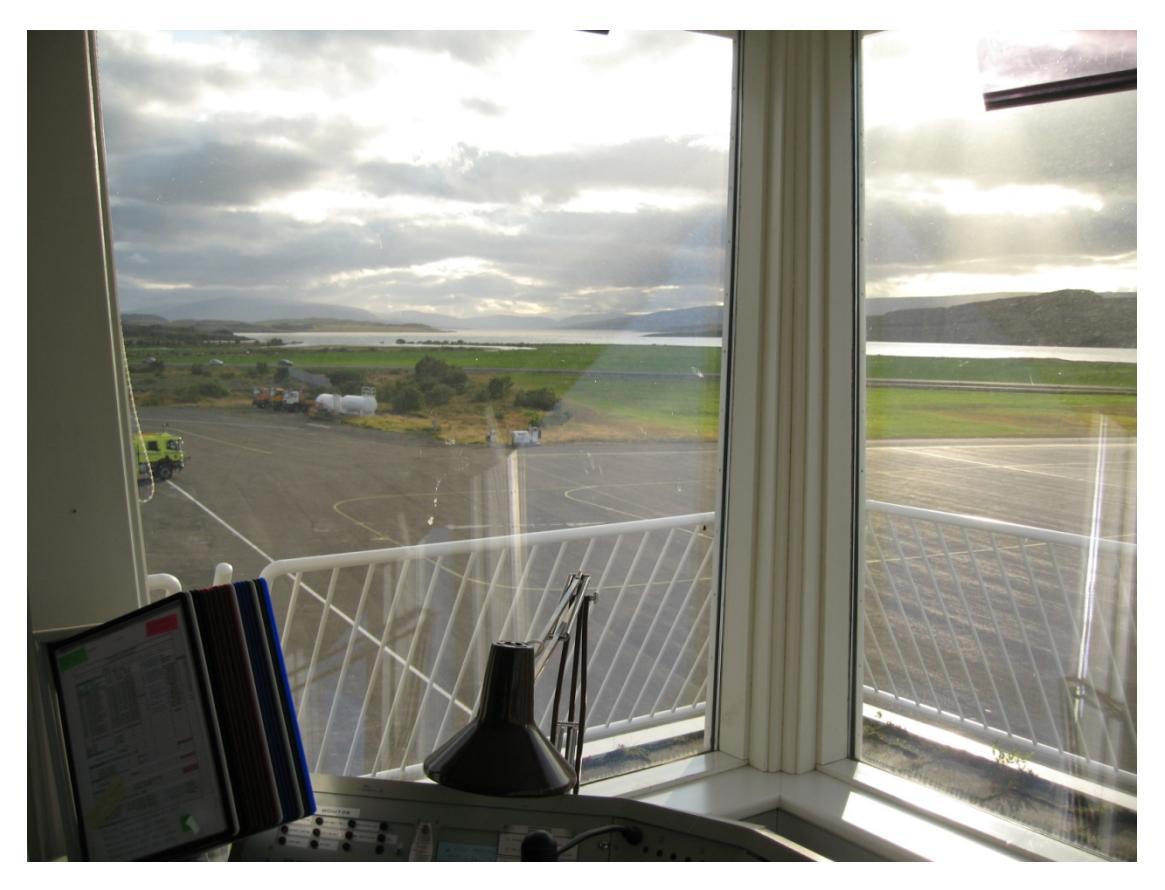
Figure 5: The view from the tower

The communication between the aircraft and the AFIS operator at the destination airport was clear and normal prior to the accident. The pilot received information of fog in the area and expected the approach to be difficult. However it was not possible to locate the fog patches precisely since it was dark and not measured on the airport weather meter. The pilot informed the AFIS that he would give the approach a try and would be ready to make a "go-around". During the approach, the AFIS operator observed the aircraft approach profile as normal until it entered the fog. When the aircraft emerged out of the fog it was however at a lower altitude than he expected. The AFIS operator then called the aircraft with a "Pull-Up" command. At the same moment the aircraft hit the ground, approximately 0.5 NM short of the runway. The pilot does not remember hearing this command from the AFIS operator but it can be heard on the recording of the communications. The following figure shows the view from the tower in the direction of the approach and the accident site.

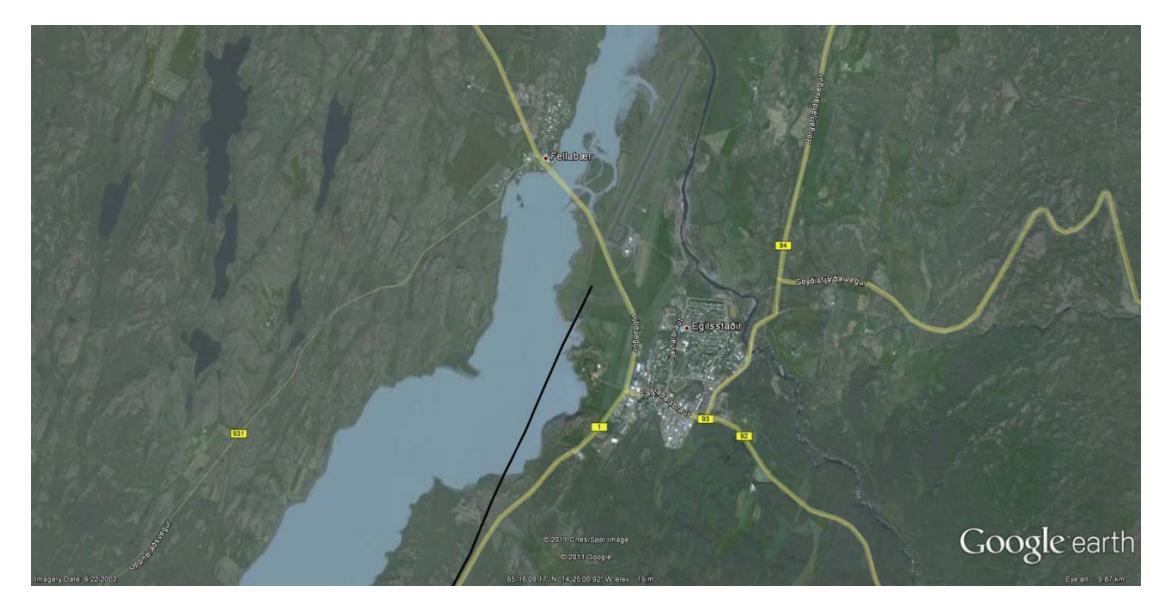
The airfield at Egilsstadir (BIEG) is located near a small town in mountainous area, where lights in the vicinity are limited. There is one runway at BIEG, RWY 04/22. The RWY is 1.850 meters long and 45 meters wide. There is a river parallel to the RWY with a bend in front of RWY 04, see Figure 6.

Figure 6: Egilsstadir area. The black line shows the GPS track of the aircraft.

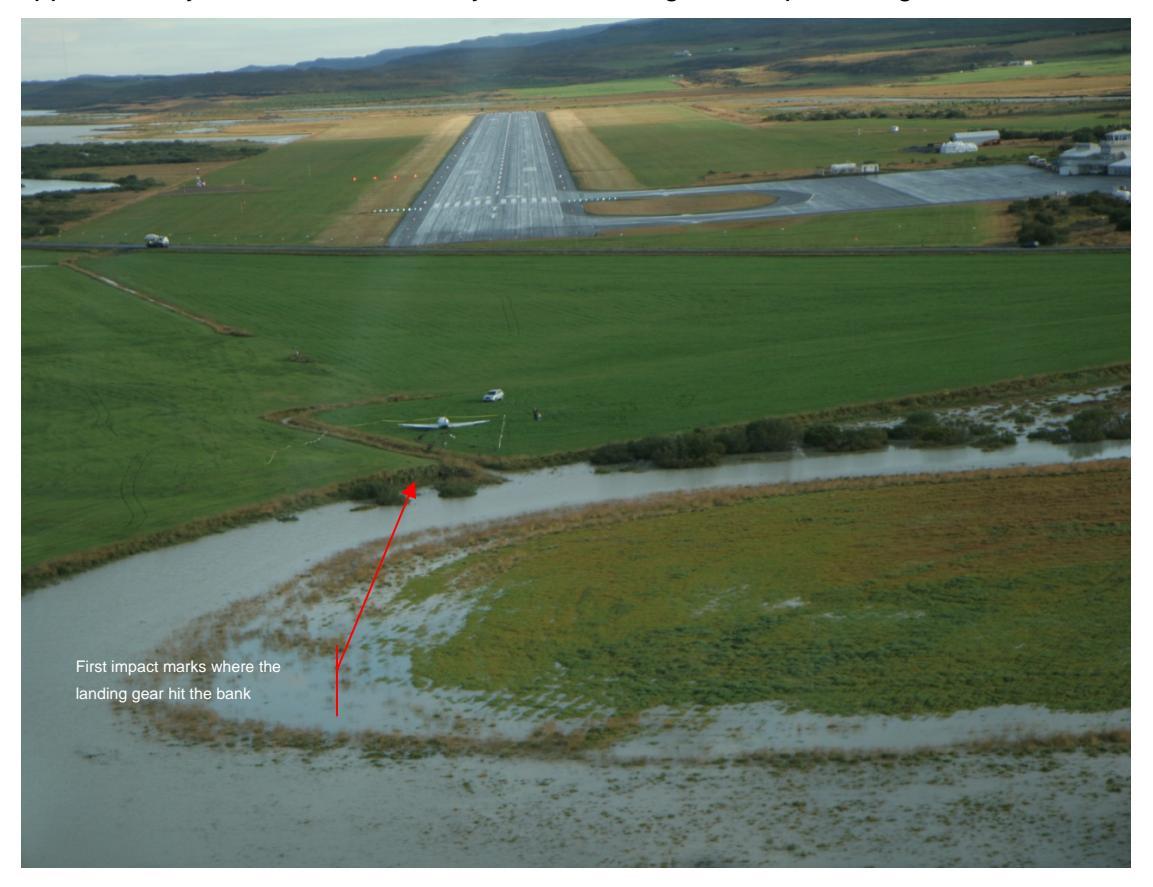
Just prior to impact the pilot had stopped the descent and pitched the aircraft up in order to perform a go-around. The aircraft hit the ground at a shallow angle and with its wings level. The landing gear struck the riverbank. The aircraft skidded forward approximately 20 meters on its belly before coming to a stop, see Figure 1.

Figure 7: The arrow shows where the aircraft hit the bank

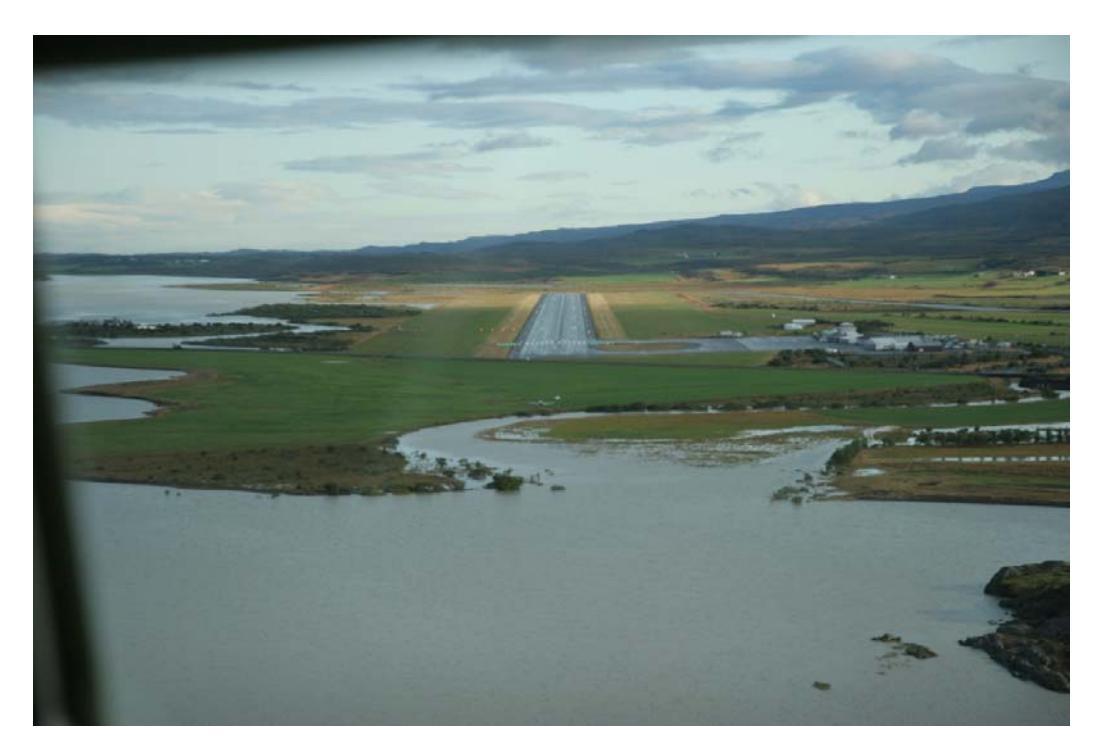
The approach for RWY 04 passes over the river "Lagarfljot". According to the statement of the AFIS operator the fog was located around the area where the picture below is taken. Due to the fog in the area, this might have given the pilot a false image of the runway.

Figure 8: Lagarfjót river in front of RWY 04
