FINAL REPORT AIRCRAFT SERIOUS INCIDENT

M-00511/AIG-05

TF-FIH

Boeing 757-200 PCF

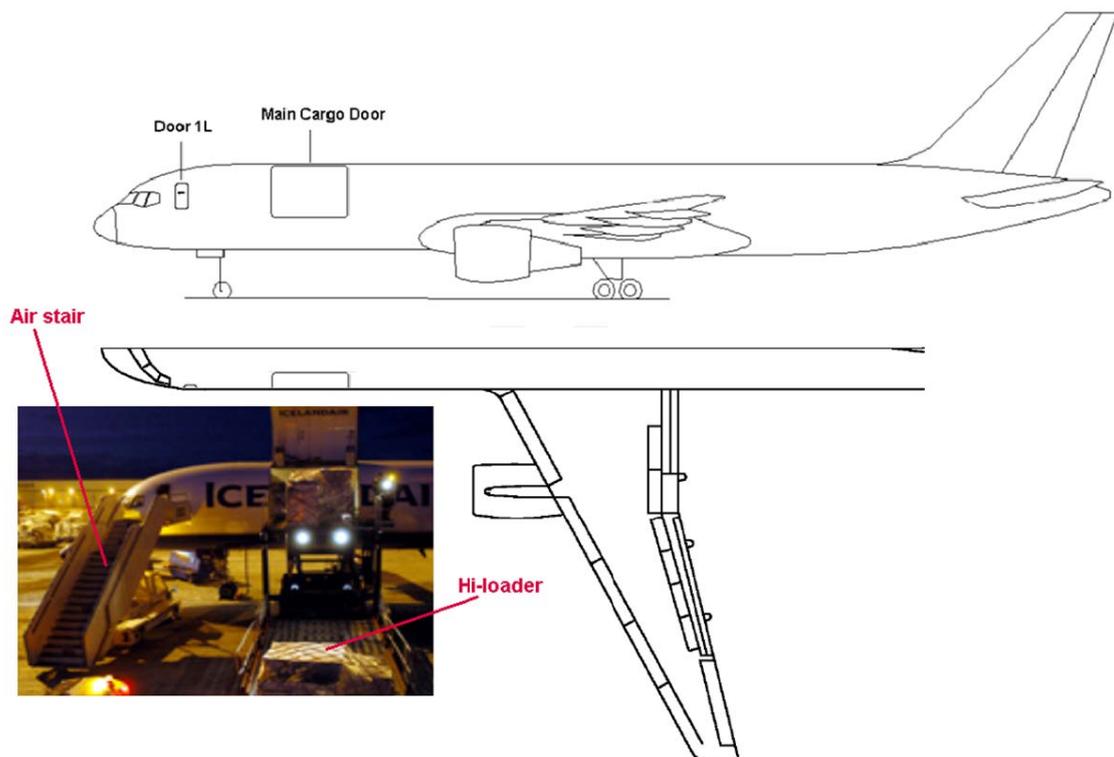
Figure 1 - Layout of Door 1L and Main Cargo Door

At 10:01:10³ on January 30th 2011, aircraft TF-FIH arrived at Stand 20 on the cargo apron at Keflavik Airport (BIKF) after a flight from New York (KJFK). The aircraft was parked with the nose heading in a direction⁴ of 290°. An air stair was positioned at door 1L, located on the forward left side of the aircraft. At the same time a cargo Hi-loader proceeded towards the aircraft's main cargo door on its left side. See Figure 1 for details.

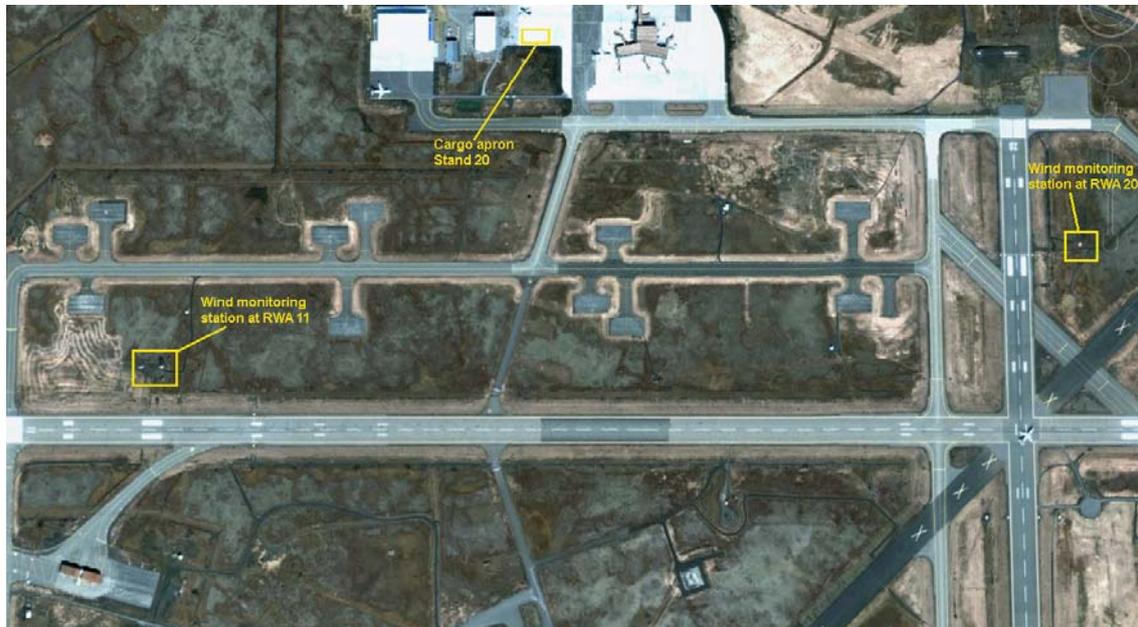
Figure 4 – Location of Stand 20 and the nearest wind monitoring stations

Figure 4 shows the location of stand 20 on the cargo apron at Keflavik Airport in relation to the nearest buildings and wind monitoring stations.

Cargo stand 20 at Keflavik International Airport is located close to several large buildings and hangars, as seen in Figure 5. At the cargo stand the local wind conditions are likely to vary slightly from those measured at the RWY11 and RWY20 monitoring stations, due to local wind channeling effects between buildings.

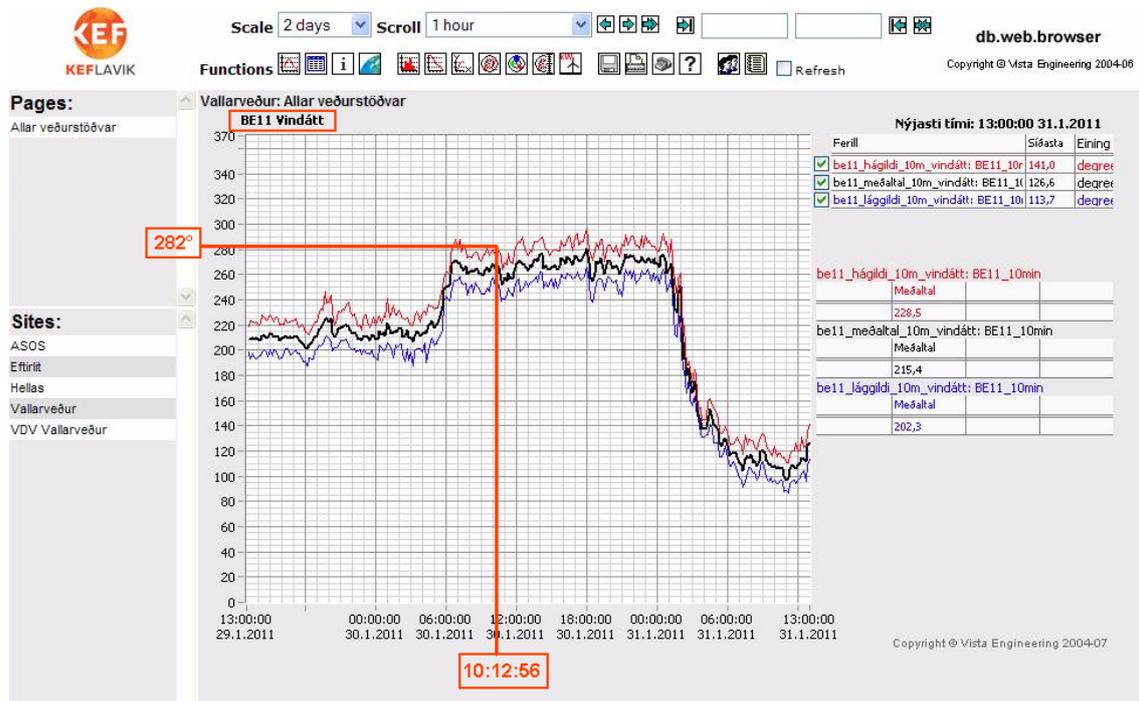
Figure 6 – Wind direction at the RWA 11 monitoring station

The actual wind data was collected from the two closest wind monitoring stations at the airport, i.e. at RWY11 and at RWY20. Figure 6 to Figure 9 in the Appendix show the wind direction and the wind strength when the incident occurred. Special attention should be given to the highest (gust) values at the time of the incident, which were as follows:
